Historic Landscape Report

OLANA STATE HISTORIC SITE HUDSON, NEW YORK

December, 1996

Robert M. Toole
Landscape Architect

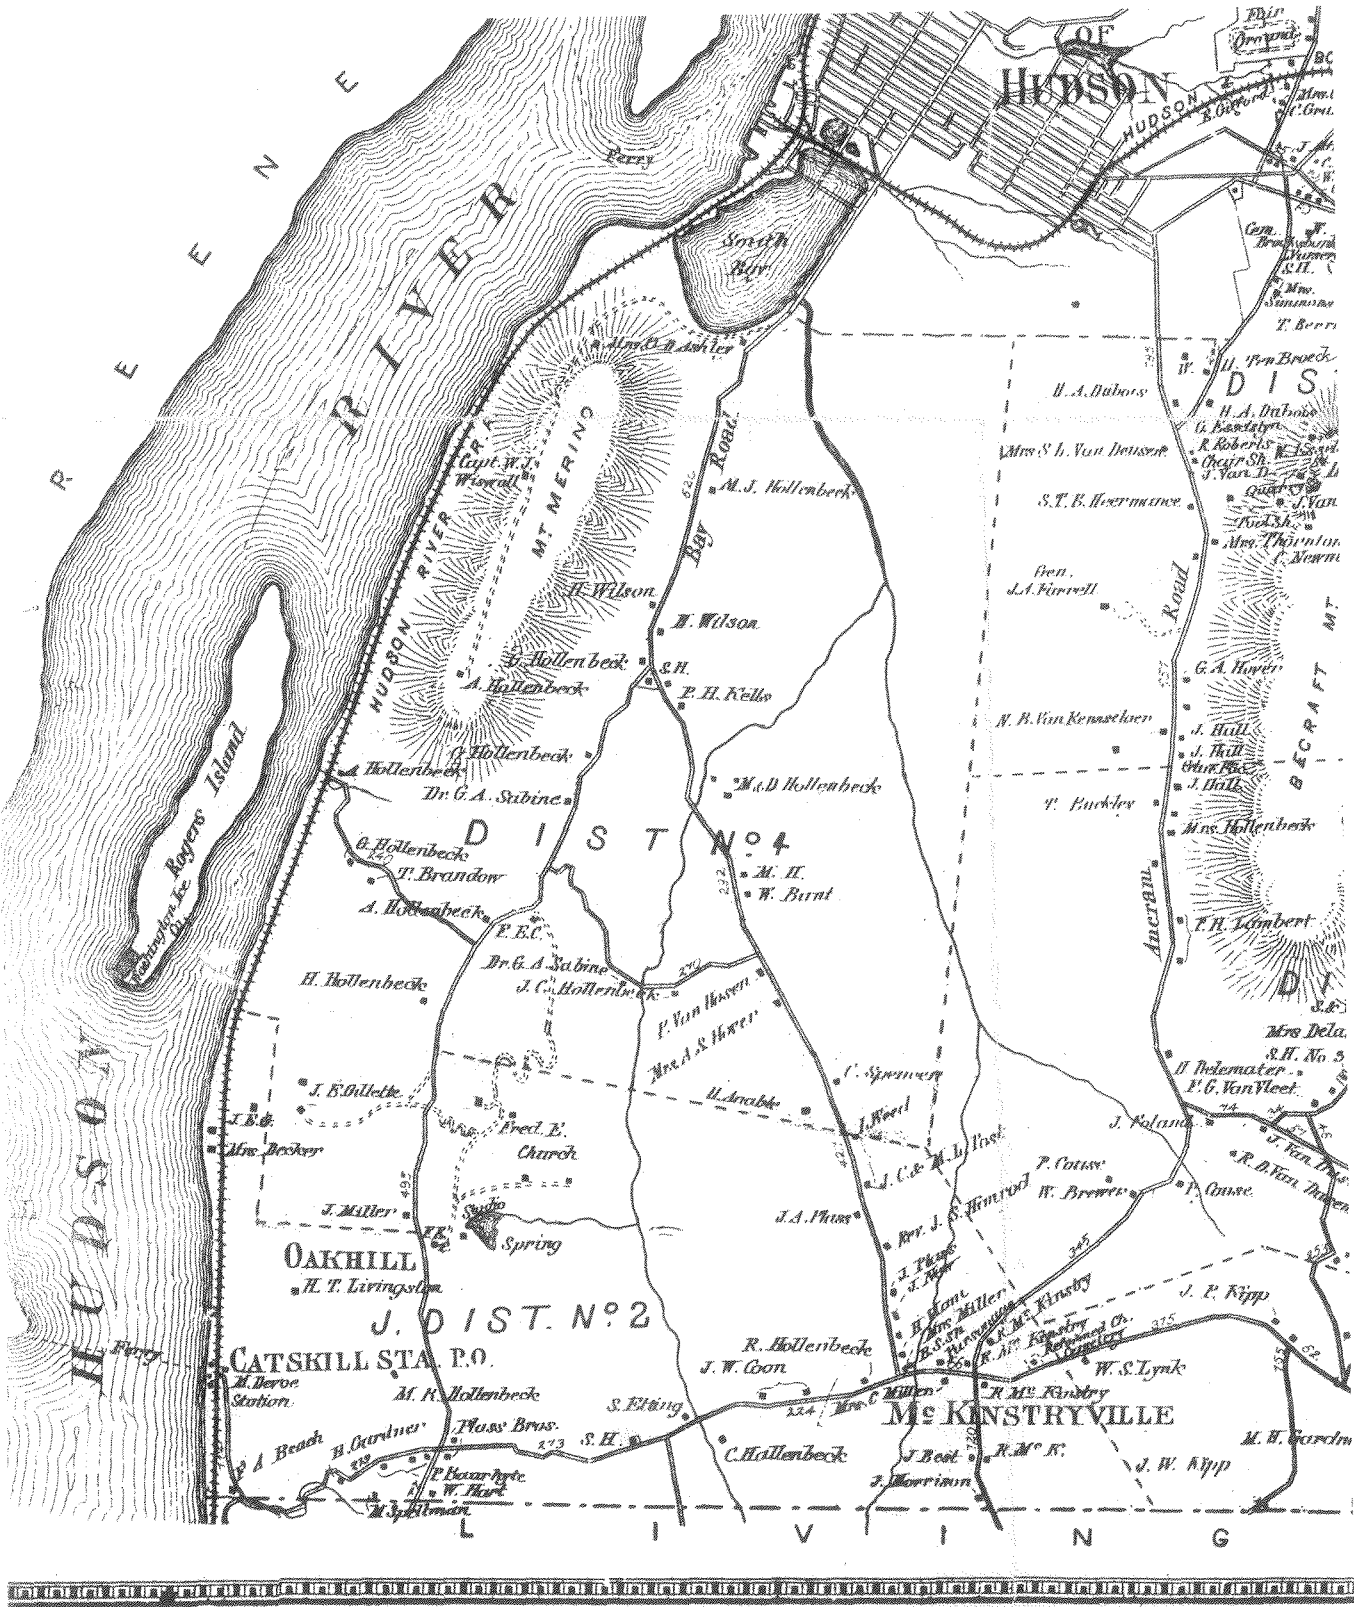
Figure 20 - Map Showing Olana, 1873.

This map was prepared just after Church completed construction of the main House and the sinuous North Road, both clearly shown here. The black square just above the "F" in "Fred." represents Church's studio. Cosy Cottage and the old farmhouse are represented northeast of the Lake. The property is illustrated with two gate houses, at the North and South Entrances, each inscribed "F.E.C." At the South Entrance, another black square is shown close to the Lake with the label "Studio" close-by. There is no other reference to this second structure and the studio label seems misplaced. The label "Spring" apparently refers to the source of the Lake. [Detail from: S.N. Beers, Atlas of Columbia County, N.Y., 1873].

Drafted fifteen years after an earlier Beers Atlas (fig. 20), the property is shown in its final developed form. The Ridge Road, the road around the Lake, and the Crown Hill Road are now included. The North Entrance shows the alterations made since the road to Hudson was re-routed in the 1870s (compare this area with the 1873 map). The distinct splay toward the east is shown (the older portion of the forked entrance is not shown). At the South Entrance, the curving entrance road oriented to the south and curving around Red Hill is clearly delineated. The studio, a black square in the "n" of "Olana," was soon dismantled as Church completed the studio wing on the house. [Detail from: S.N. Beers, *Atlas of Columbia County, N.Y.*, 1888].

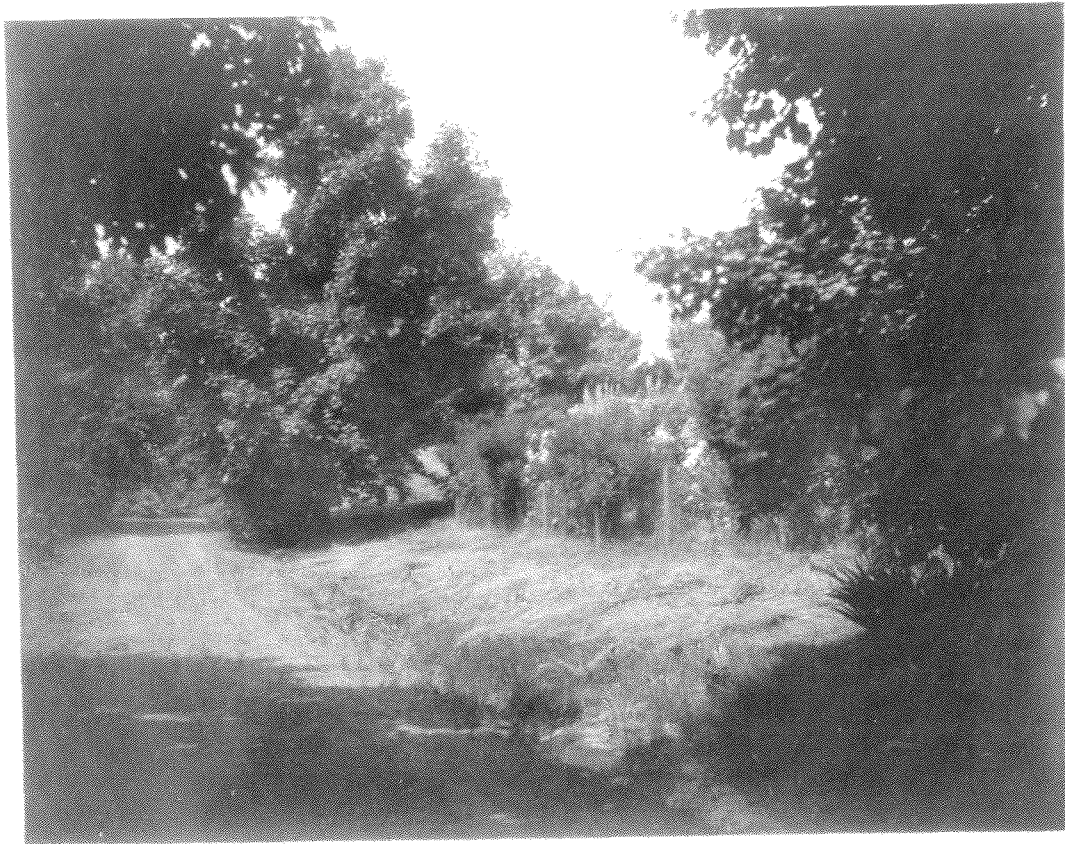
Figure 32 - Photograph of New Approach Road and mingled garden from the north, 1890-1900.

The view looks south and clearly illustrates the relationship of the carriage drive to the garden, which was installed in conjunction with the road's development after 1888. Note the wire fence on wood posts, and the road surface of shale with considerable turf stubble, showing a somewhat rural and unkempt appearance. [OL. 1987.188].

The final approach drive to the House was reached from the south by this route - the New Approach Road constructed by about 1889 -- Today, it is a faint turf track (compare with figure 32). The mingled garden, behind the wood posts on the right, was a feature approaching the House (coming toward the camera). Photographed here in spring, this garden will be a blowsy profusion of blooms during the summer. [RMT].

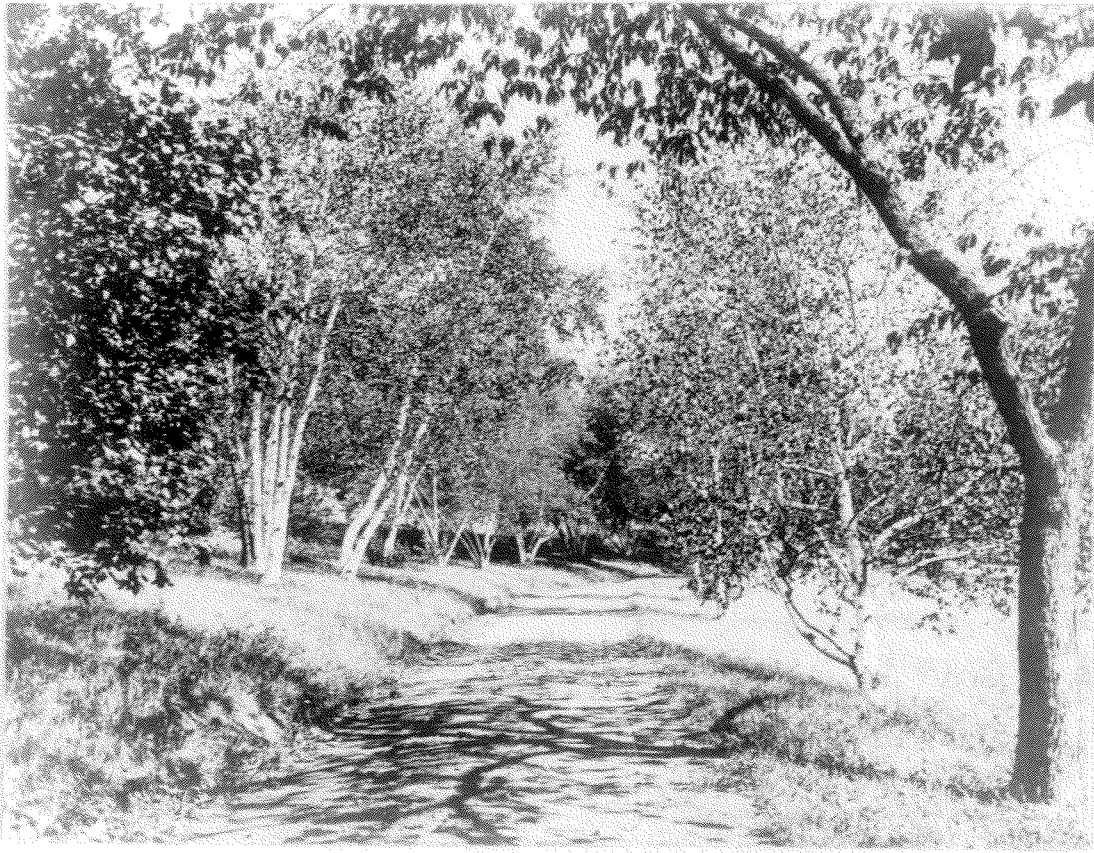
Figure 33 - Photograph of South Road with birch trees, 1906.

This is one of the photographs taken by John Eberle, dated 1906. It is believed to show the South Road (looking northeast) as it approaches the switch-back turn onto the New Approach Road, seen in the distance above the dark embankment. The birch trees, planted by Church, dominated the road edges in this area. [OL.1986.424].

This view shows the New Approach Road, today a turfed path, beside a portion of the modern paved exit road. These routes were once part of a single carriage drive -- the South Road -- leading to the House from the south. The former dominance of white birch trees (compare with fig. 33) is much reduced today with only a few birch still present. [RMT].

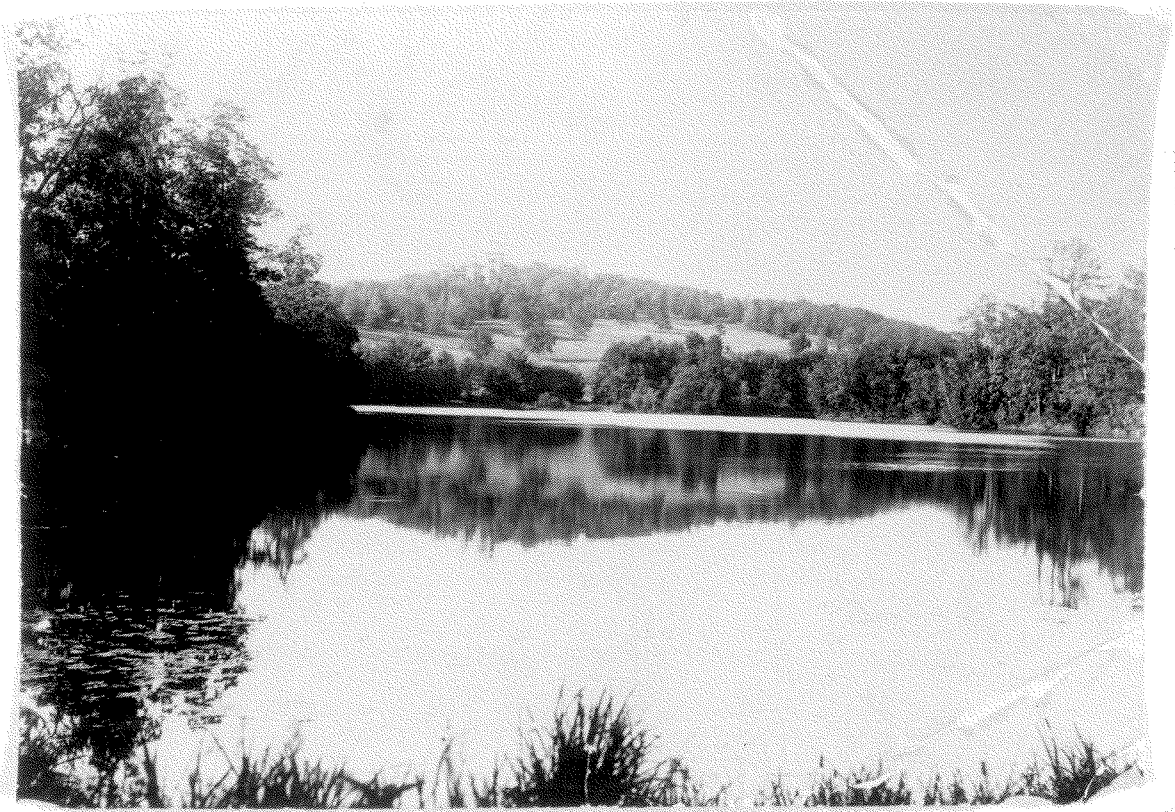
Figure 34 - Photograph of Lake, park and House from the south, 1890-1900.

The view looks north and shows the completed Lake with the park and House beyond. Note the scattered trees in the park. Some of these can be identified as American elms. The South Road is visible crossing below the House. The density of the foliage uphill is apparent as a more heavily treed backdrop. [OL.1987.66].

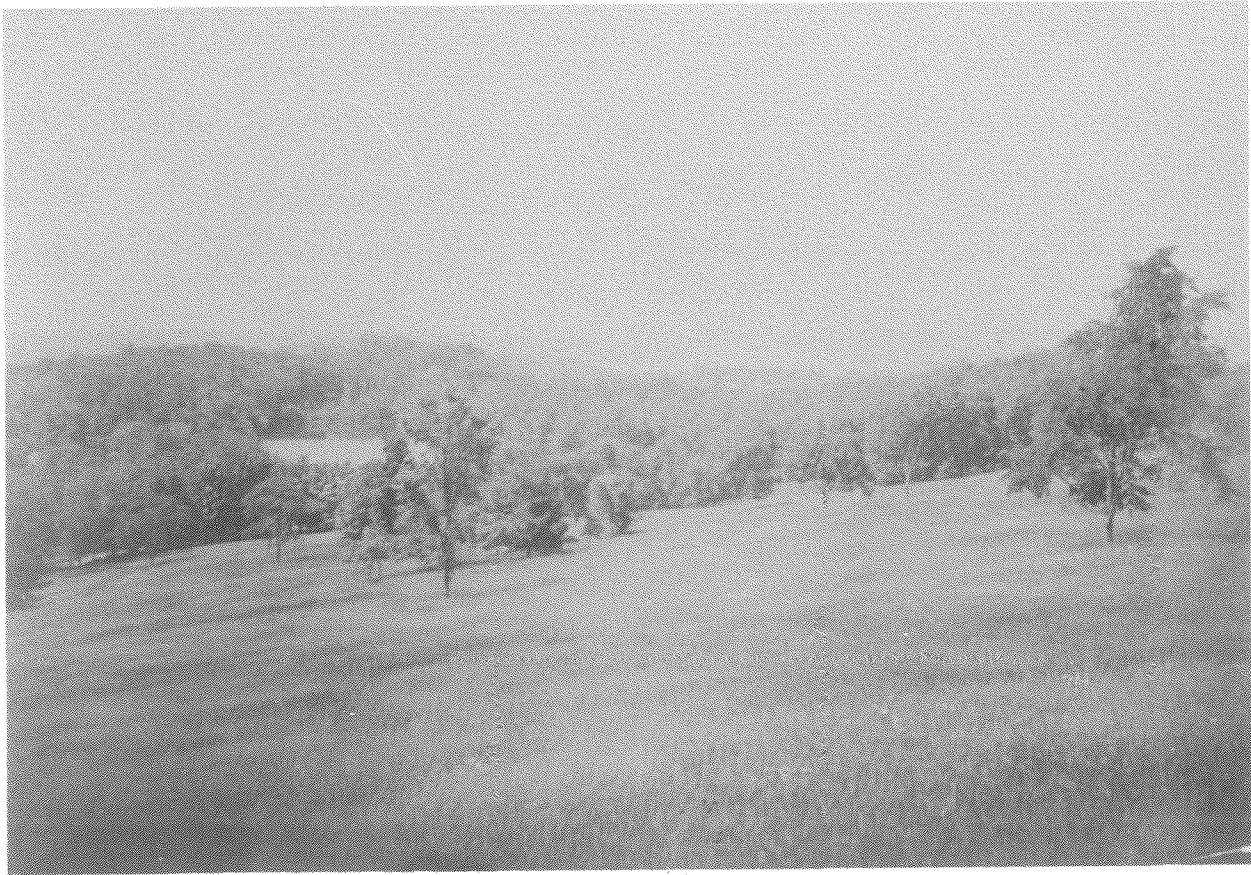
Figure 35 - Photograph of the park looking southwest, c. 1900.

The Lake is visible in the background, left. Some of the trees that are shown here are small and these suggest that there may have been ongoing plantings in the park even late in Frederic Church's lifetime. The uniform meadow grasses reflect the secondary use of the park as a hayed field and impart a distinctive, homogeneous character to the ground surface in this area [OL.1986.378.11.c].

The park was a mown meadow in Church's lifetime (fig. 35), but is today a less-monolithic turf with high percentages of invasive species. These include extensive areas of naturalized, yellow-flowering coreopsis, patches of lilac in the north corner just south of the House (reduced to a ground cover by frequent mowing), and extensive poison ivy that could seriously spoil an impromptu picnic in the wrong spot. These and other weedy

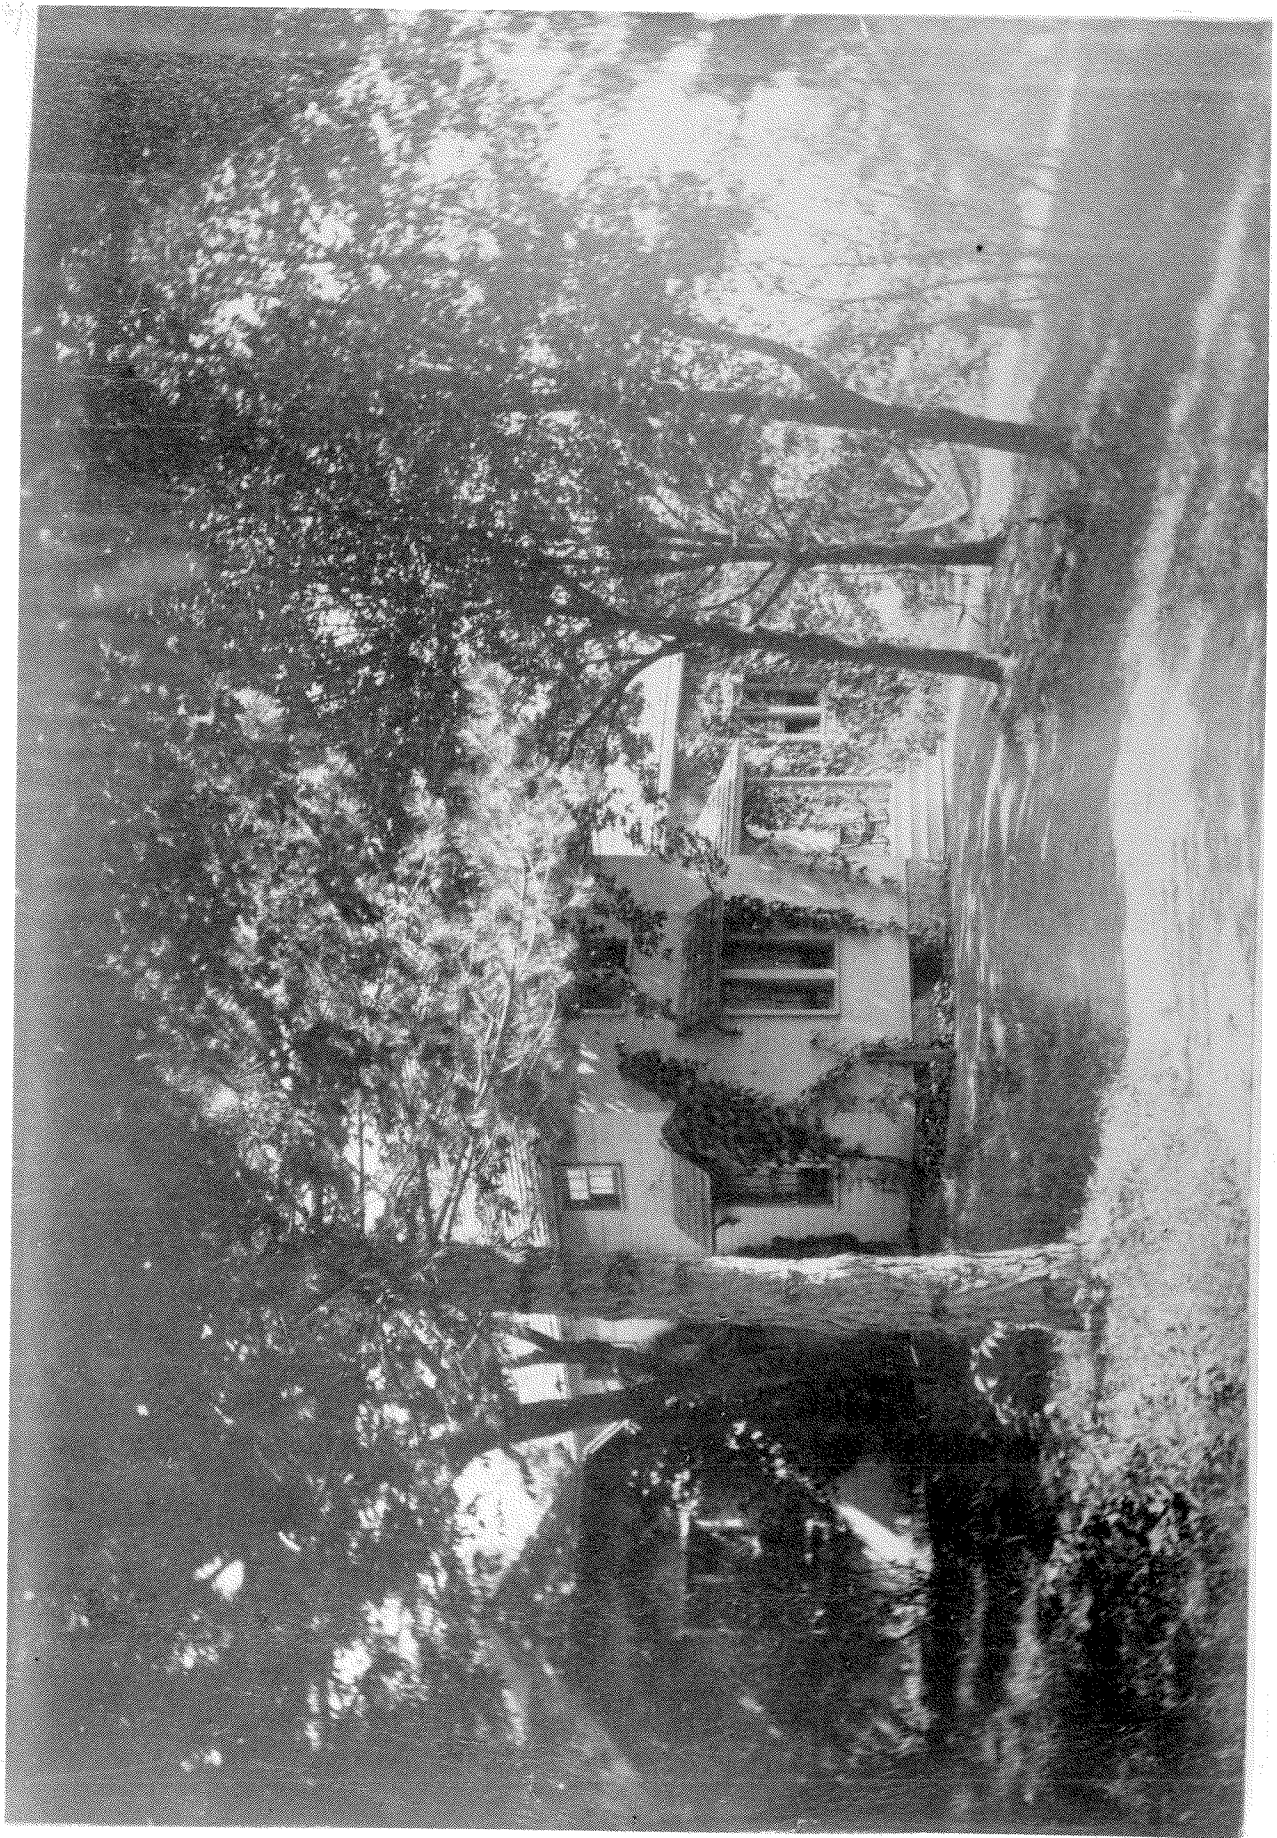
Figure 38 - Photograph, pre-1890s.

View of Cosy Cottage from the southeast. This view shows the completed, vine-embowered cottage as seen approaching on the driveway. The original 1860 core is ahead, with the later west wing seen on the left. Note the hammock between the trees opposite the entrance [OL.1986.59.2].

The area around the cottage is a lifeless and blighted version of its historic condition. The looping shale driveway surfaces are now obscured beneath turf. The road edges can still be traced and the lawn south of the cottage is now embowered under the mature trees seen in early photographs (fig. 38). Several pines believed to date from the historic period remain.

The illustration is the most detailed view available for the western wing of the cottage. Also, the trees (the pine and curving trunk behind it, left of center; and the three to the right of the car) can be compared with the earlier view (compare with Figure 38). The ornamental trappings (e.g., vines and bird house) that so distinguished the romantic *cottage ornée* were at this date reduced to the austere orderliness of the house of Olana's farmer. [OL.1996.1].

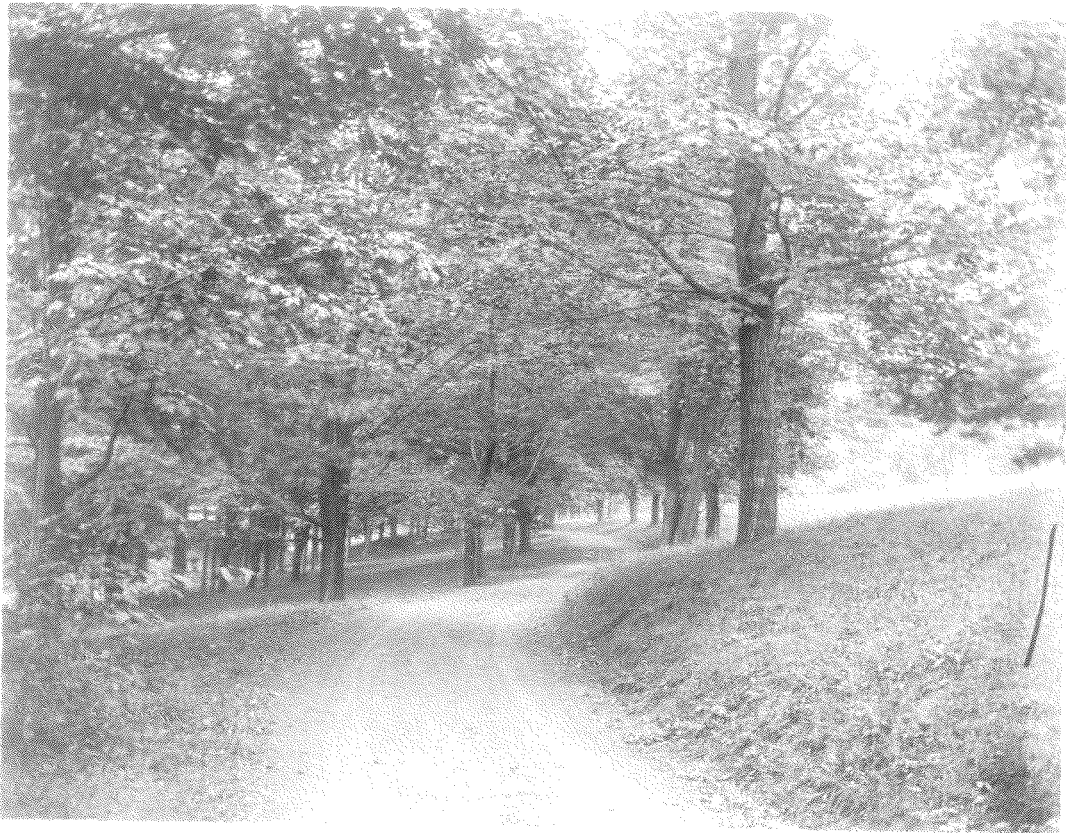
Figure 40 - Photograph of driveway to Cosy Cottage from the east, 1906.

Another Eberle photograph showing the maple tree-lined driveway built by Church to give access to the cottage, separated from the lower Farm Road (left). In the distance, left, is the screened pump house. [OL.1987.131.21.a].

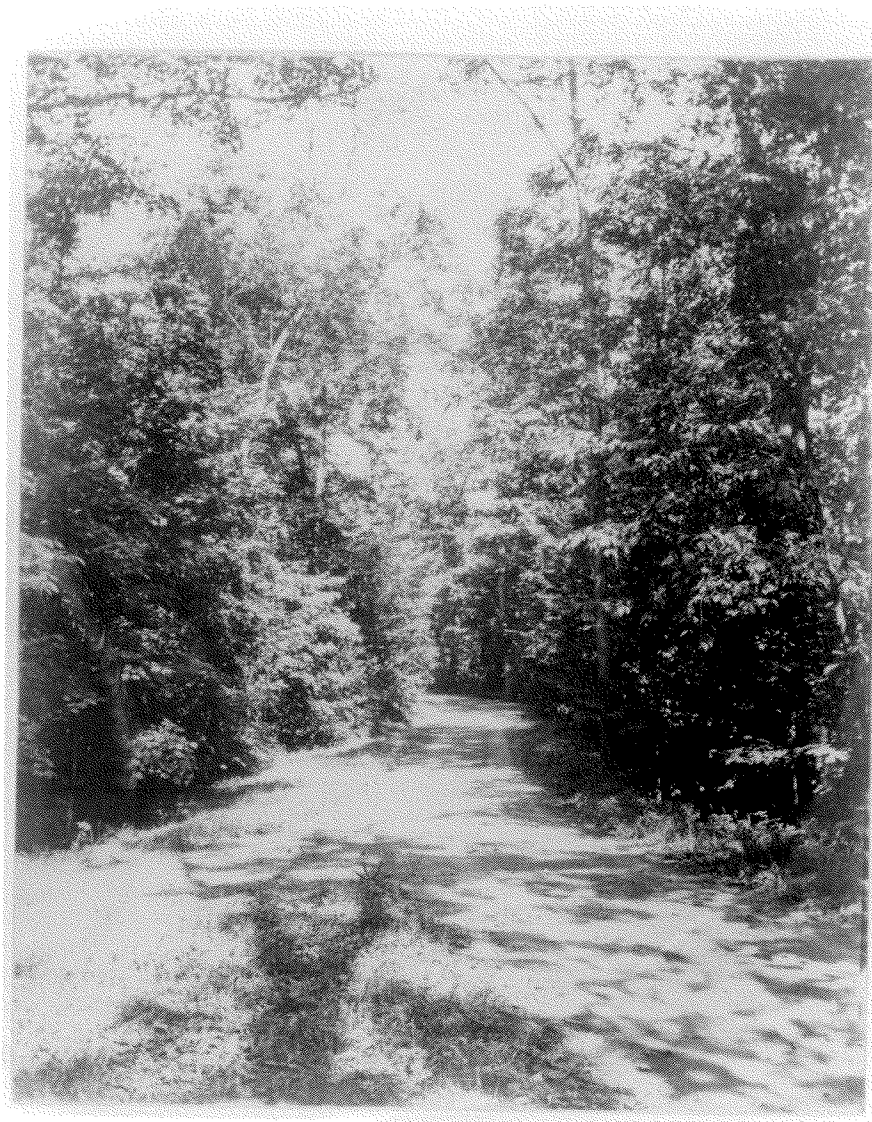
Figure 41 - Photograph of the North Road from the south, 1906.

The Eberle photograph is taken at the point where the lower Farm Road (foreground, right) joins the North Road. Ahead, a half-mile away is the North Entrance, while the North Road turned uphill, to the left, from this intersection. Note the density of the woods and the rough, rural appearance of the roadway. [OL.1987.131.36.a].

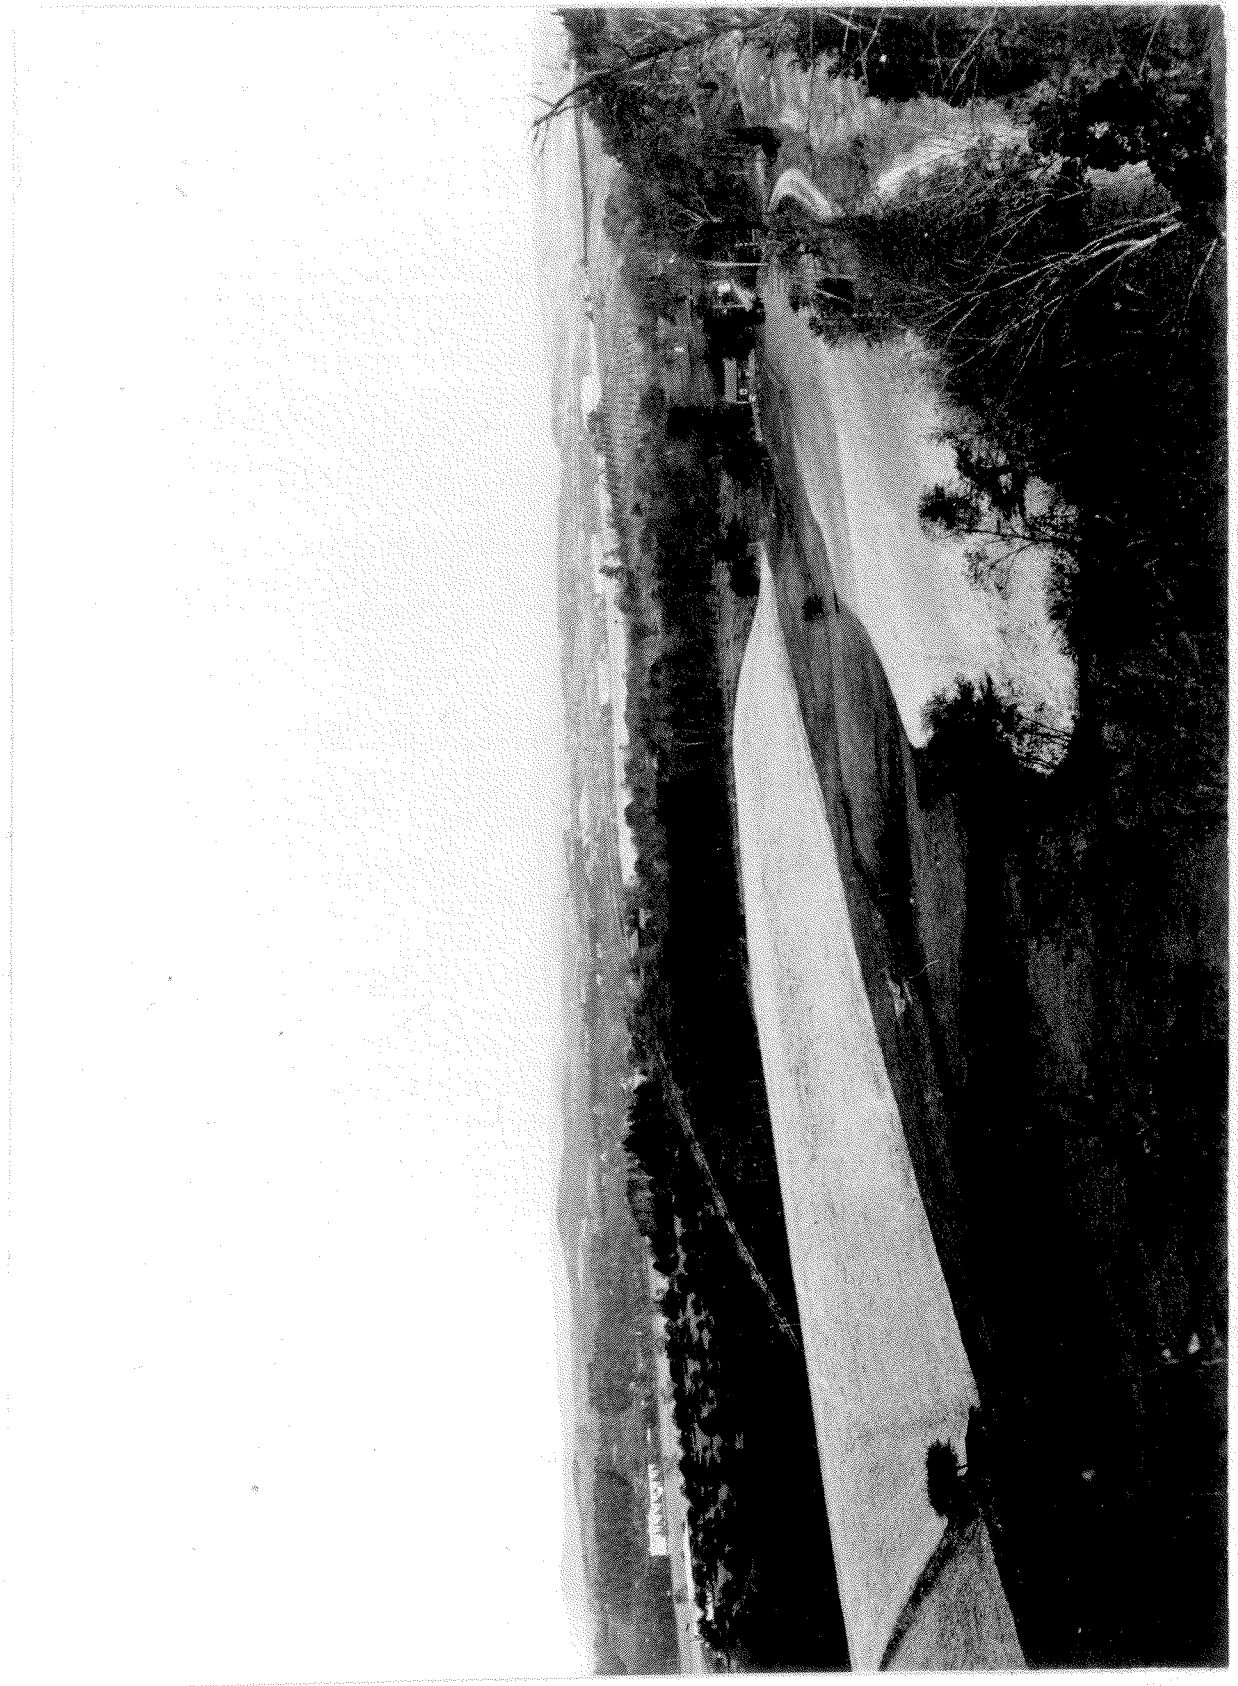
Figure 47 - Photograph showing South Entrance, 1896-1914.

The view looks north from Red Hill (just south of Olana), showing the South Entrance at the extreme lower right. The Oak Hill-Hudson Road (today Rt. 9G) is shown clearly on its pre-1930s alignment. The public road was realigned in the 1930s to the field seen here west of the older road. [OL.1987.132.13.c].

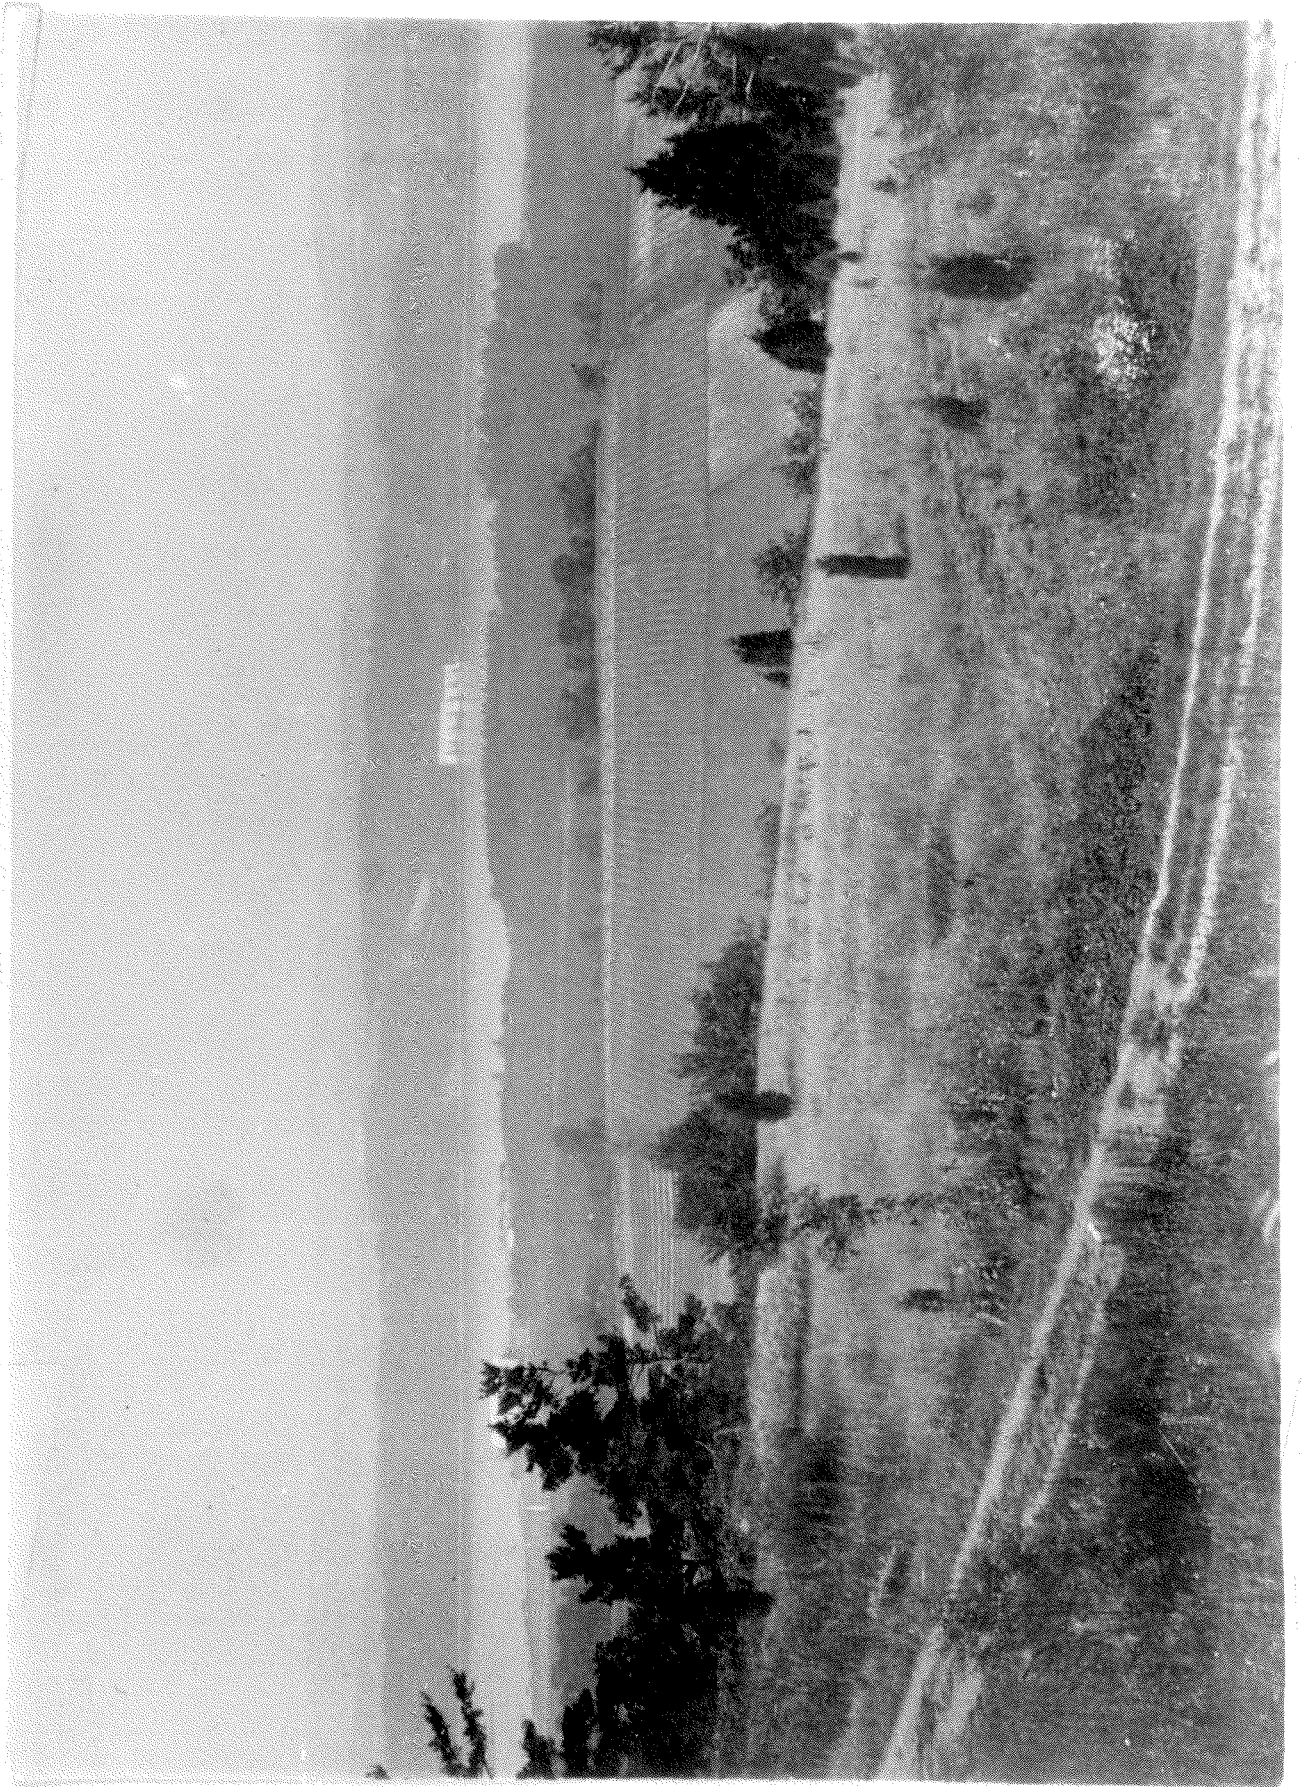
Figure 50 - Photograph of view from the Ridge Road, 1906.

The view looks west from the Ridge Road showing the open aspect that Church maintained along this portion of the road. Older wooded areas are seen to the south (left). One small sapling, seen beside the road (left of center), is today a mature field tree set in second-growth woods that developed after Church's death [OL.1986.59.29].

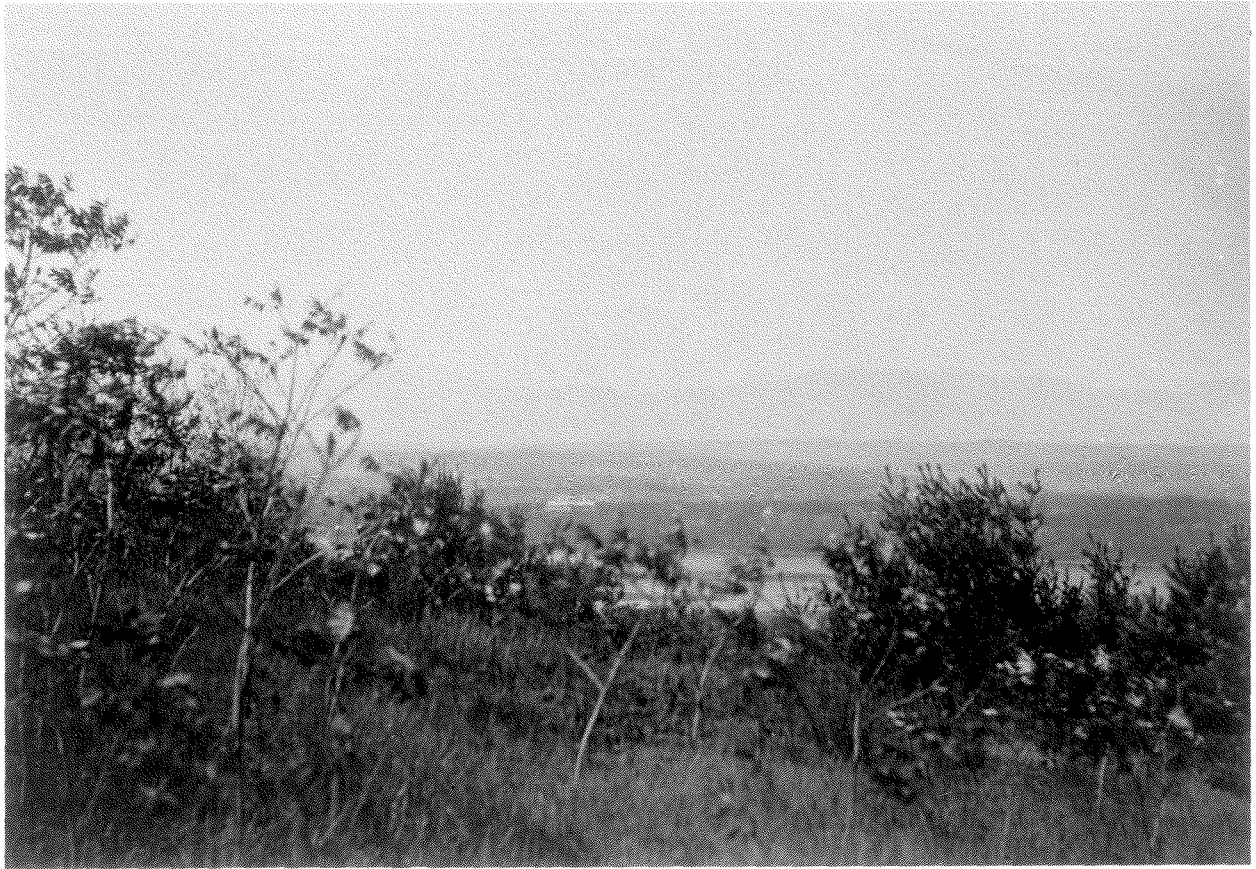
Figure 51 - Photograph of western view from Ridge Road, 1895-1910.

This image looks west from the Ridge Road at a point where the road emerges from the woods into the open north meadow. Note the second growth of sumac and pine. As this vegetation began to obscure the views, Church undertook selective clearing to enhance the scene. The large white building in the view is the Prospect Park House Hotel at the Village of Catskill [OL.1986.426].

Here, the open Ridge Road approaches an old woodland edge that existed prior to Church's development (compare with figures 51 and 52). Even here, where views were preserved by the sharp descent of the topography, second-growth has encroached to the point where foliage screens all outward prospects. [RMT].

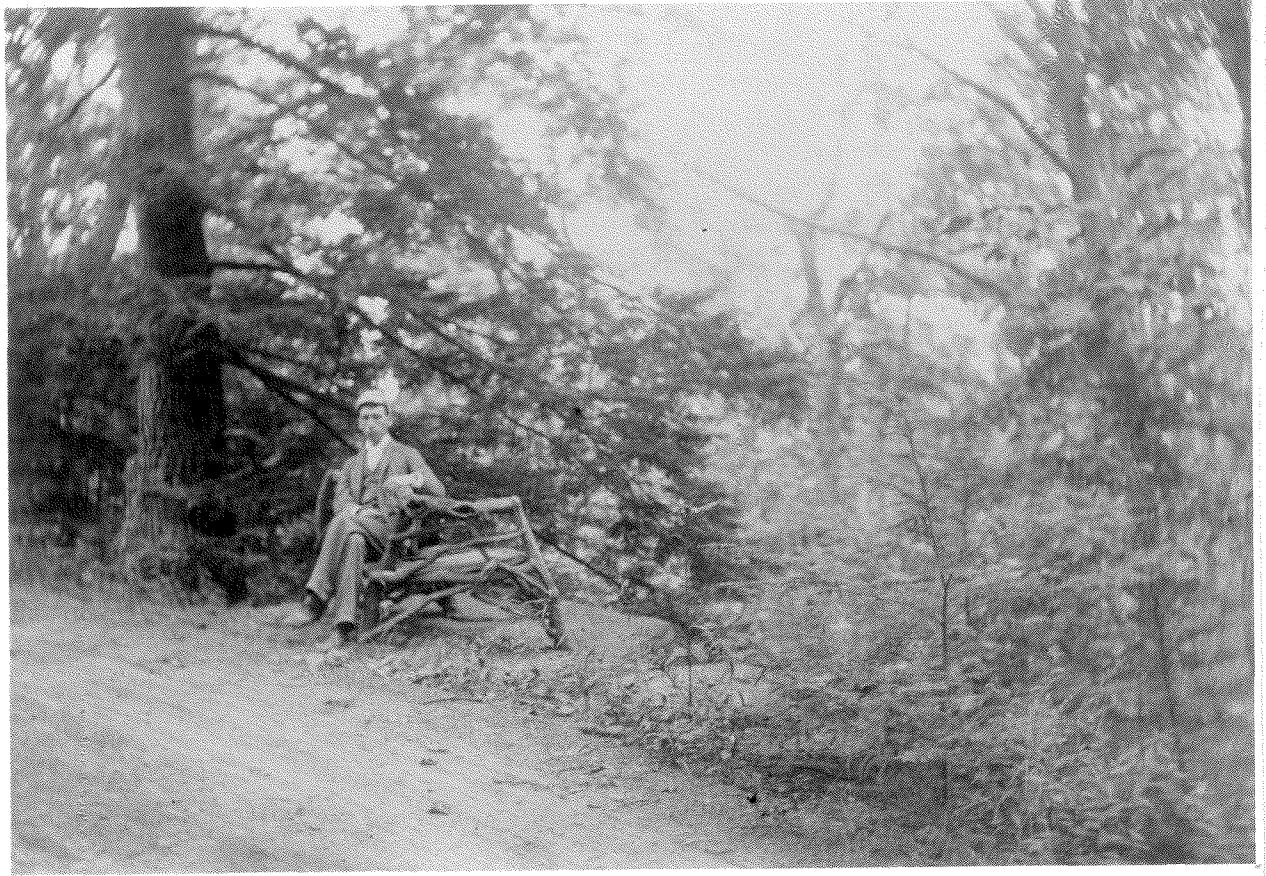
Figure 52 - Photograph of rustic tête-a-tête seat, late 1880s - early 1890s.

Louis P. Church, about age 18, is shown sitting on a unique piece of rustic furniture that appears to be constructed of mountain laurel with a timber slab seat. The seat was probably located along the Ridge Road on the west side of the hill at a spot where the ground dropped precipitously and the road was supported by a low stone retaining wall, today collapsed. The seat may have featured a view west, with Church selectively clearing trees and limbs to compose a particularly scenic prospect. Note the hemlock trees, an old specimen on the left and a young sapling close to the road on the right. [OL 1986.425].

rustic bench - Distinctive seats (built of mountain laurel branches) seen in one photograph (fig. 52) and illustrated by F. E. Church.

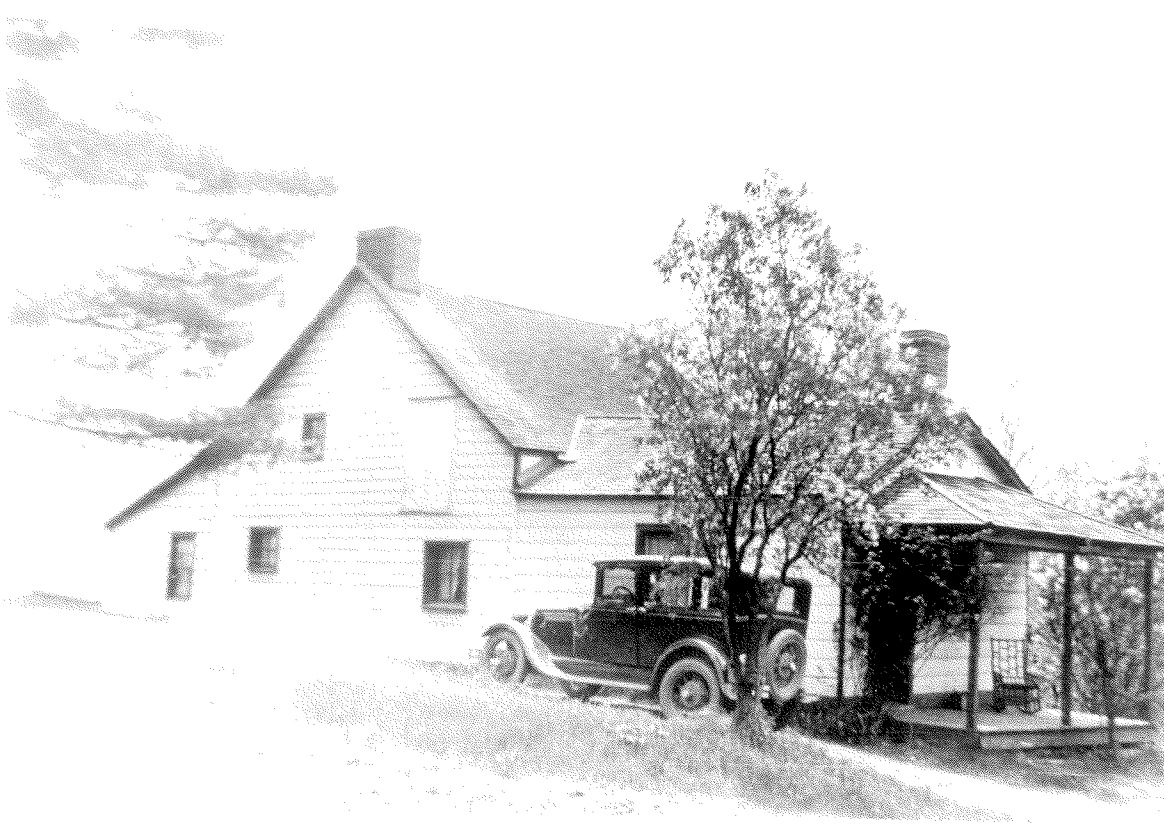
Figure 58 - Photograph of farmhouse from the northwest, 1934.

The old farmhouse appears to have been in good condition in 1934. As at Cosy Cottage, the fittings are more austere than earlier views (compare with Figure 42). Note the large pine tree, and the fruit tree. Other orchard trees are seen to the south of the house [OL.1996.1].

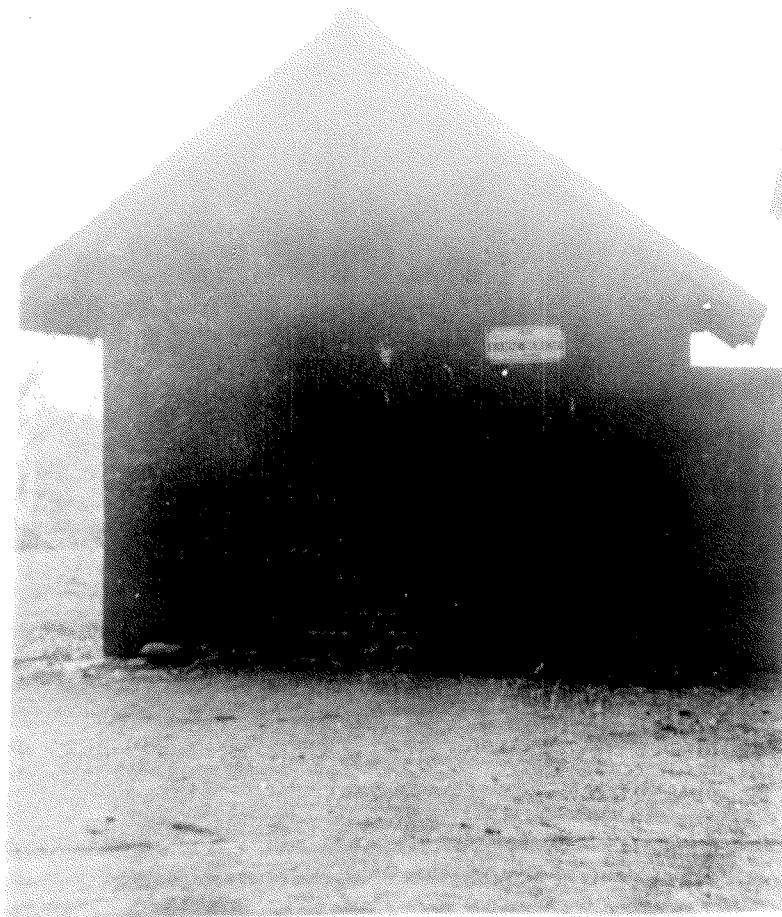
Figure 60 - Photograph of tool house from the north, 1934.

It is uncertain if this small building (13'x10'-6") was in place during Frederic Church's lifetime, but it seems that it was moved to this location at some point after his death (see below). [OL.1996.1].

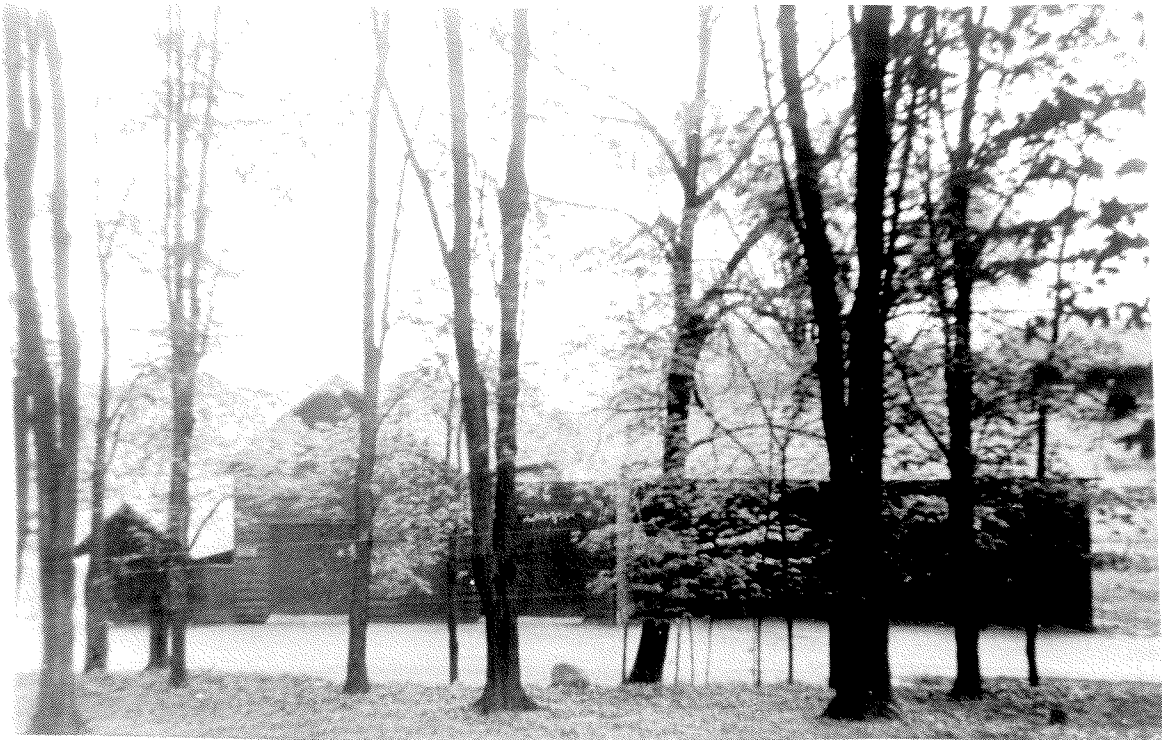
Figure 61 - Photograph of tool house, farm Stable and wagon house from the north, 1934.

The tool house is on the left. After a gap (closed with a gate) the gable end of the farm Stable is seen through the foliage. Continuing west, there is a linking building and then the wagon house, with eave line running east-west. The farm Stable and wagon house complex was in place during Church's lifetime (compare with Figure 44). The grove of trees in the foreground seems to have been planted to screen the farm buildings from the park [OL.1996.1].

It is unclear if the little shed shown beside the farm Stable in a photograph from 1934 (fig. 61) is the structure shown in this same spot in photographs from the historic period.⁷⁰⁹ If so, it has been altered and repositioned (turned 180° and moved slightly north and west from its earlier location). While extant, this structure is in very poor condition (the roof is a frayed lattice of rotted boards). What is left of its reddish color does blend with the other farm buildings.

Only the Stable remains, in poor condition. The reddish color is appropriate and relates it to the other farm structures. The south facade appears in photographs from the early 20th century (fig. 44). The north facade is shown in a photograph from 1934 (fig. 61).
