Historic Landscape Report

OLANA STATE HISTORIC SITE HUDSON, NEW YORK

December, 1996

Robert M. Toole
Landscape Architect

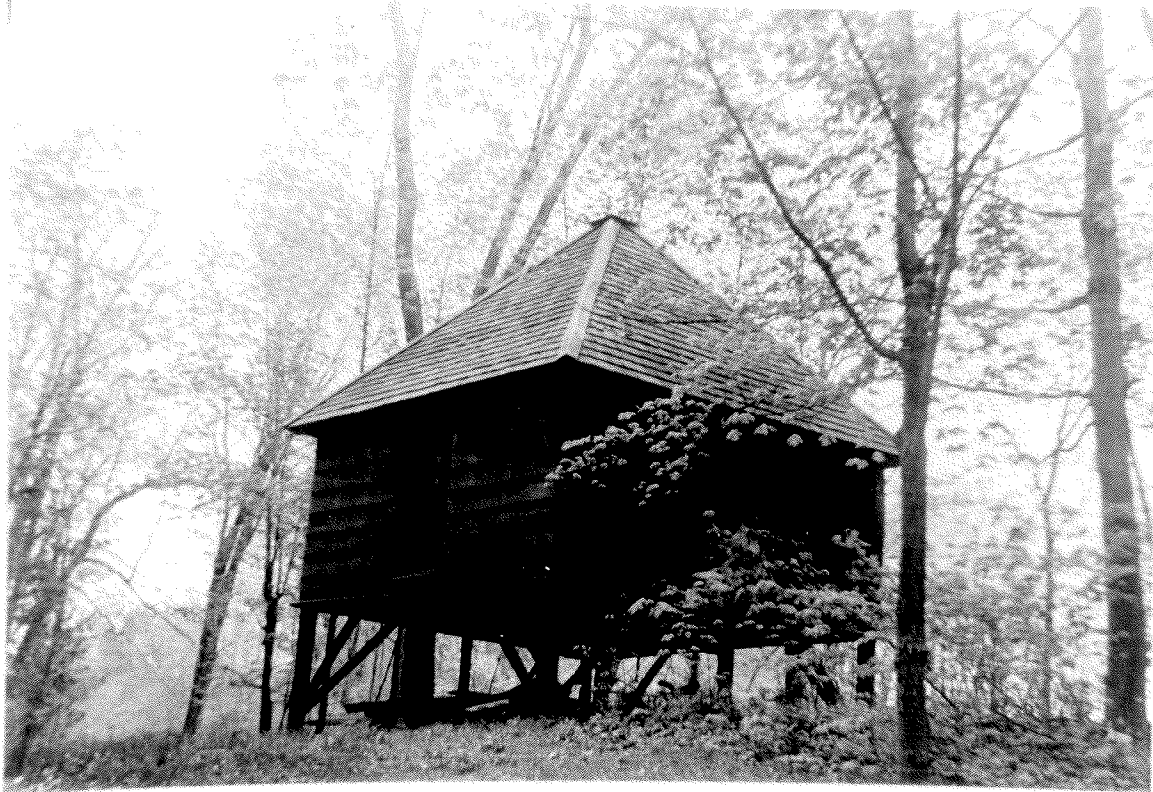
Figure 64 - Photograph of Corn Crib from the southeast, 1934.

The Corn Crib was located on the eastern side of the Lake dam. The road around the Lake was apparently aligned east (to the left) of this building, with the Lake to the west (right). It is unclear if the building seen in the photograph (15'-4" square) is the same as that recorded as having a straw roof in Church's lifetime. [OL.1996.1].

Not extant. The historic building may have been that photographed in 1934 (fig. 64).

- Corn Crib** - 47 (note #211), 73, 124; fig. 64.
 - design description - 109.
 - existing conditions - 160.

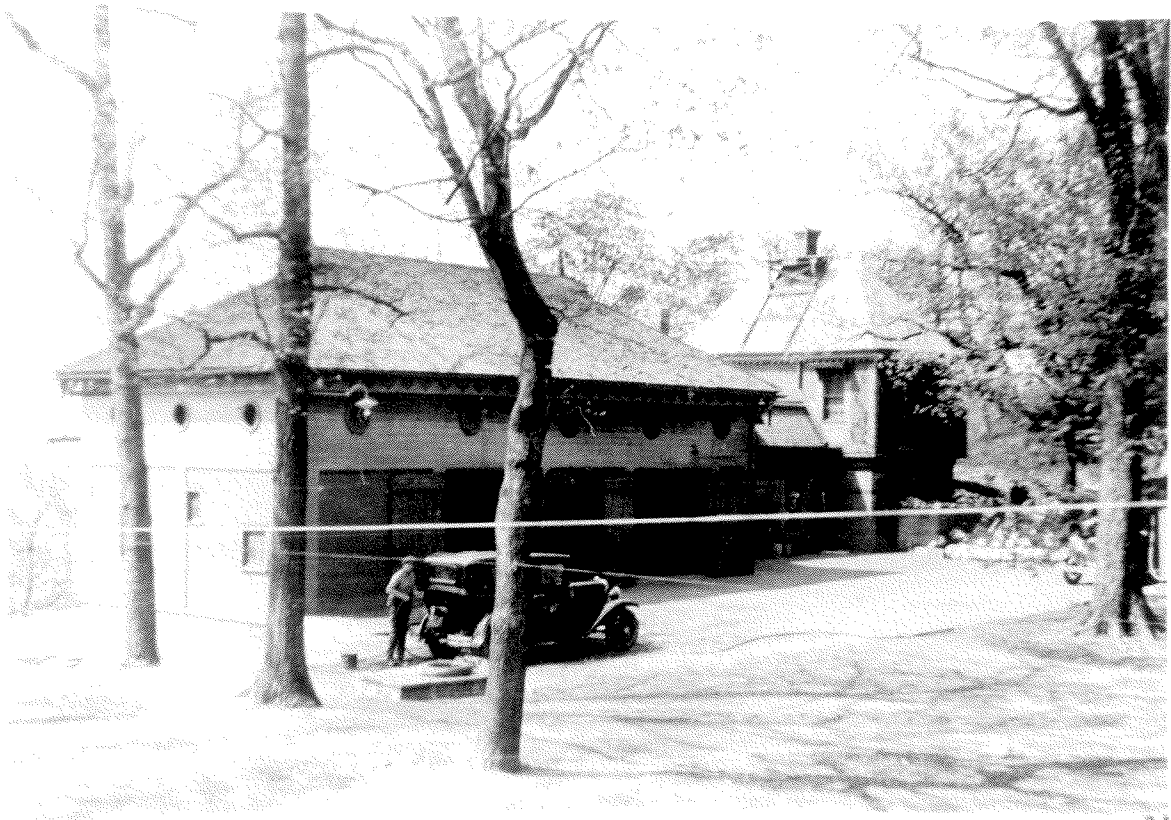
Figure 66 - Photograph of the Stable and coachman's dwelling from the southeast, 1934.

The complex is shown after the alteration brought about by the introduction of the automobile, which was first owned by Louis Church in about 1901. Note the large tree on the right. [OL.1996.1].

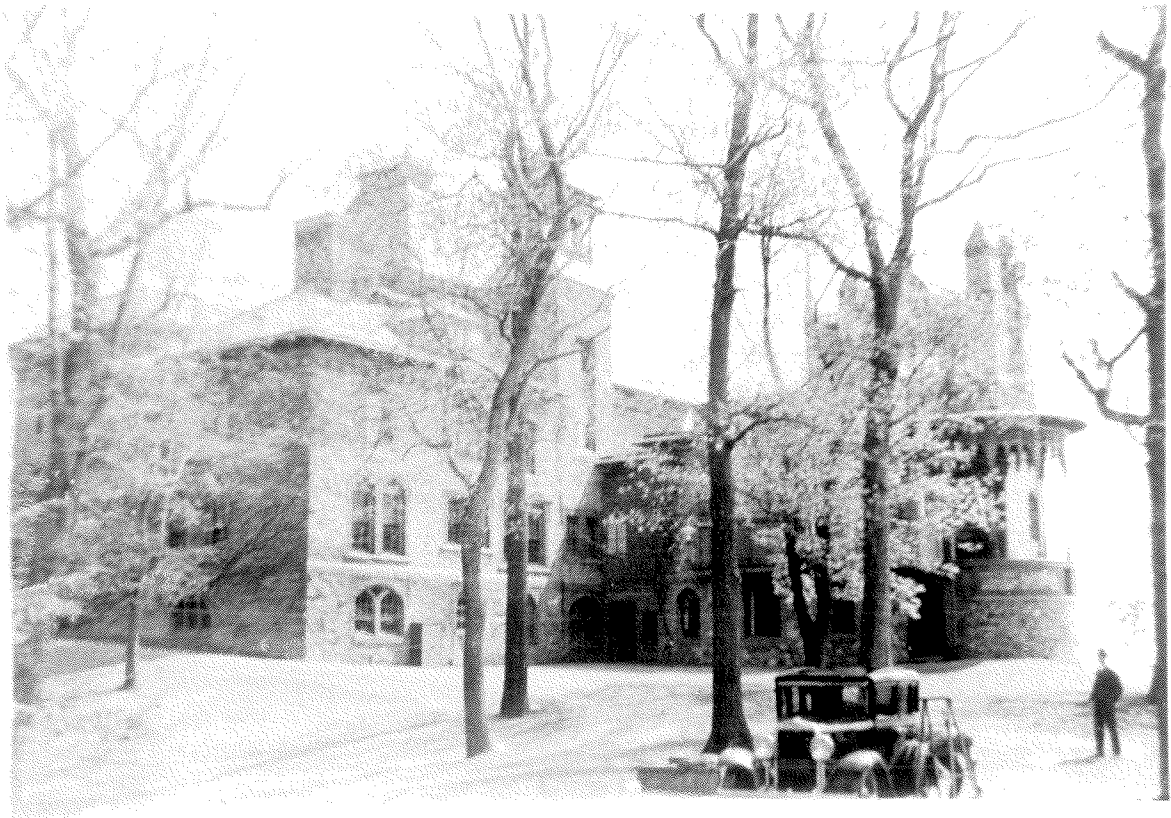
Figure 67 - Photograph of House from the north, 1934.

This view is not documented in photographs from Frederic Church's lifetime. It shows the placement of trees in the service yard formed in the "L" of the main House. Trees (notably the three to the left of the car) defined the shale surface. At this date it seems that the ground vegetation had been extensively cleared in this area. [OL.1996.1].

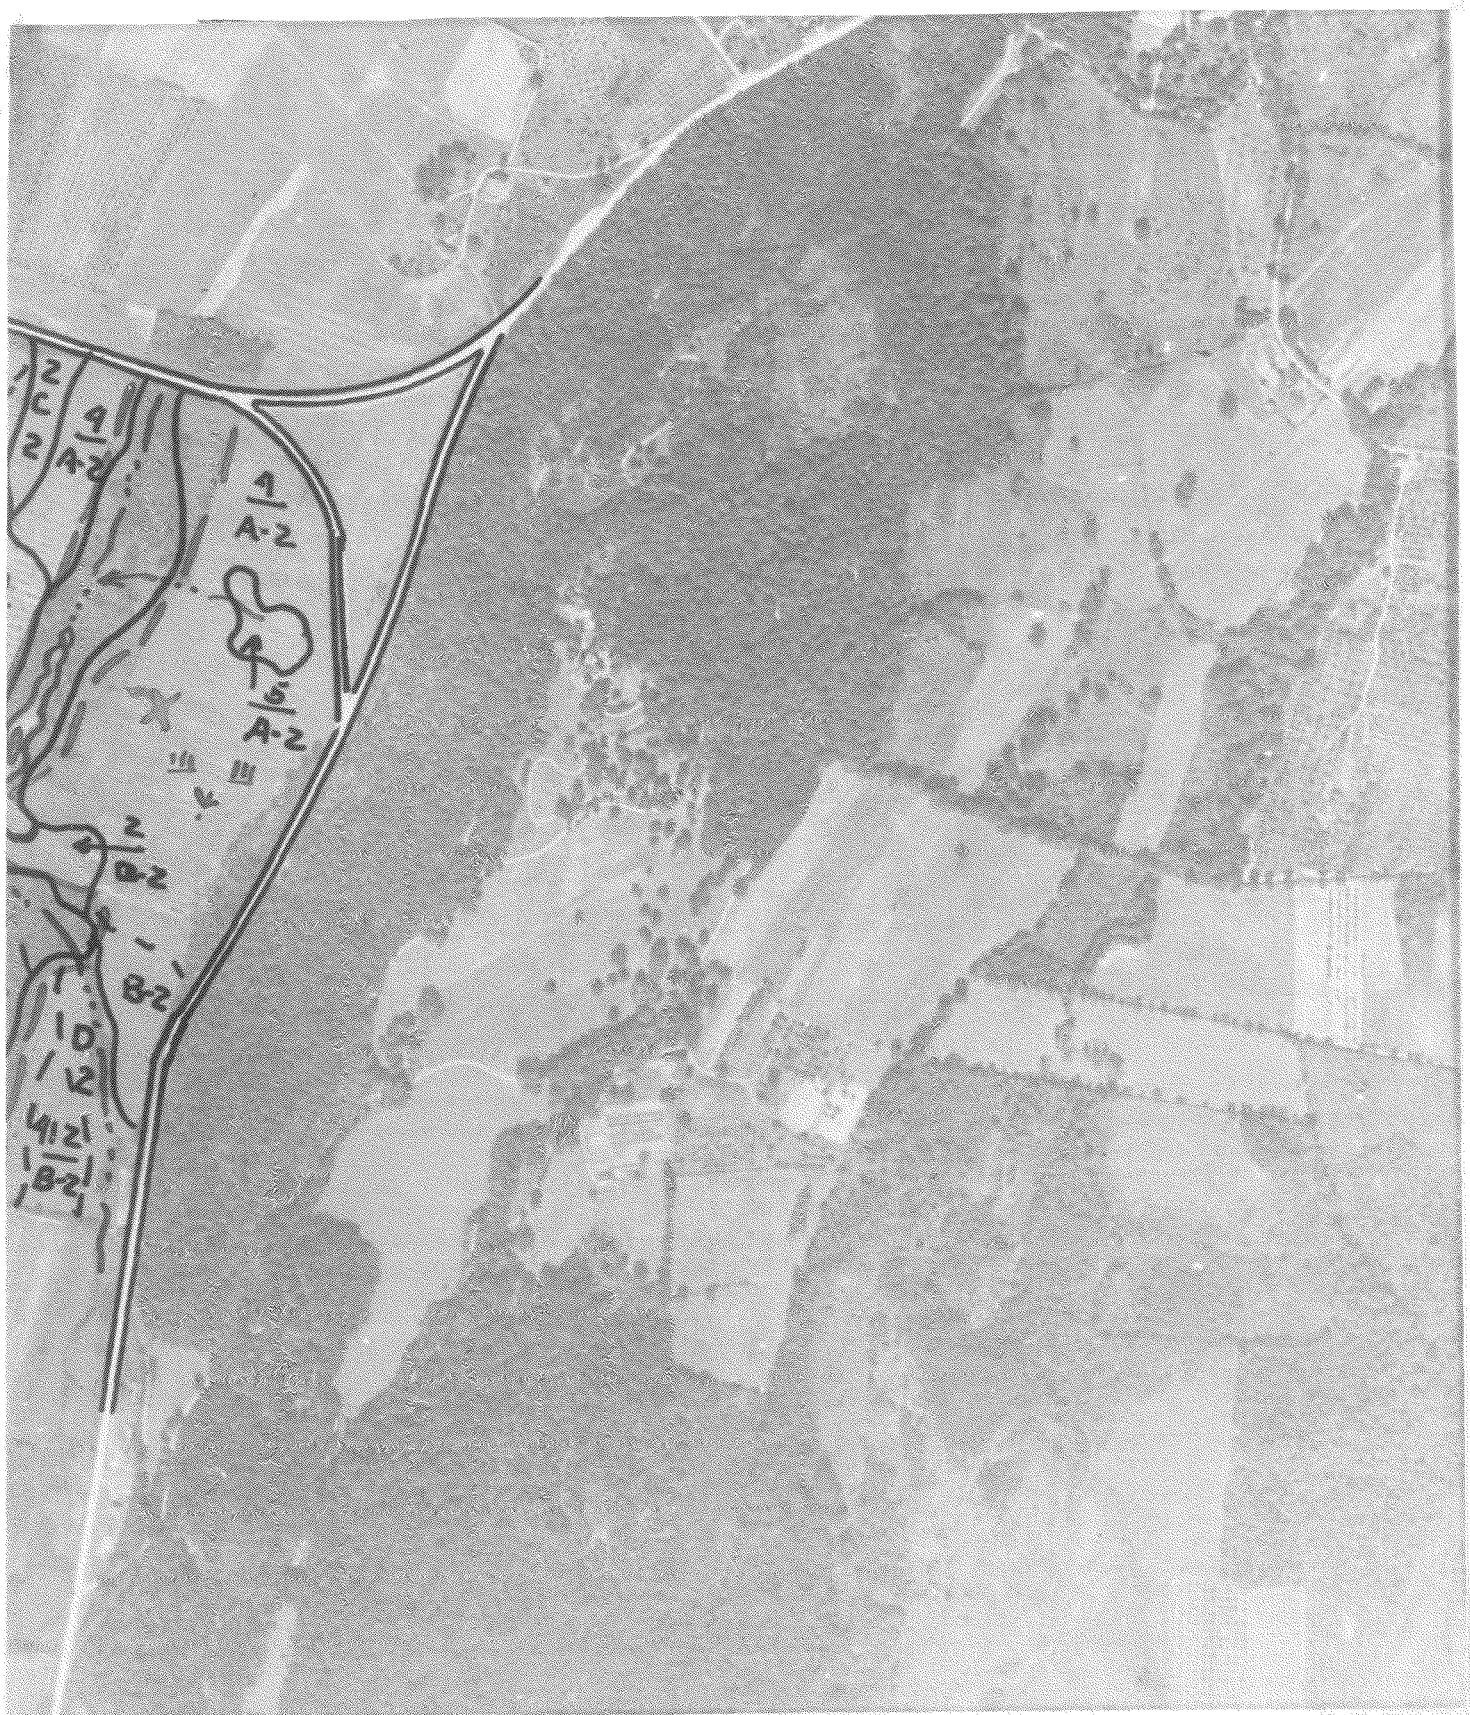
Figure 68 - Aerial Photograph, 1942.

This is the earliest known aerial view of Olana. Taken just prior to Louis Church's death in 1943, it shows the extent of field abandonment at this date and also the details of landscape elements, such as orchards and the Kitchen Garden, not revealed in later aerial photographs. Note, the open park and cleared shoreline on the north side of the Lake. The New Approach Road is shown in use, but the uphill Farm Road has been reduced to a turfed track, nearly indiscernible. Annotations on the property west of Olana are from a soil map, the only known source of this image. North is at the top of the page. [USDA, Soil Conservation Service, Hudson, NY].

After 1900, the agricultural acreage was reduced even while Louis and Sally Church purchased about 28 acres of additional land east of the property. These activities were offset by the abandonment of the north meadow (although views from the Ridge Road seem to have been maintained). The southern portion of the farm also reverted to second-growth in this period. In turn, many trees were cleared from the park (perhaps after a storm) and along the north side of the Lake (to open the view from the House). The old apple trees in the north orchard were removed. Slowly, Olana was changing to a non-agricultural landscape. An aerial photograph, dated 1942, shows the property at the end of this period (fig. 68). [RMT, 1996].

1942 (fig. 68) - #GSAE - M-4-160 [USDA, Soil Conservation Service].

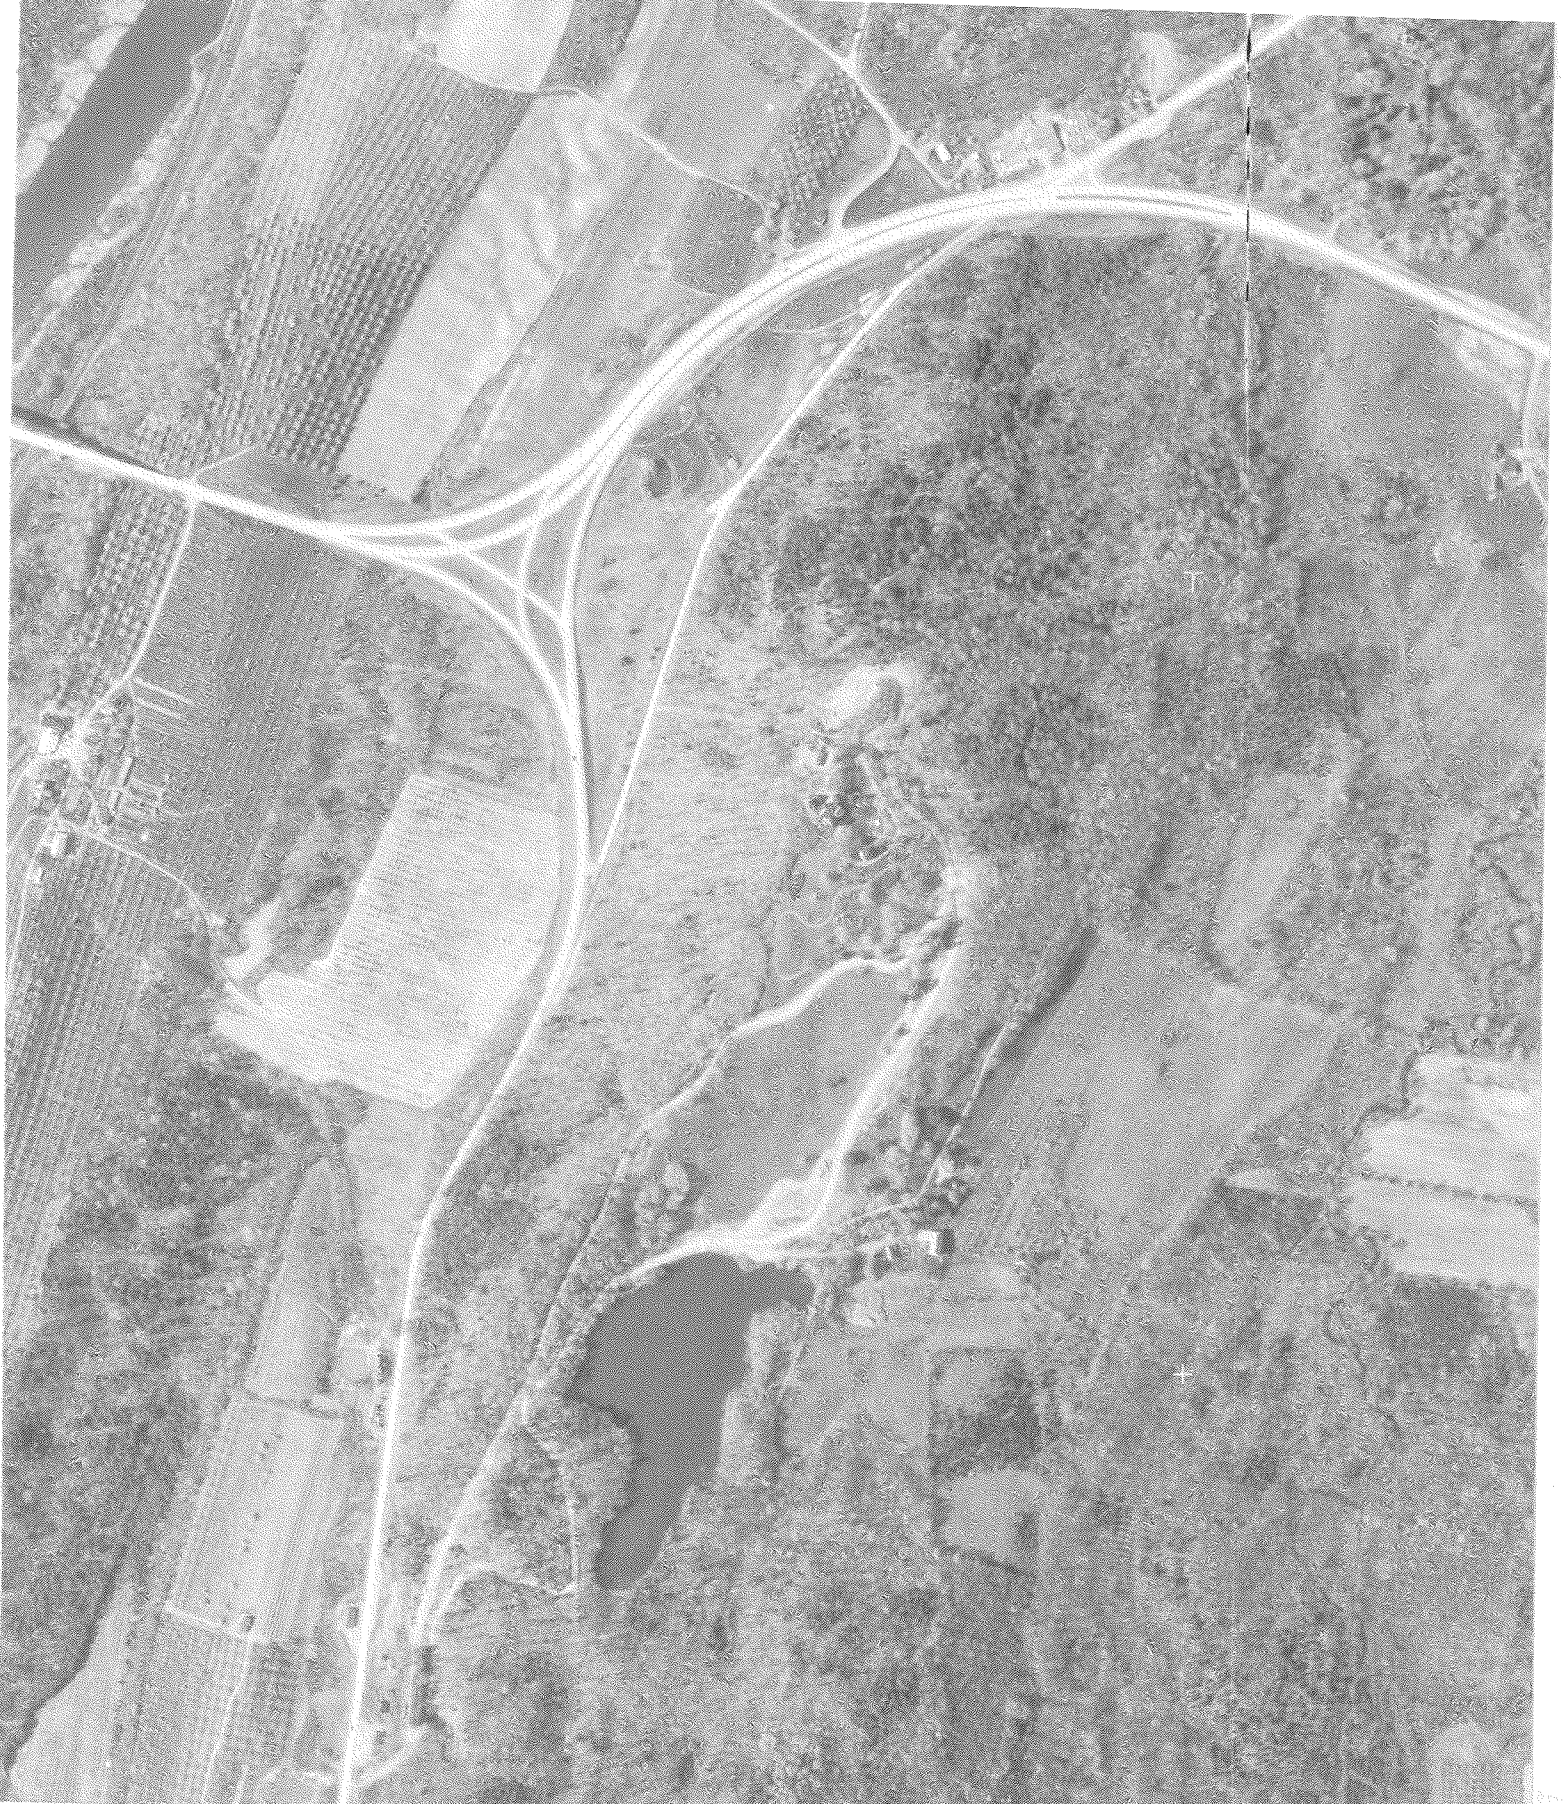
Figure 69 - Aerial Photograph, 4/26/1967.

This important view documents the "as received" conditions of Olana when the State acquired the property. It clearly shows the construction of the State's paved road system installed before Olana opened to the public only five weeks after this aerial photograph was taken. Changes in the landscape since Louis Church's death are also apparent and the springtime foliage documents the pattern of evergreen and deciduous trees in considerable detail. North is at the top of the page. [USDA, Soil Conservation Service, Hudson, NY].

1967 (fig. 69) - #EFB-2 [USDA, Soil Conservation Service].

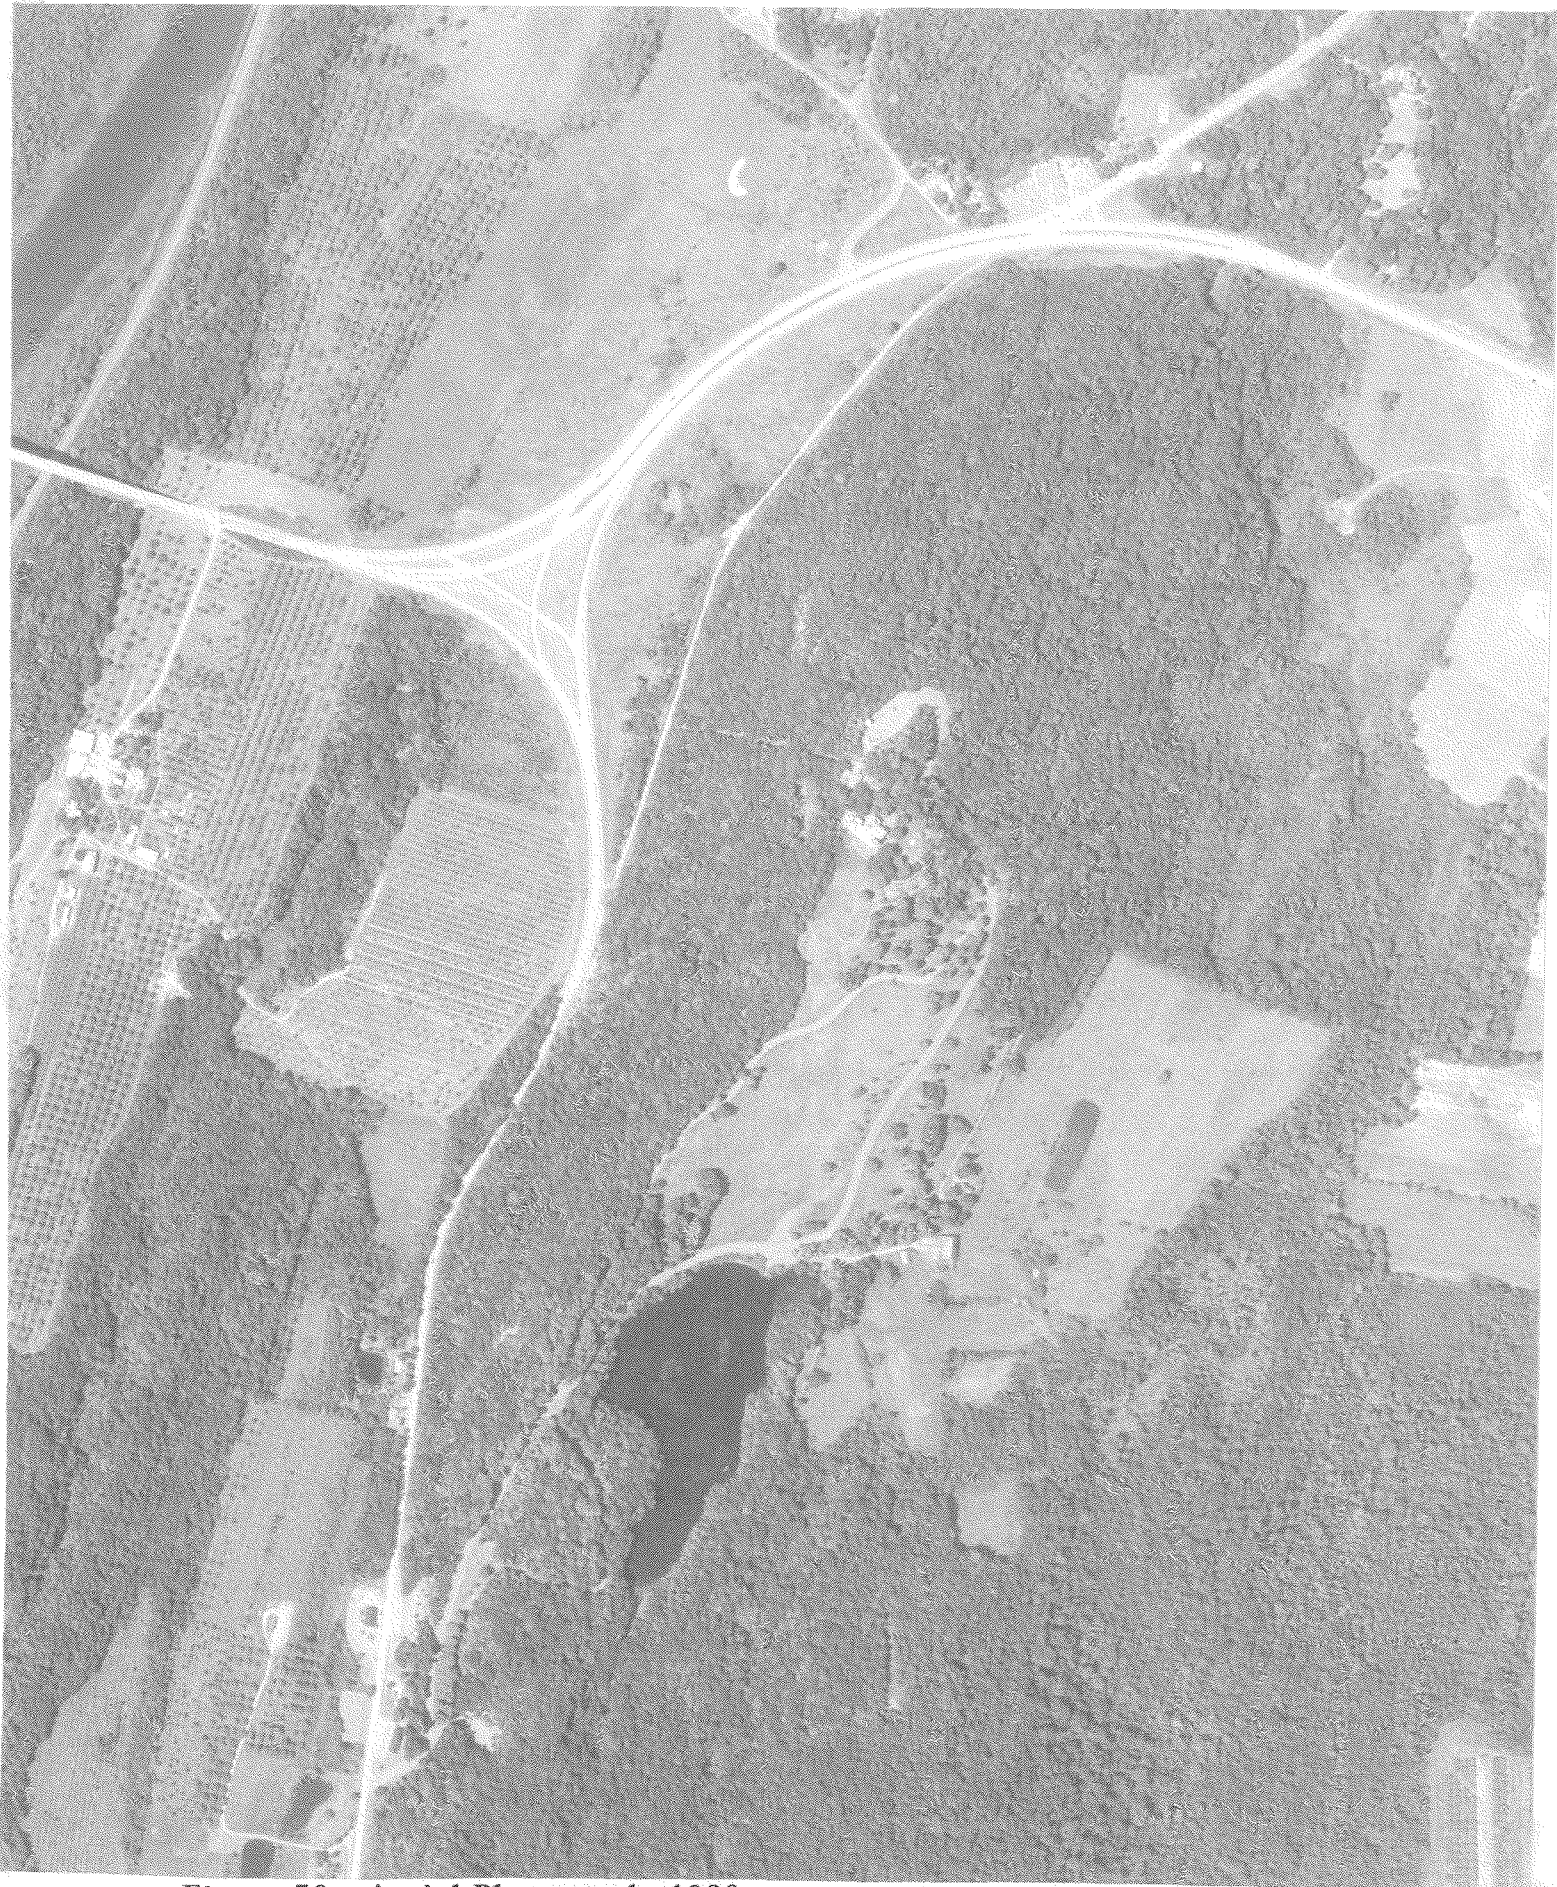
Figure 70 - Aerial Photograph, 1980.

This view records the situation thirteen years after State acquisition. Woodland vegetation continues to encroach along the edges of formerly open fields, especially notable in the southeast corner of the property. A narrow viewway cleared from Crown Hill in the 1970s is visible in the lower center. North is up the page. [USDA, Soil Conservation Service, Hudson, NY].

1980 (fig. 70) - #36021-180-101 [USDA, Farm Service Agency].

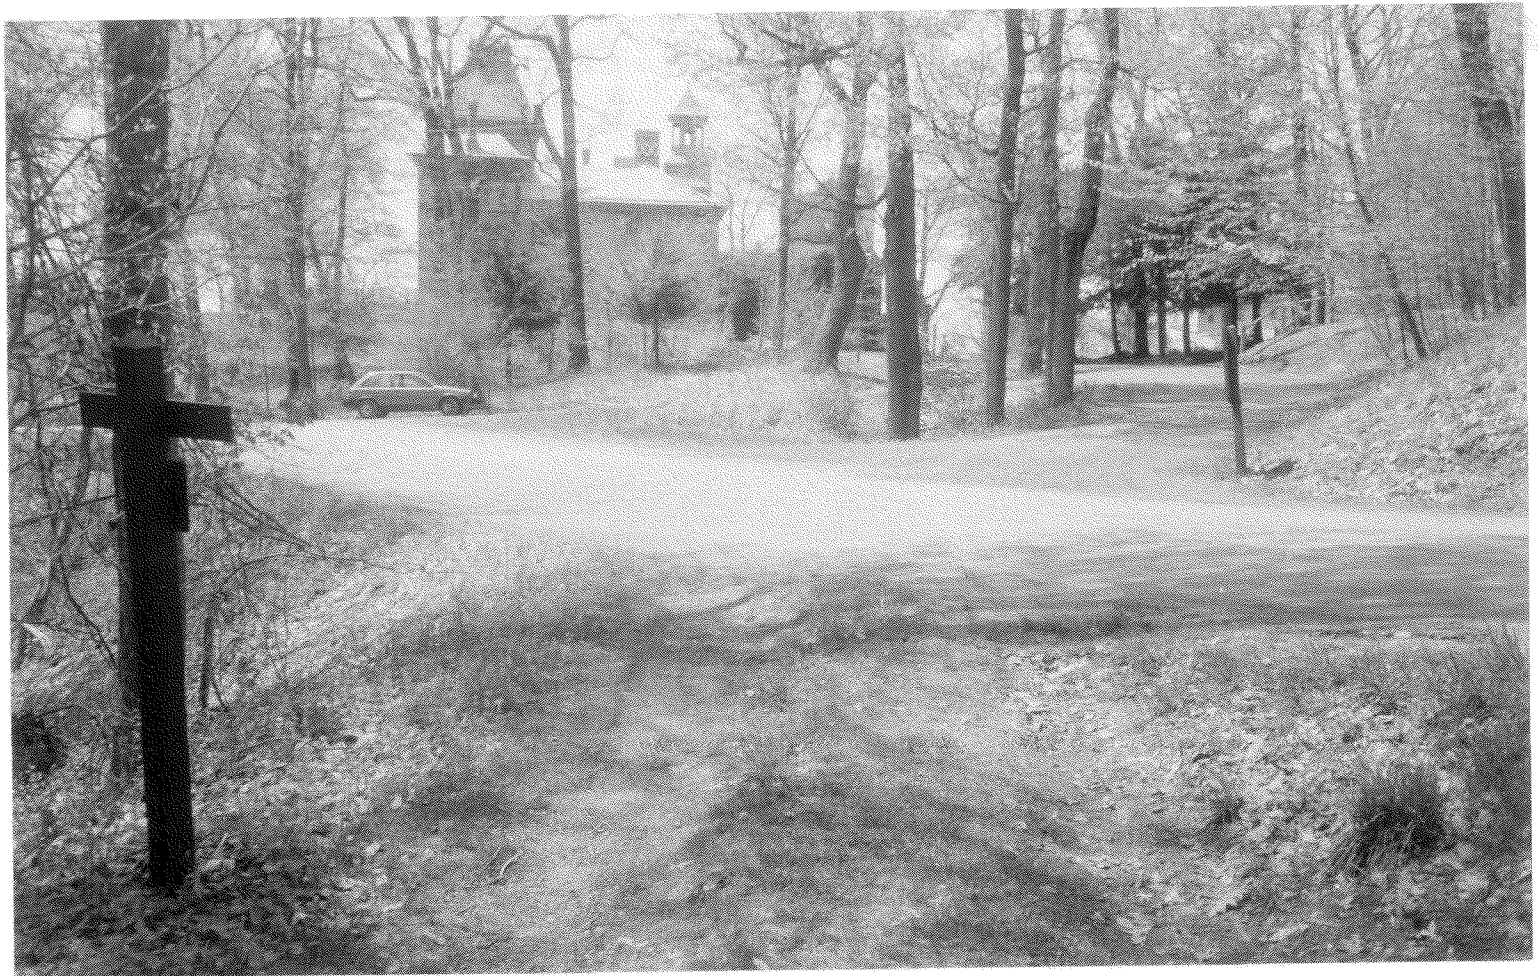
Figure 84 - Photograph of North Road approach from the north, 1996.

After entering on the North Road (foreground), this is the prospect approaching the House from the north, with the original South Road entering from the left (the car is on the original South Road alignment). After joining, the North Road and original South Road form the final approach drive (fig. 85). Today, the modern paved road in the foreground cuts across the historic intersection as it leads uphill (to the right) toward the parking lot. The House, Stable and service areas are ahead, screened from view when the foliage is in season. [RMT].

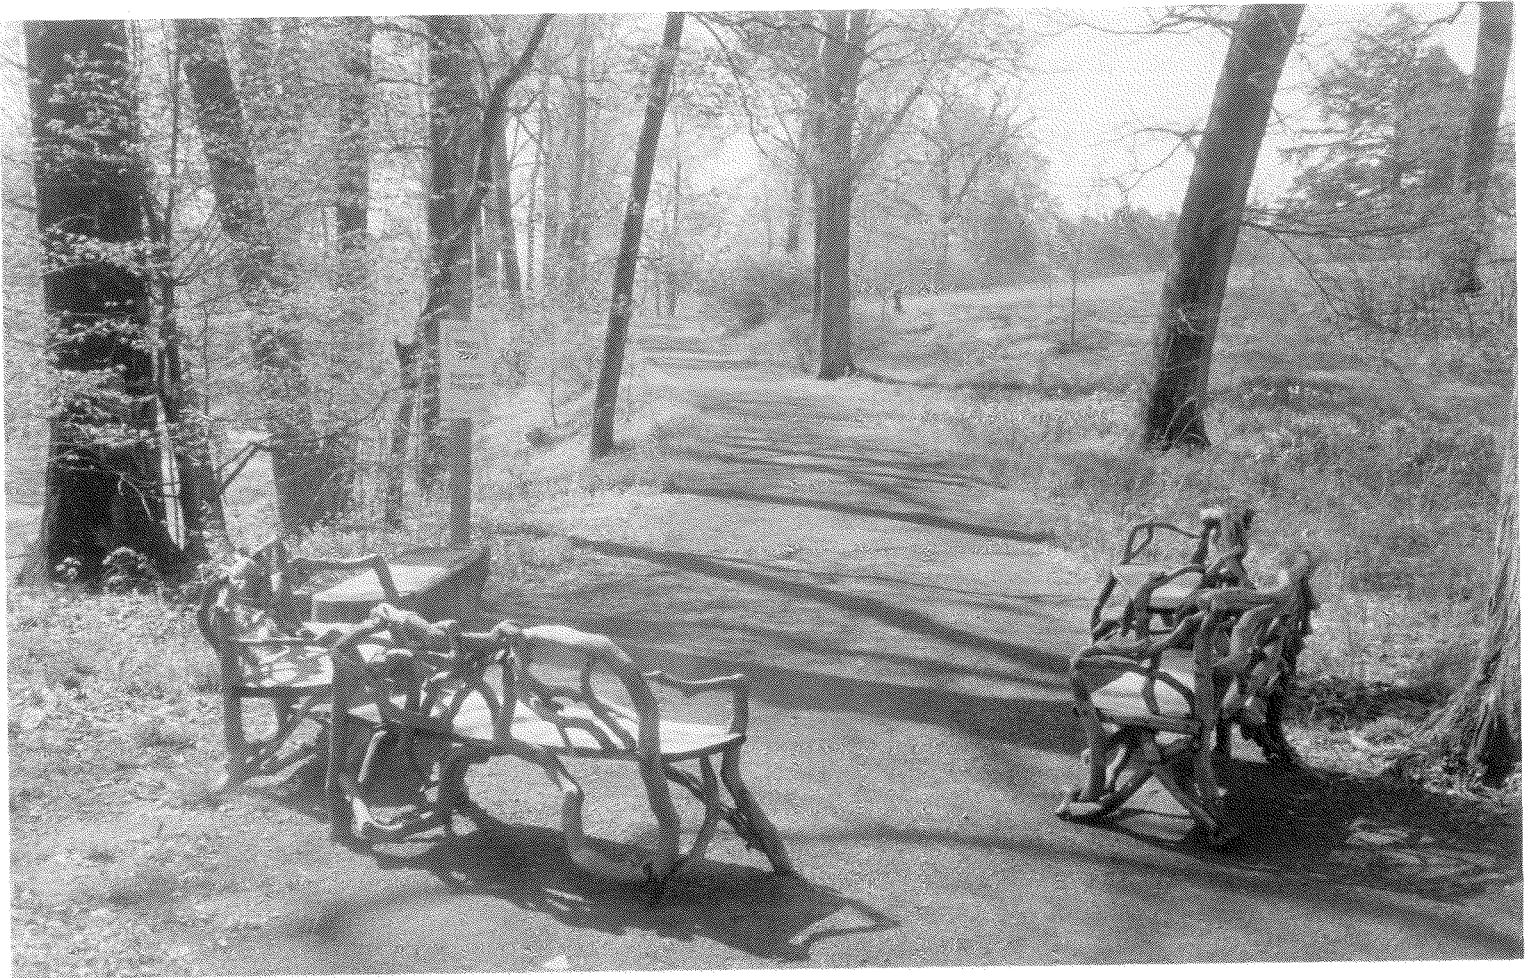
**Figure 85 - Photograph of final approach drive with rustic seats
from the west, 1996.**

After the original South Road and North Road combine, to the left of this view, the final approach drive turns away from the House toward the east (view shown here), where it joins the New Approach Road -- the South Road after 1889 -- before coming to the House. Today, this is the departure point for tours. Participants gather on rustic seats modeled after a design drawn by Frederic Church in 1889. Note the conspicuous fire hydrant ahead on the right. [RMT].

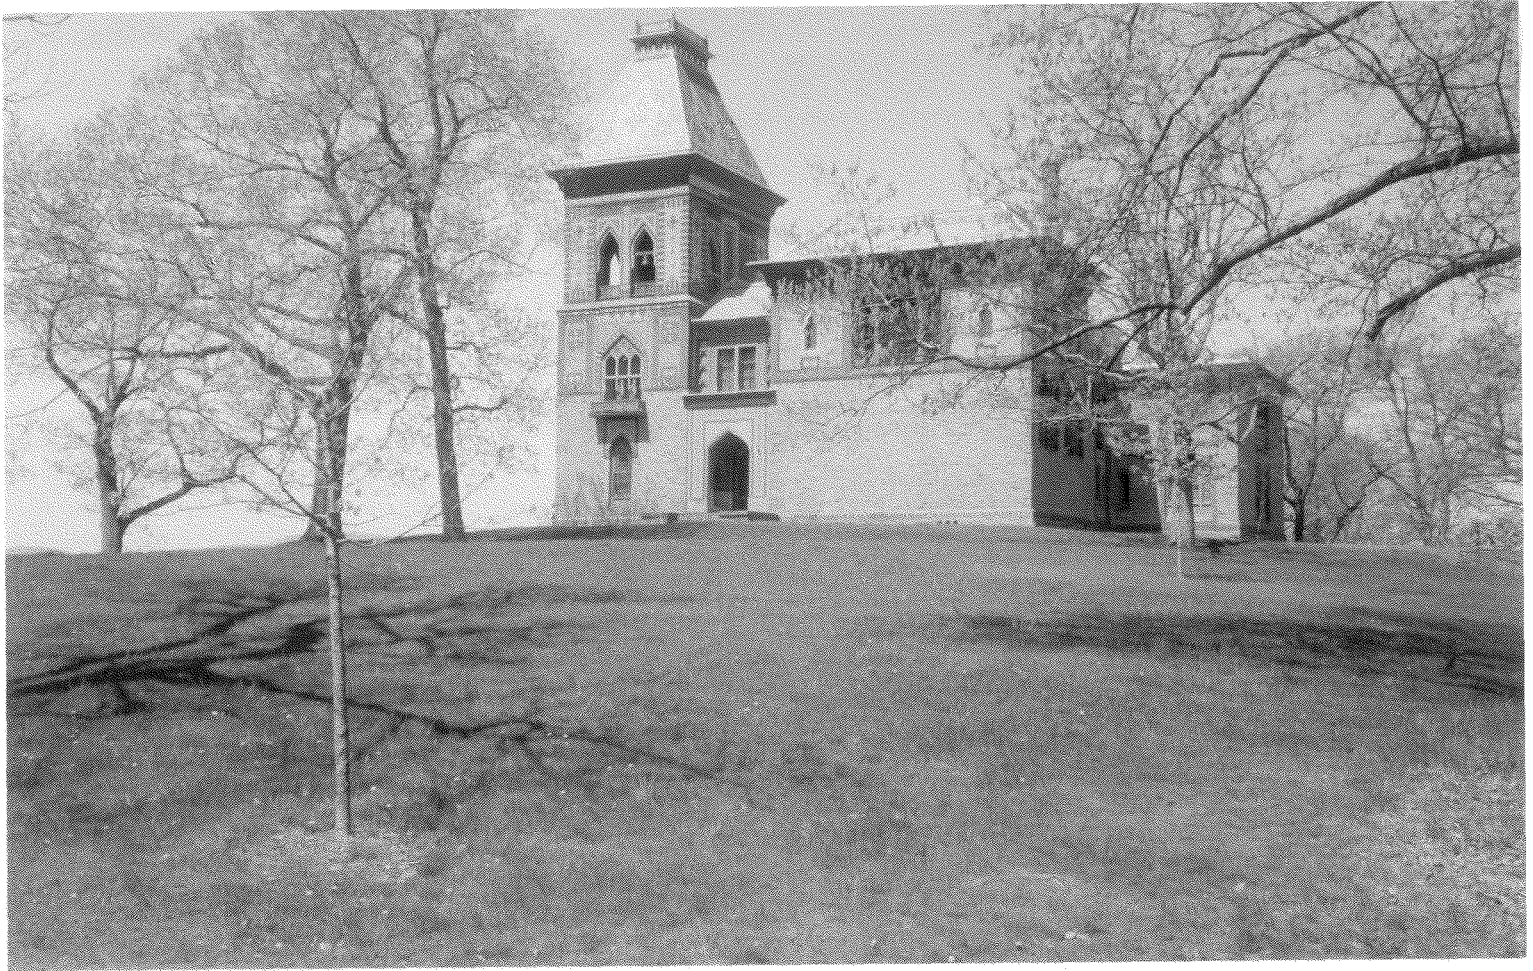
Figure 86 - Photograph of House from the east, 1996.

This is the so-called “first view” of the House seen across the East Lawn at a point where the New Approach Road intersects the final approach drive (compare with figure 27). The East Lawn provides a tranquil foreground for the assertive mass of the architecture, set on a low grass terrace flanking the entrance porch and front door. The House is framed within mature trees. Today, after removal of a modern garden on the East Lawn, this scene is very close to that intended by Frederic Church. Newly planted trees, as in the foreground, instill a sense of ongoing renewal. [RMT].

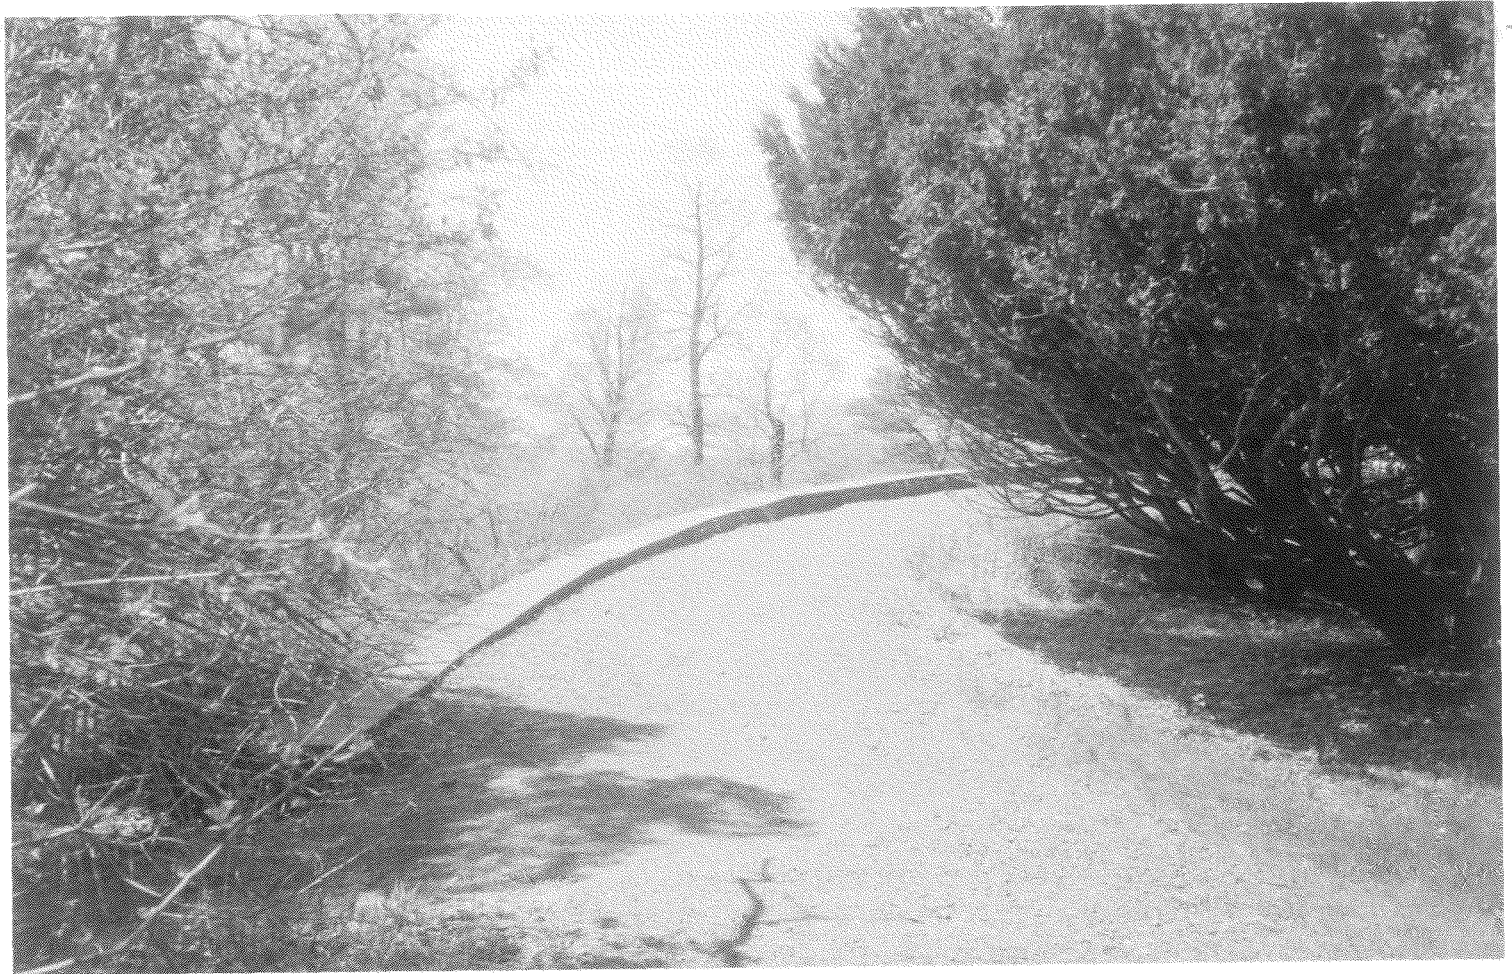
Figure 87 - Photograph of final approach drive from the northeast, 1996.

Turning toward the House (a 90° left from the above, figure 86), the final approach drive continues with an orientation to the south. Distant views are screened by the larger trees ahead. On the right, shrubbery has intruded into the carriage way, narrowing the drive and causing an awkward diversion in its curving alignment. [RMT].

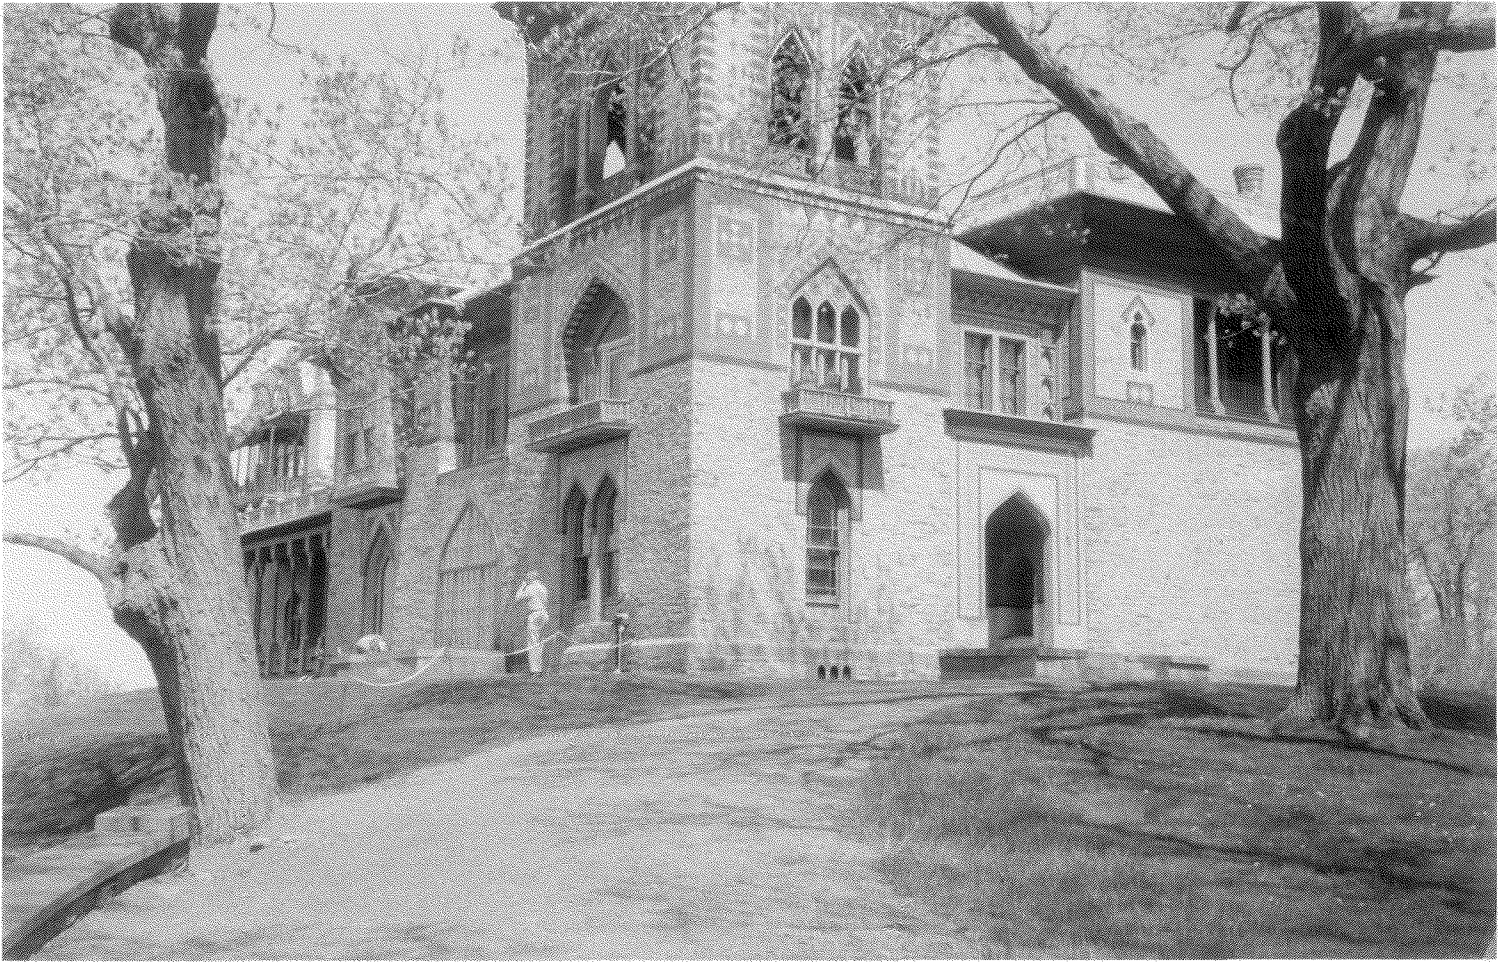
Figure 88 - Photograph of House from the southeast, 1996.

Framed by mature trees, this is the culminating view coming to the House, seen in an attractive oblique prospect (compare with fig. 28). The entrance door is ahead with the lawn terraces and the south front to the left. Visitors, as here, gravitate to the lawn terraces where the south panorama is experienced (see fig. 93). The white plastic chain is used to control foot traffic which can create excessive wear on the turf surface of the lawn terraces. Note the lack of vines, removed by the State to protect the masonry. [RMT].

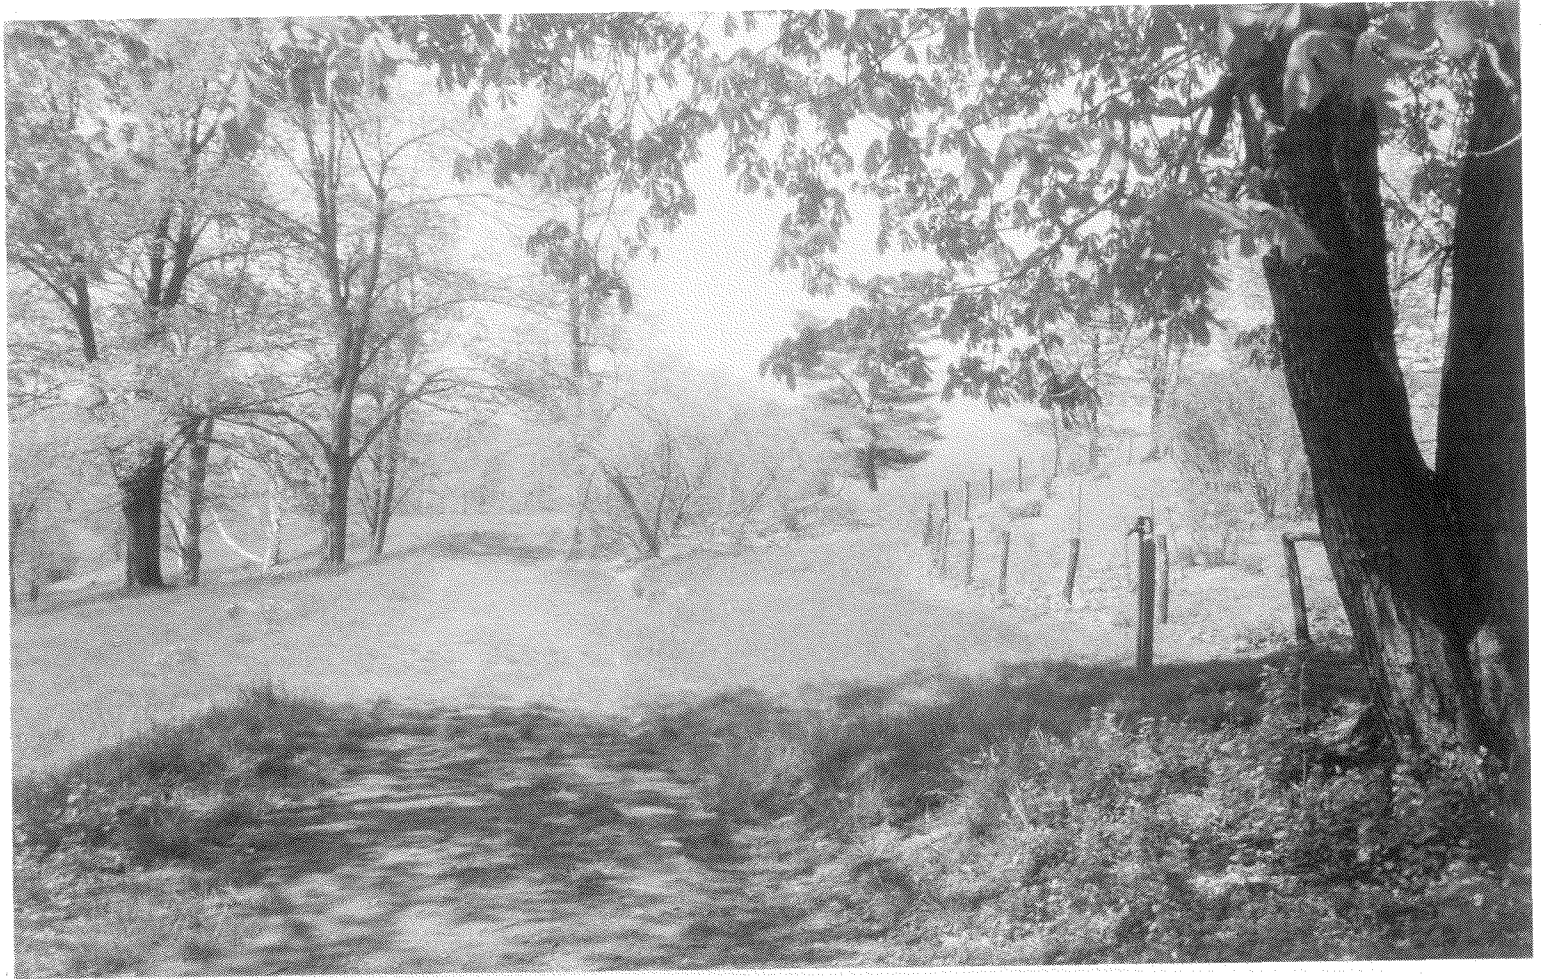
Figure 89 - Photograph of New Approach Road and mingled garden from the north, 1996.

The final approach drive to the House was reached from the south by this route - the New Approach Road constructed by about 1889 -- Today, it is a faint turf track (compare with figure 32). The mingled garden, behind the wood posts on the right, was a feature approaching the House (coming toward the camera). Photographed here in spring, this garden will be a blowsy profusion of blooms during the summer. [RMT].
