Historic Landscape Report

OLANA STATE HISTORIC SITE HUDSON, NEW YORK

December, 1996

Robert M. Toole
Landscape Architect

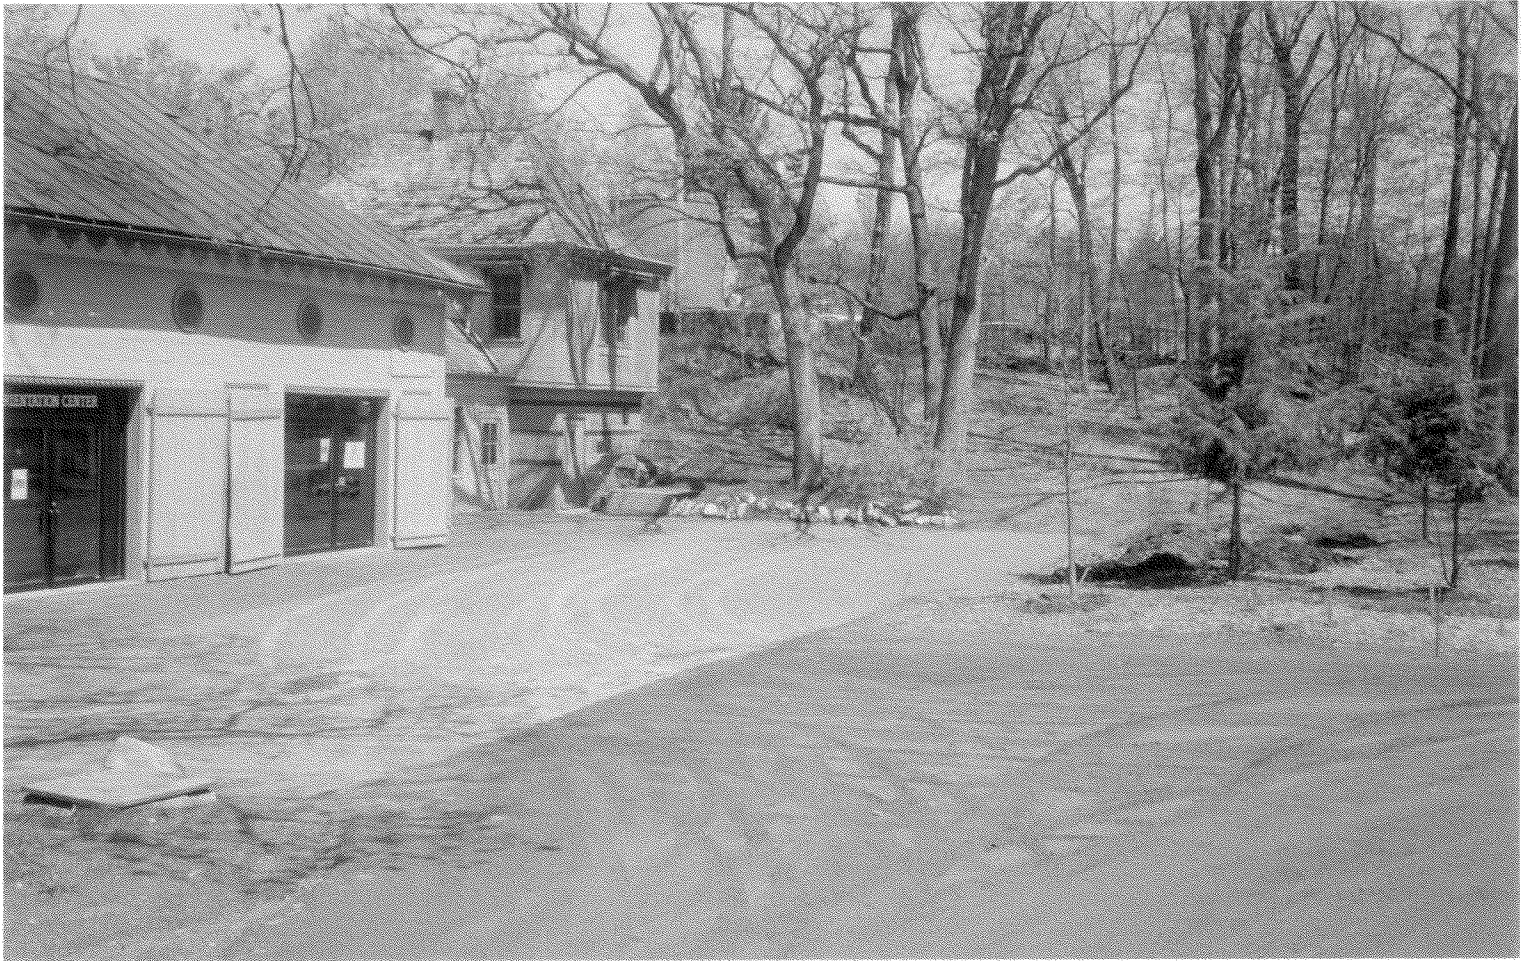
Figure 90 - Photograph of Stable and Stable yard from the south, 1996.

The Stable, today the Visitors Center (left), and the attached coachmen's dwelling to the north (ahead), define the Stable yard. This utilitarian space remains generally as Frederic Church left it (compare with figure 29), although the extent of the brick surface seen here is from later additions added during Louis Church's ownership and by New York State. While many trees have been removed since 1900, new plantings (on the right) will help to screen the service area as intended by Church. In foliage season the parking lot, visible in the background at the top of the hill, is screened. [RMT].

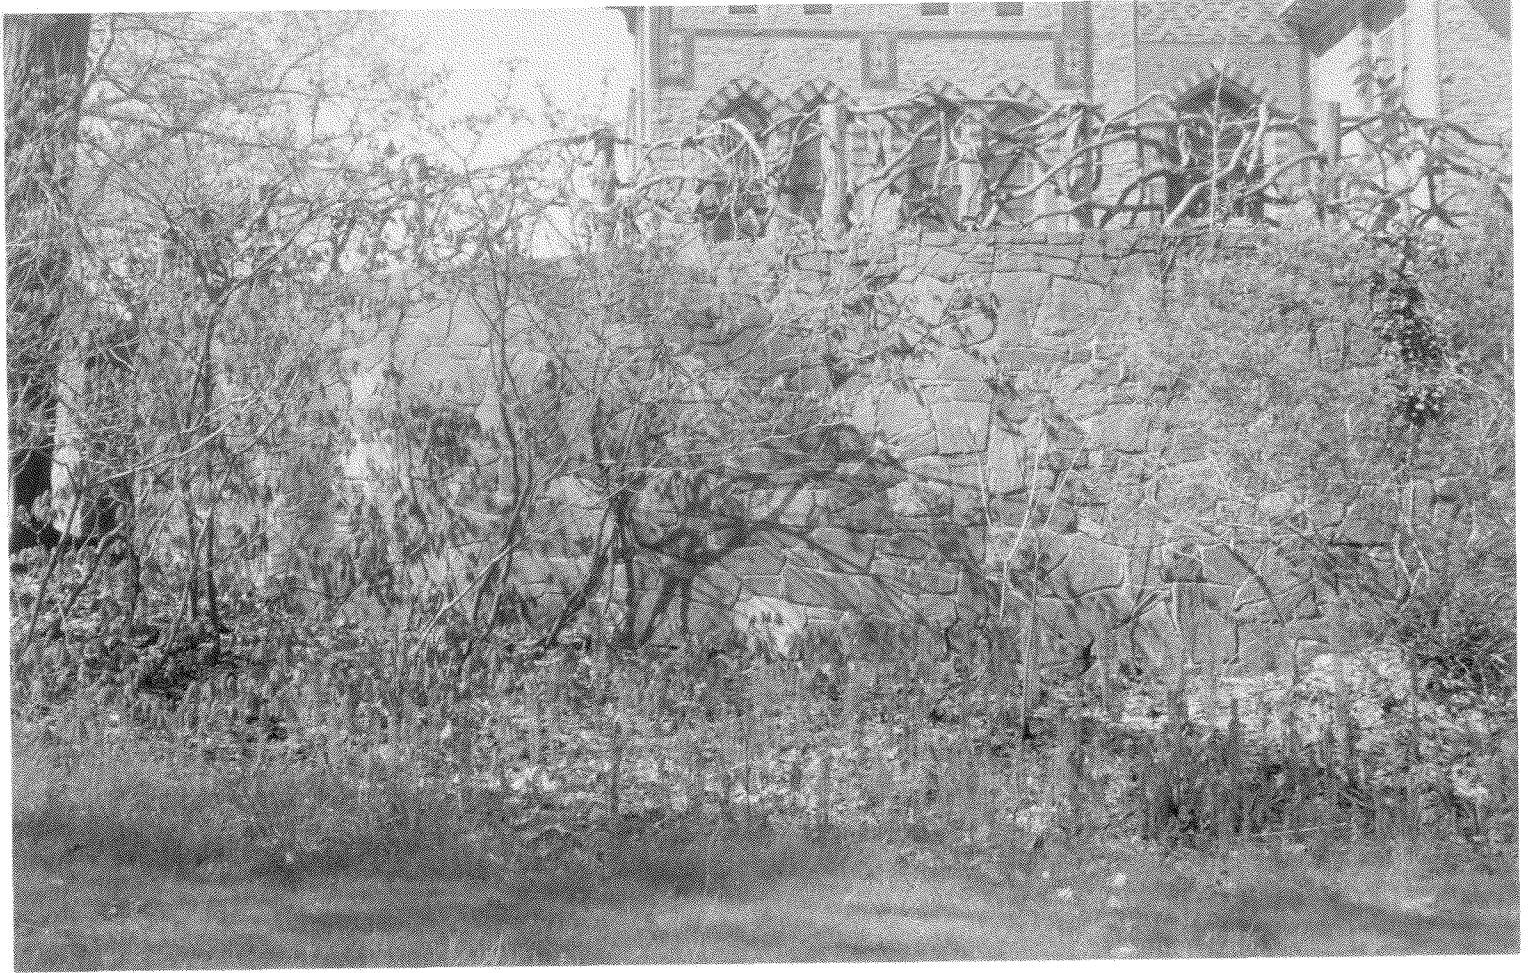
Figure 91 - Photograph of fern garden and rustic railing at turn-around from the north, 1996.

This view is a near duplicate of the historic appearance (compare with figure 30). The rustic railing was reconstructed in 1992. Ferns, just emerging in this early spring photograph, still dominate the plantings which includes mingled shrubs and perennials as in Frederic Church's lifetime. The most notable change is the stone wall, today a concrete and veneer stone reconstruction (installed by New York State) replacing the original dry-laid masonry. [RMT].

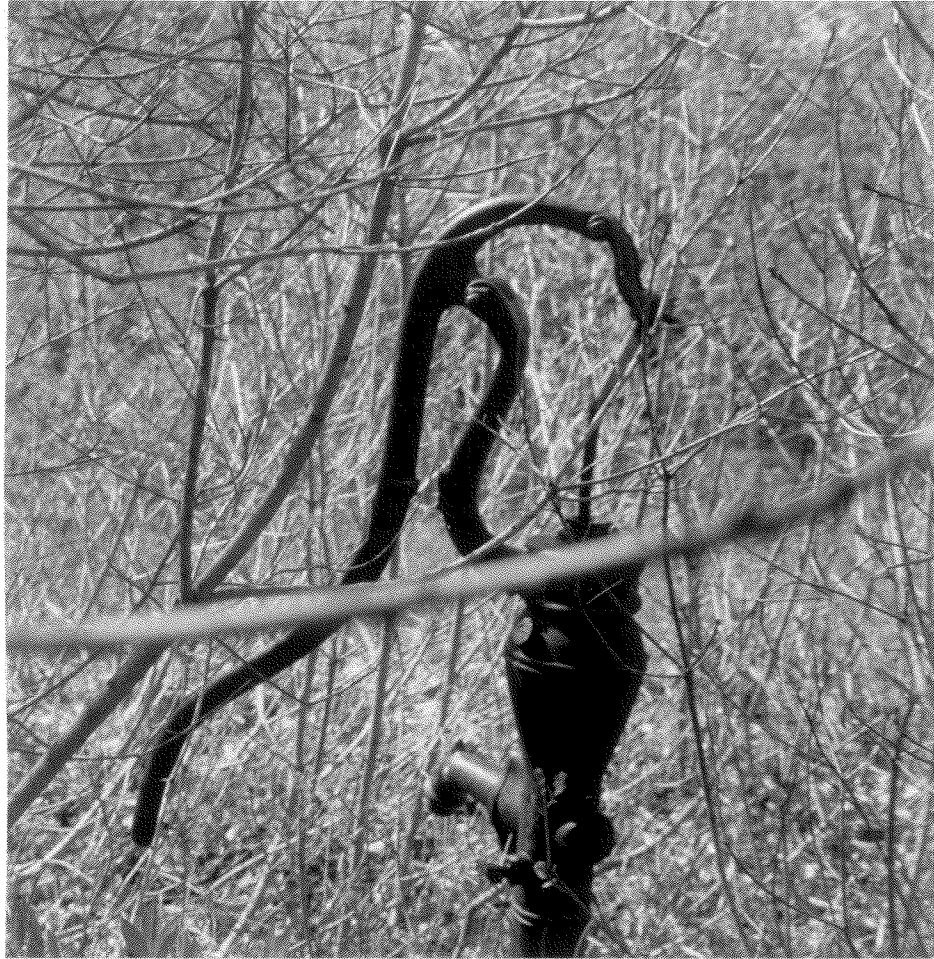
Figure 92 - Photograph of water pump (site of Greenhouse) from the west, 1996.
This pump is all that remains visible from the Greenhouse development located in this sheltered spot. Here it was screened from the New Approach Road, utilized in the period when the Greenhouse was built. [RMT].

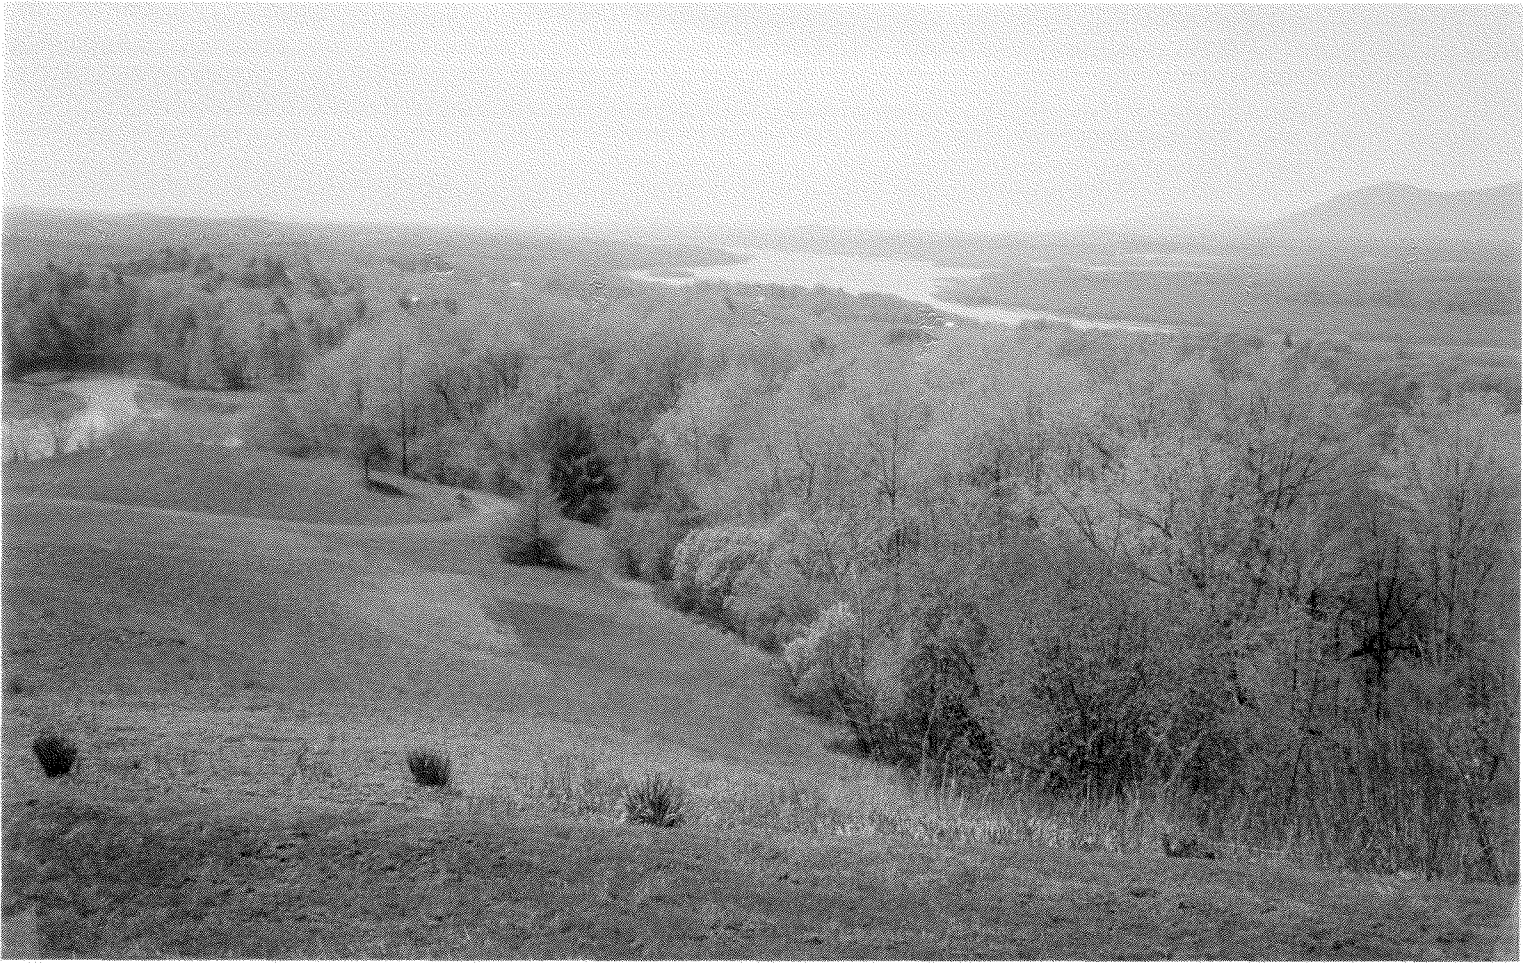
Figure 93 - Photograph of panorama from the lawn terraces looking southwest, 1996.

The panorama is centered on Inbocht Bay, a wide section of the Hudson River that creates a clear focus for the eye. The Catskill mountains to the west (right) balance and frame the view which is balanced and given interest by the park and Lake (left). A portion of the New Approach Road is seen in the meadow directly below the lawn terraces. Recent clearing of about 60 spindly maples along the immediate wooded edge has restored the long view to its earlier character. Views to the Rip Van Winkle Bridge (out of view to the right) have been screened by preserving taller trees in that direction. View management requires selected clearing to allow the optimum composition - a process akin to Frederic Church's landscape paintings. [RMT].

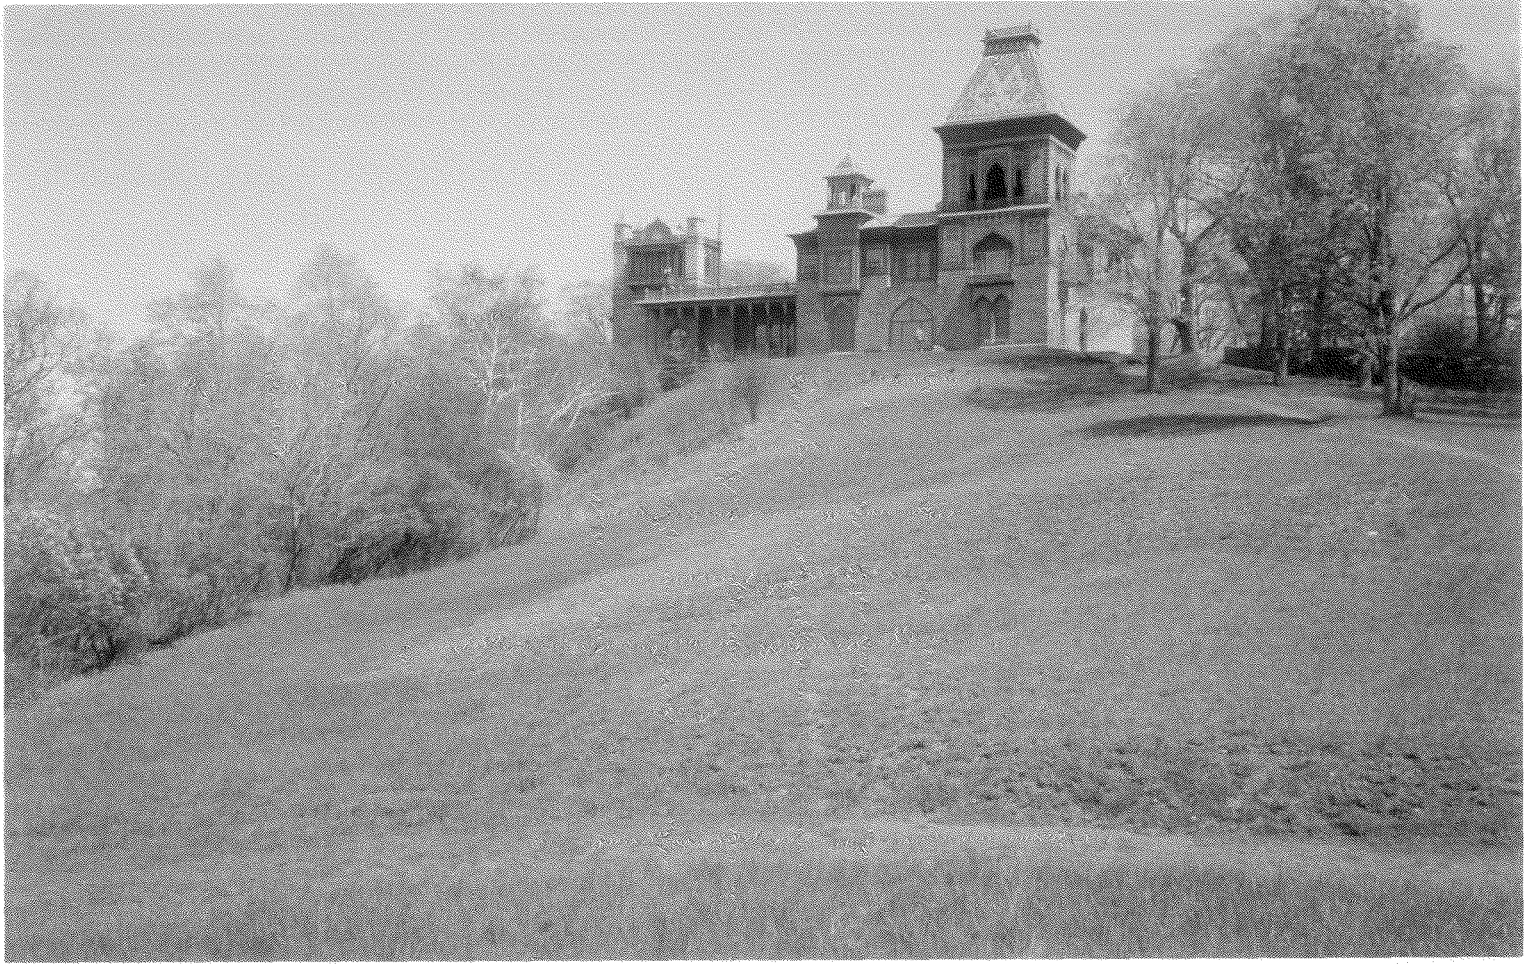
Figure 94 - Photograph of House from the south, 1996.

This view is experienced from the New Approach Road (foreground) as it winds its way through the park below the House. Today, the barren slope is devoid of the evergreen and deciduous trees that once covered this area (compare with figure 24). Note the informal footpath being formed by visitors on the slope to the right of the House. [RMT].

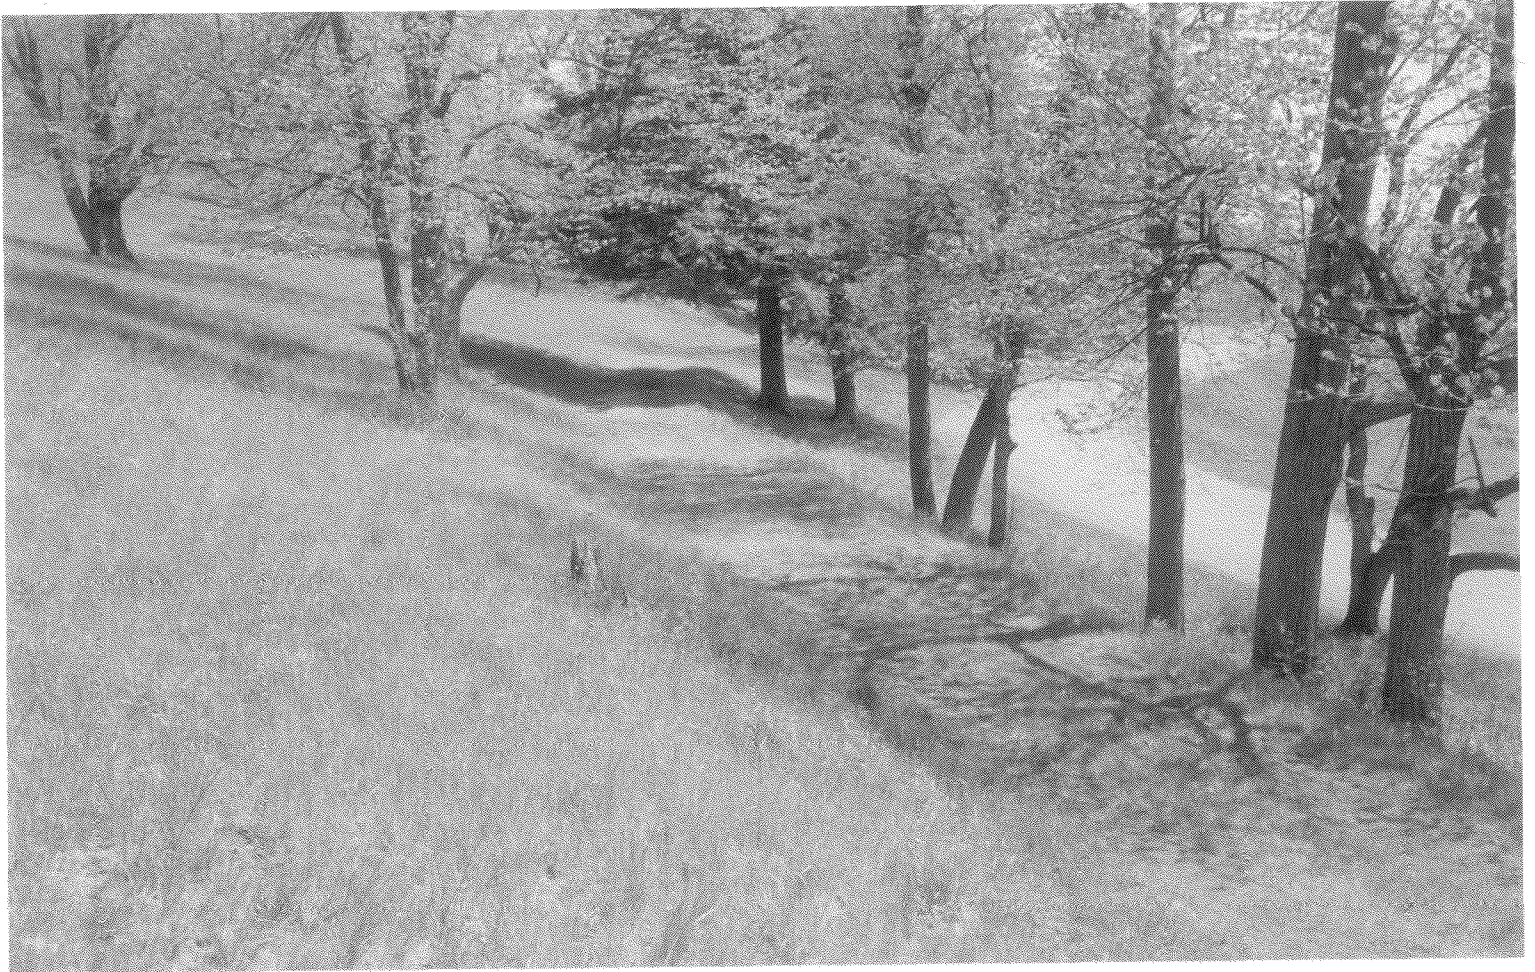
Figure 95 - Photograph of South Road from the west, 1996.

This view shows the New Approach Road, today a turfed path, beside a portion of the modern paved exit road. These routes were once part of a single carriage drive -- the South Road -- leading to the House from the south. The former dominance of white birch trees (compare with fig. 33) is much reduced today with only a few birch still present. [RMT].

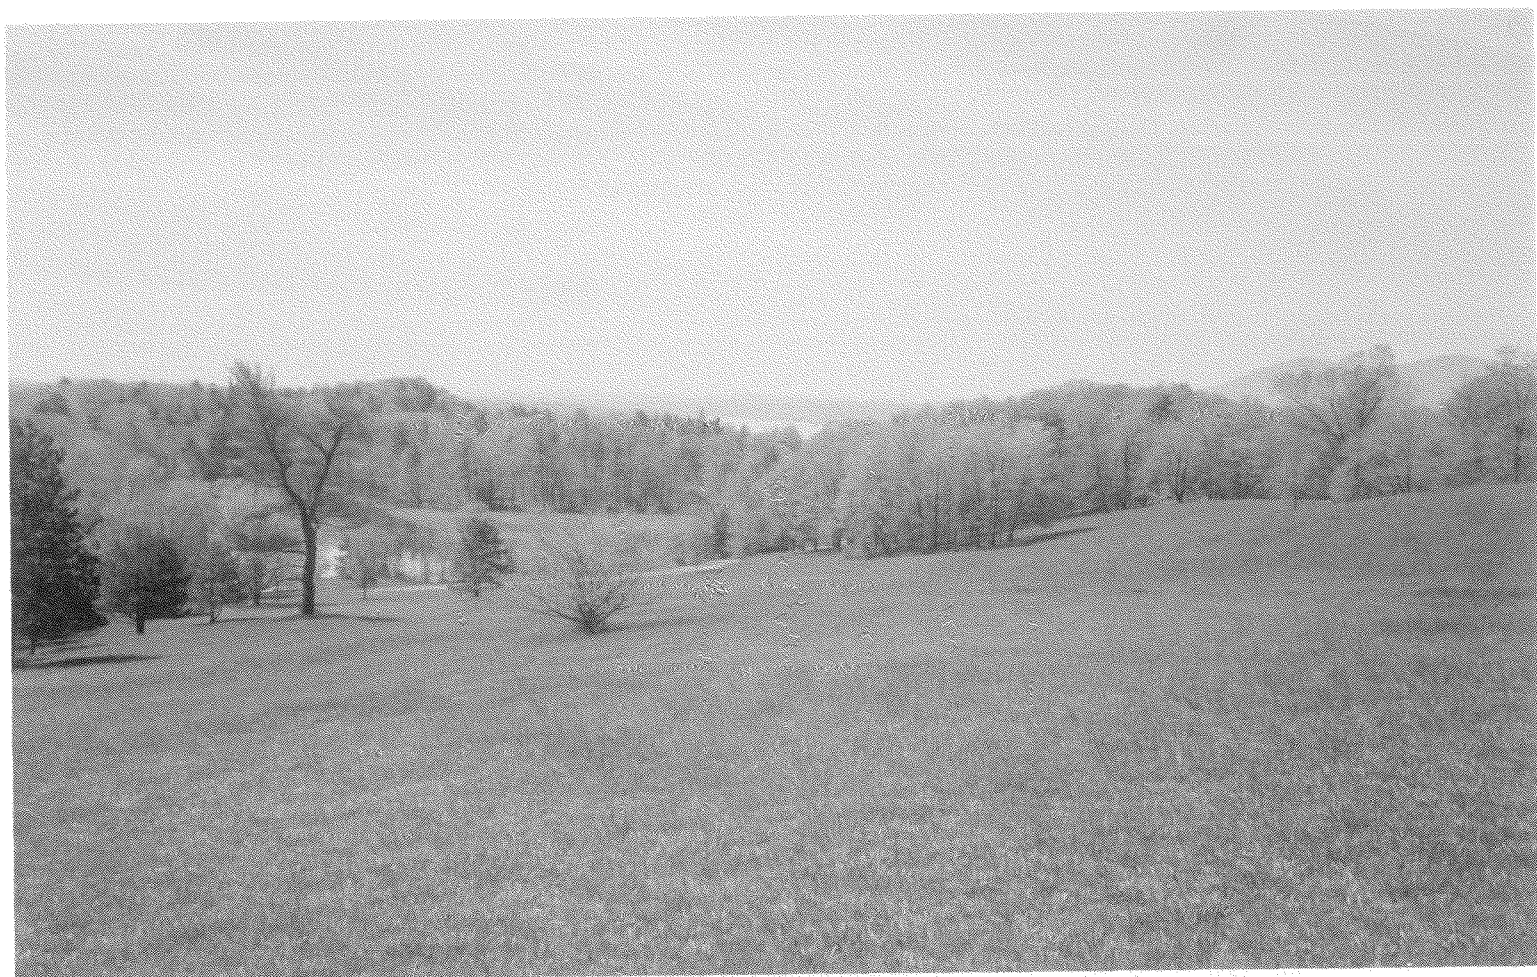
Figure 96 - Photograph of park and Lake from the northeast, 1996.

This view can be studied along side earlier images (compare with figure 35). The Lake is seen below (south). The distant Catskills are visible on the right (west). Quarry Hill, once a prominent foreground feature (see figures 15 and 16), is today an inconspicuous high point masked by a canopy of second growth trees (left of distant Catskills). In the open park, few specimen trees remain. [RMT].

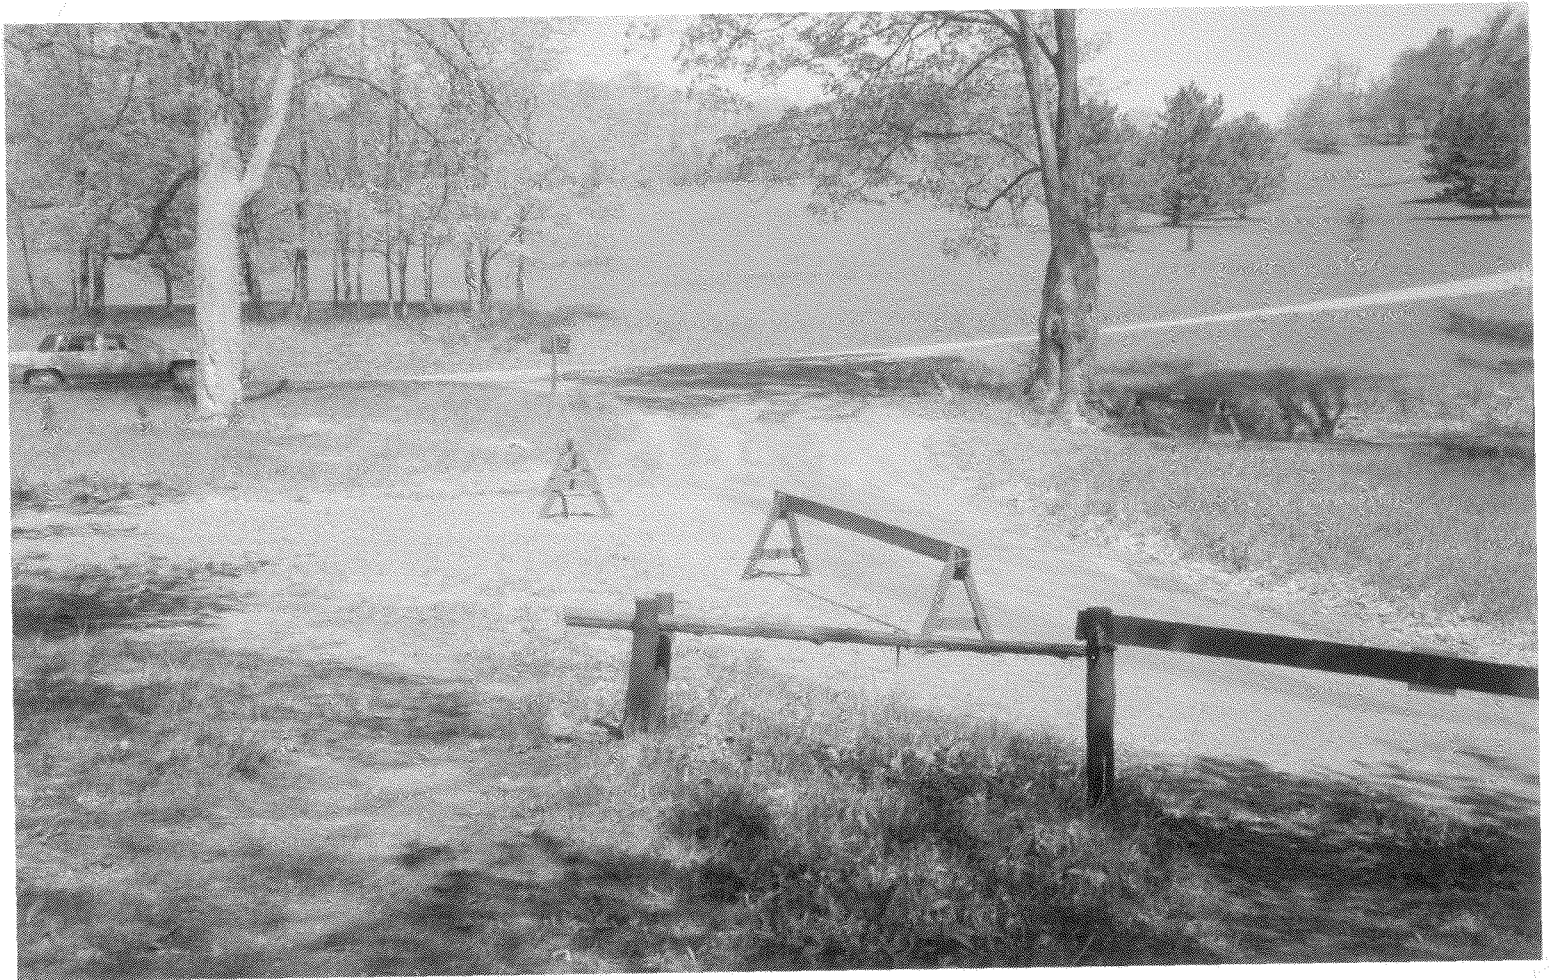
Figure 97 - Photograph of five-point intersection from the southeast, 1996.

In Church's period, this scene was a meeting of several carriage roads (see: 1886 Plan, fig. 22a). The lower Farm Road entered from the west (left) crossing in front of the large maple tree seen here (in front of the automobile parked on today's modern paved entrance road). The lower Farm Road then continued to the Barn, downhill to the east (right). Other roads coming together at this point include the driveway to Cosy Cottage, seen aligned beside the large maple tree on the right of the photograph, with a sawhorse blocking the way. An uphill Farm Road led toward the hilltop about as the modern entrance road goes today (upper right). The Lake road enters from the camera's viewpoint.

Today, this intricate arrangement of carriage lanes is cluttered with sawhorses, signs and a jumble of realigned and unrelated surfaces, including crushed stone on the left which has been spread to give access to the shore of the Lake. [RMT].

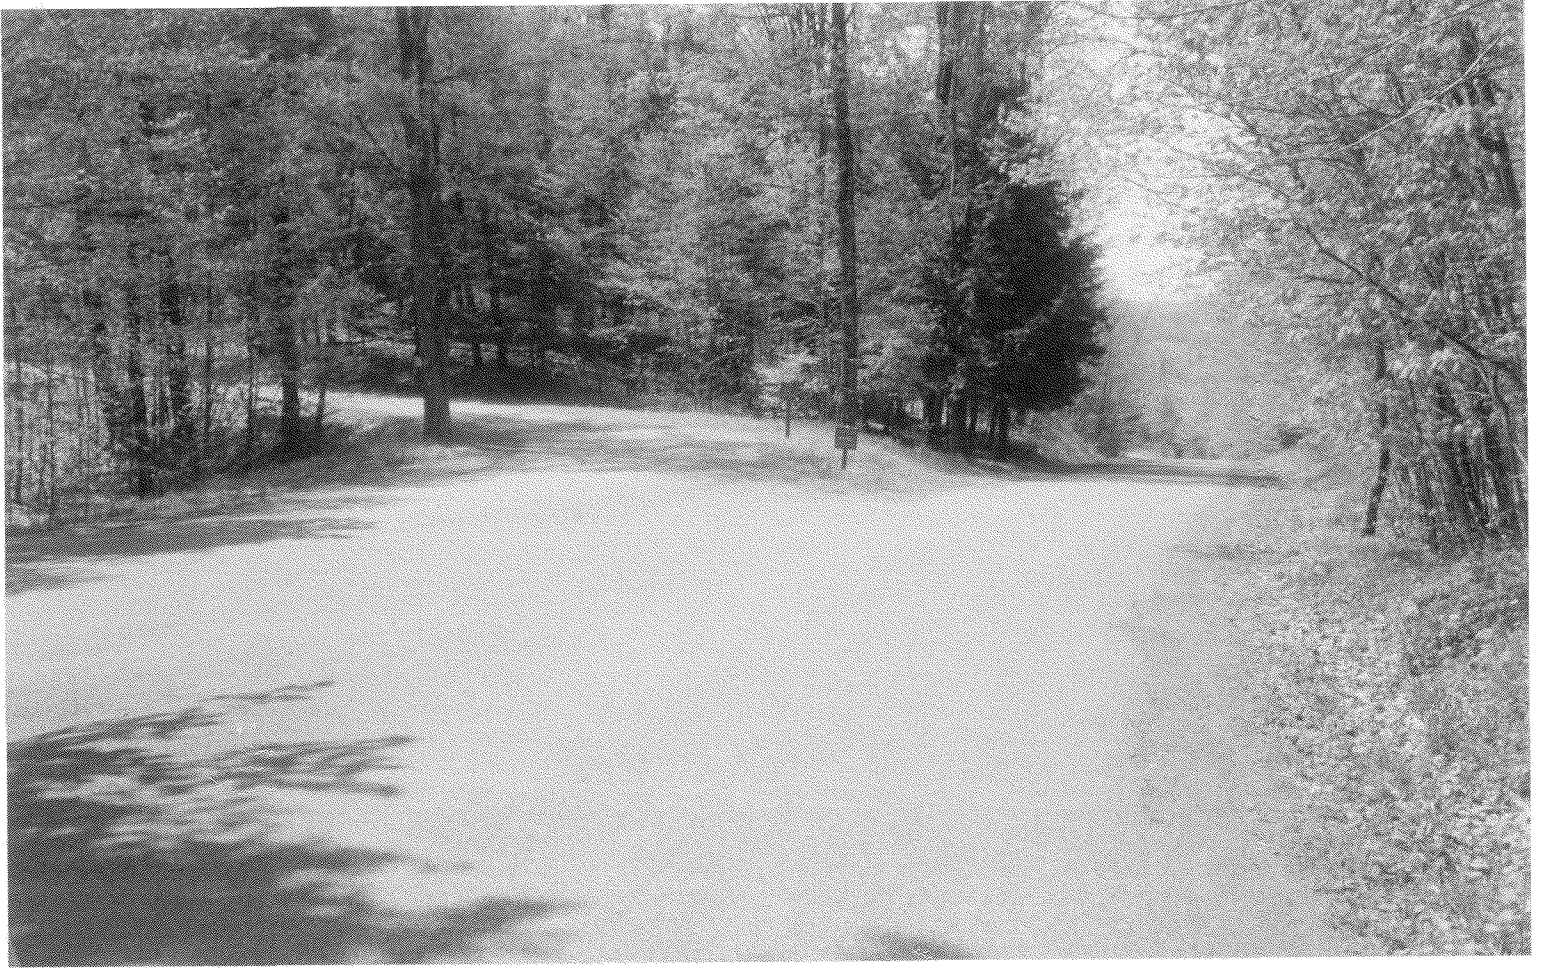
Figure 98 - Photograph of South Road and modern exit road from the north, 1996.

Standing on the South Road, the view shows the exiting orientation where a modern exit road (leading straight downhill to the right) is used instead of staying on the historic alignment (ahead to the left). Today, that route is used for entering traffic only. But from this point, access is detoured onto the lower Farm Road (off to the lower left) instead of coming straight to the camera and up the historic route. At this intersection, the historic South Road has been modified in fundamental ways. [RMT].

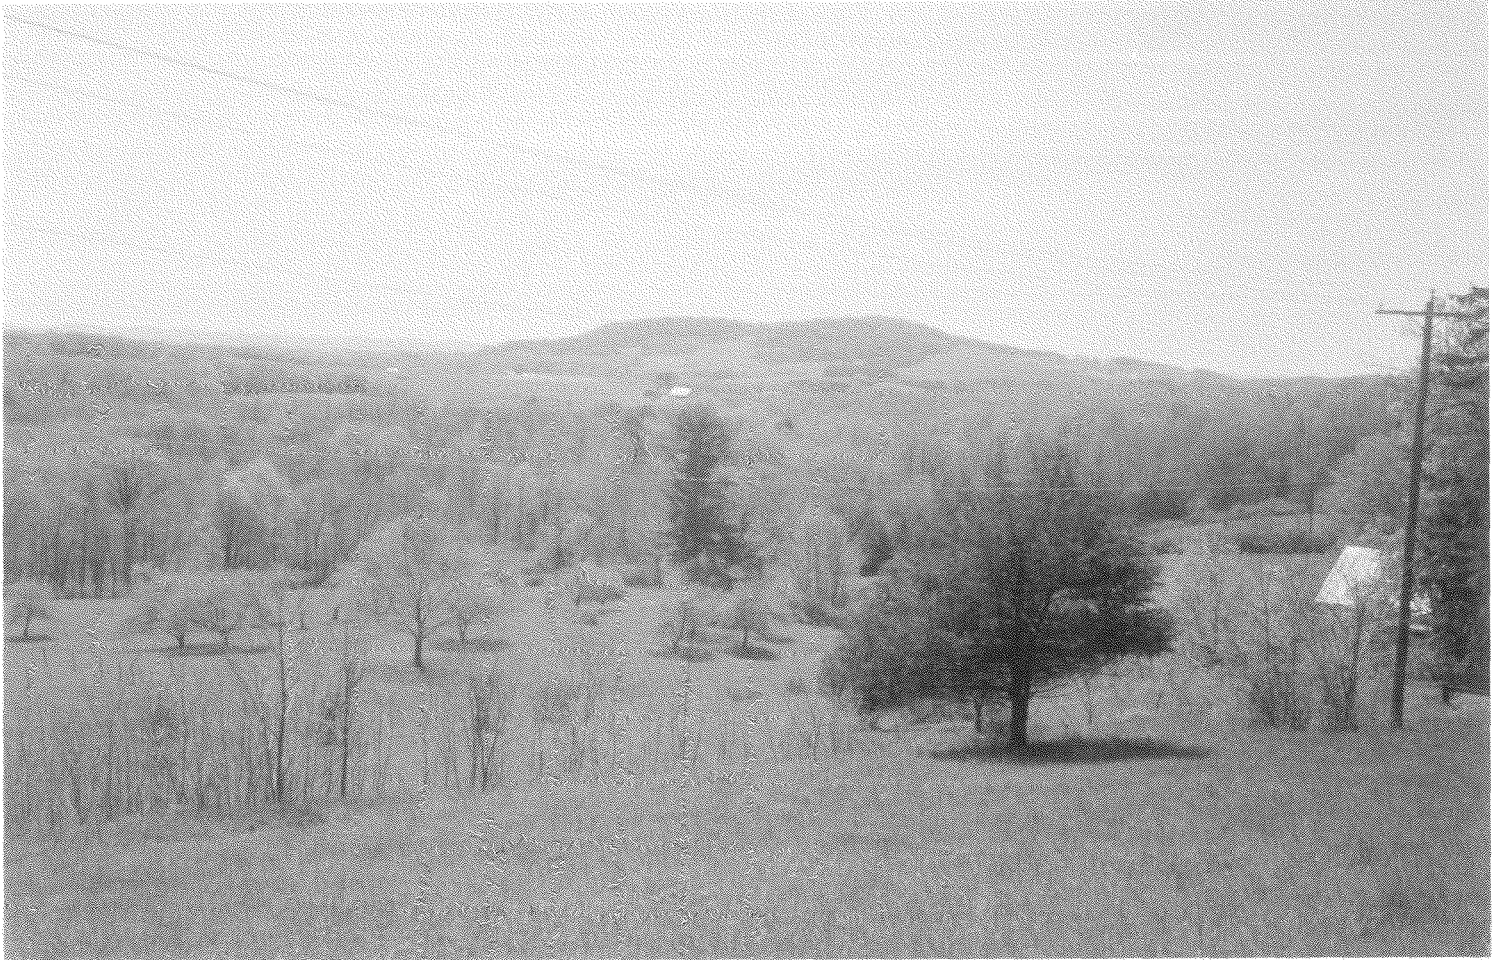
Figure 99 - Photograph of farm from the northwest, 1996.

This view looks over the site of the cottage garden, the Brezie farmhouse (now a ruin located just to the right of the lone pine tree in the middle distance), and the adjacent farmhouse lot (compare with figure 36). Today, little remains of the once extensive fruit trees. Note, Blue Hill in the distance, a prominent landmark in Church's time, today a vulnerable part of Olana's eastern viewshed. In the foreground, modern overhead wires bring electric service to the farm area. The shed north of Cosy Cottage is visible on the right. [RMT].

- **cottage garden** (fig. 99)

- **farmhouse lot** (fig. 99)

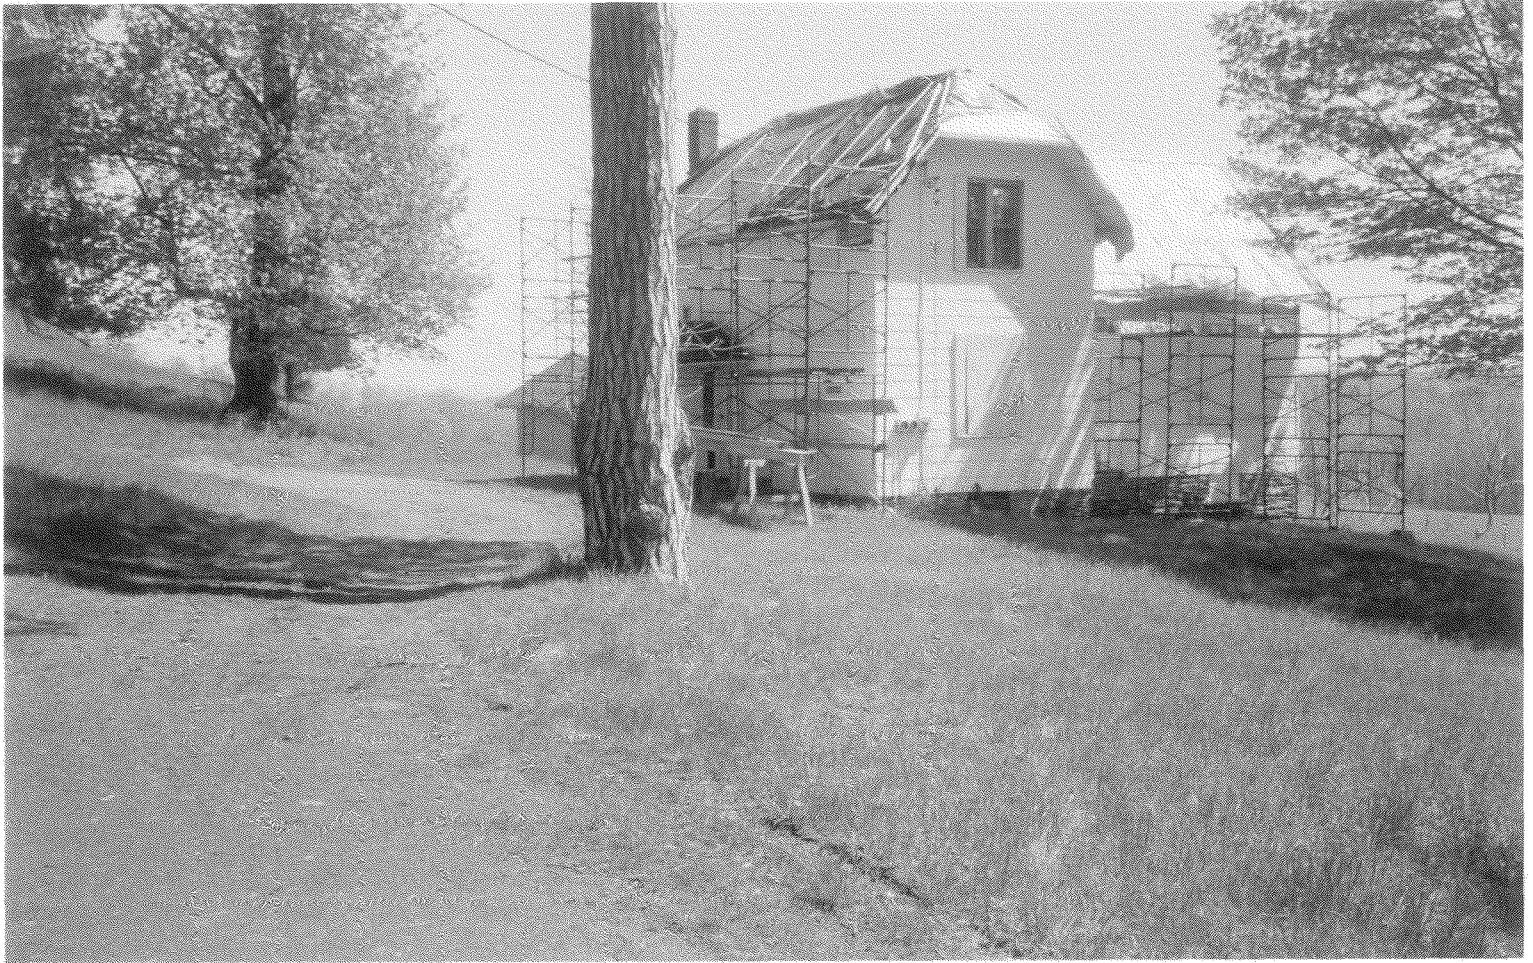
Figure 100 - Photograph of Cosy Cottage from the southwest, 1996.

Cosy Cottage is severely deteriorated and has lost both its residential appearance and several of its elements (compare with figs. 38 and 57). The foreground pine tree remains from the earlier plantings. The roof is temporarily covered with a tarpaulin. Scaffolding is in place in preparation for installing a new roof which was installed in the autumn of 1996. [RMT].

- **Cosy Cottage** (fig. 100)

- **cottage grounds** (fig. 100)

The area around the cottage is a lifeless and blighted version of its historic condition. The looping shale driveway surfaces are now obscured beneath turf. The road edges can still be traced and the lawn south of the cottage is now embowered under the mature trees seen in early photographs (fig. 38). Several pines believed to date from the historic period remain.

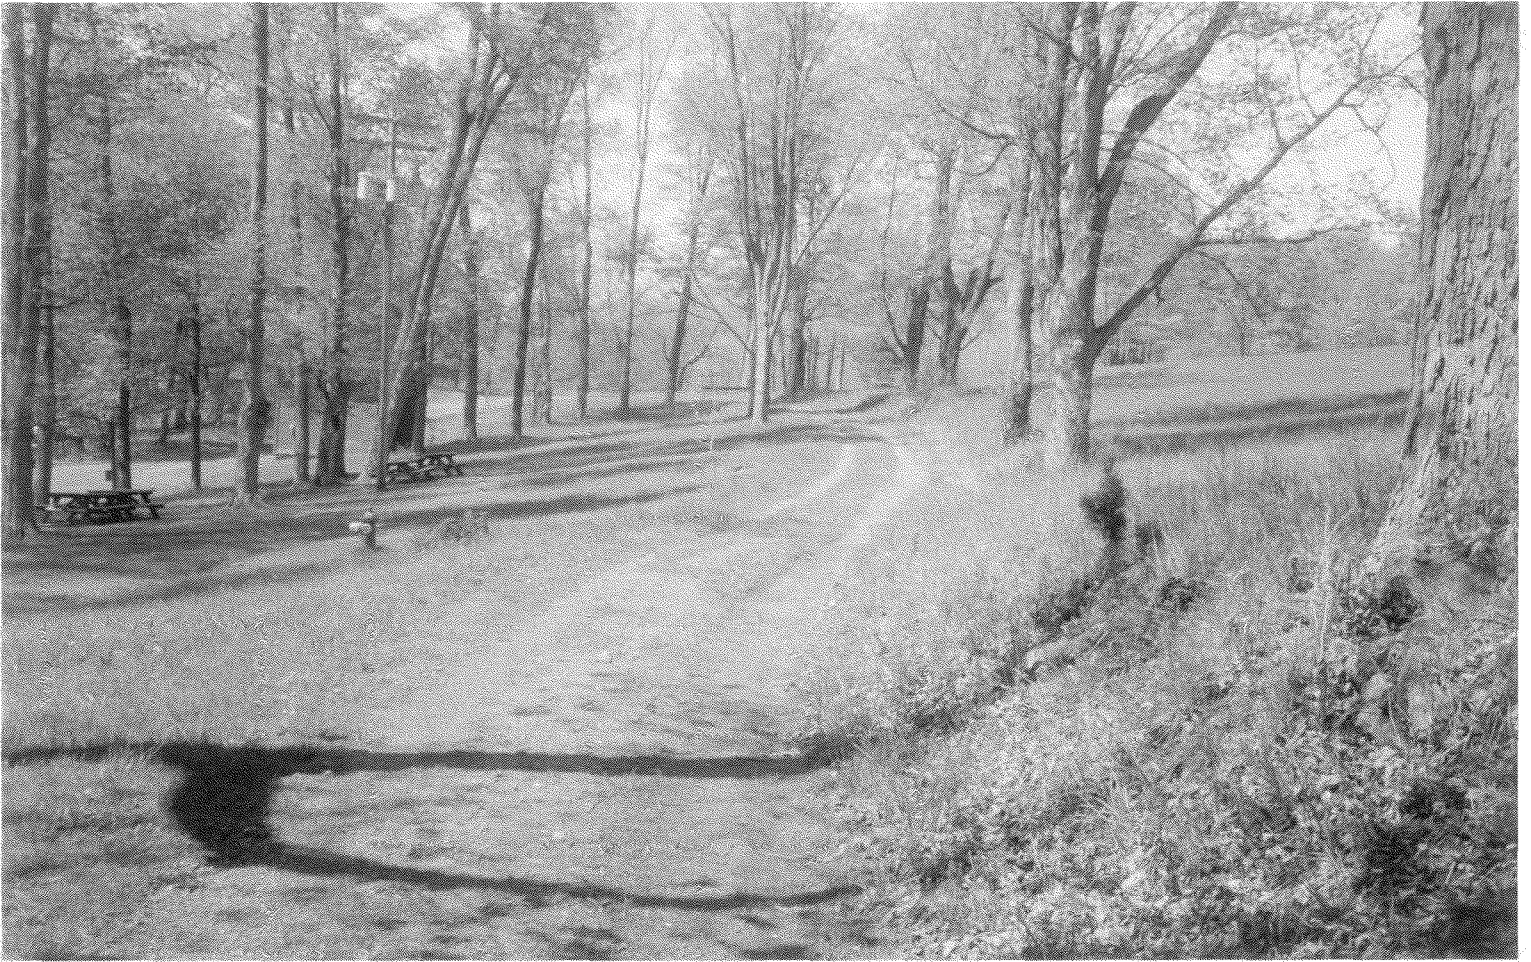
Figure 101 - Photograph of driveway to Cosy Cottage from the east, 1996.

Several old maples remain from the historic situation when this approach drive was planted with an arrangement of flanking trees (compare with figure 40). The driveway led to the five-point intersection, ahead. The pump house is seen in the distance behind a picnic grove that has been set up with tables south of the driveway. The lower Farm Road is seen behind the grove. [RMT].

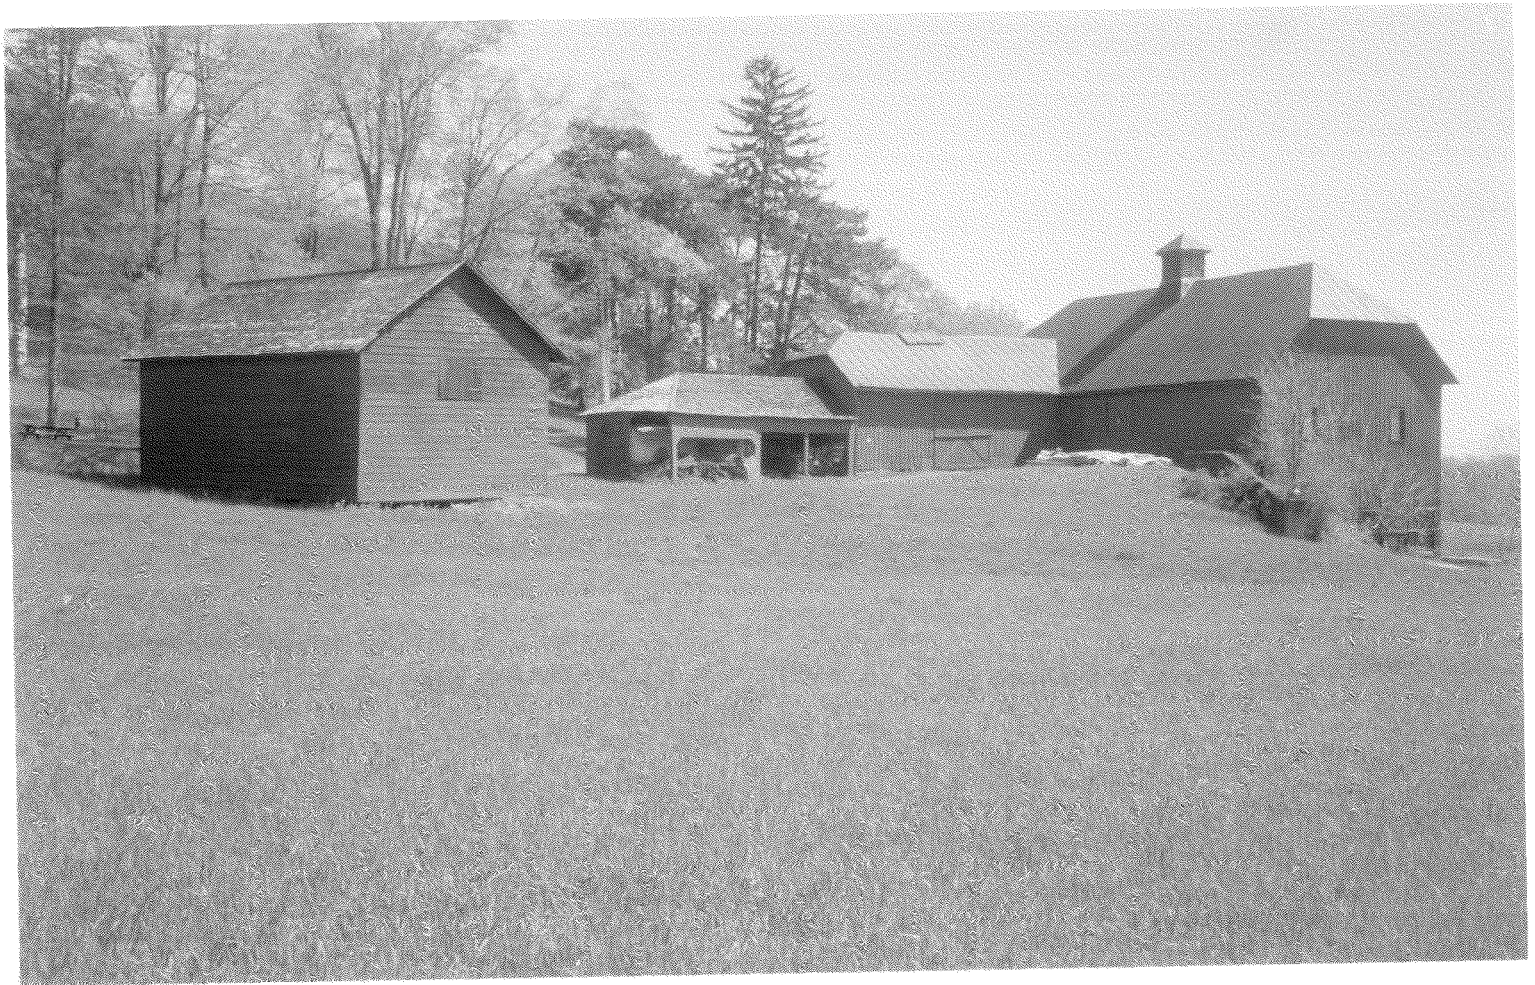
Figure 102 - Photograph of Barn, farm Stable and site of Kitchen Garden from the south, 1996.

The abandoned character of this scene is apparent (compare with figure 44). The 1899 dairy Barn and older attached smaller Barn (on the west) are in relatively good condition. The farm Stable is all that remains of an earlier cluster of attached structures that included the wagon house and lean-to sheds. Also missing today is a small building that occupied the south side of the Barnyard, thought to have been a Coachman's House and perhaps later a garden / tool shed. The Kitchen Garden Church installed in 1880 and irrigated from the Lake (off to the west, left in this view), is today the field in the foreground. [RMT].

- **Barn** (fig. 102)

- **farm Stable / wagon house** (fig. 102)

- **Kitchen Garden** (fig. 102)

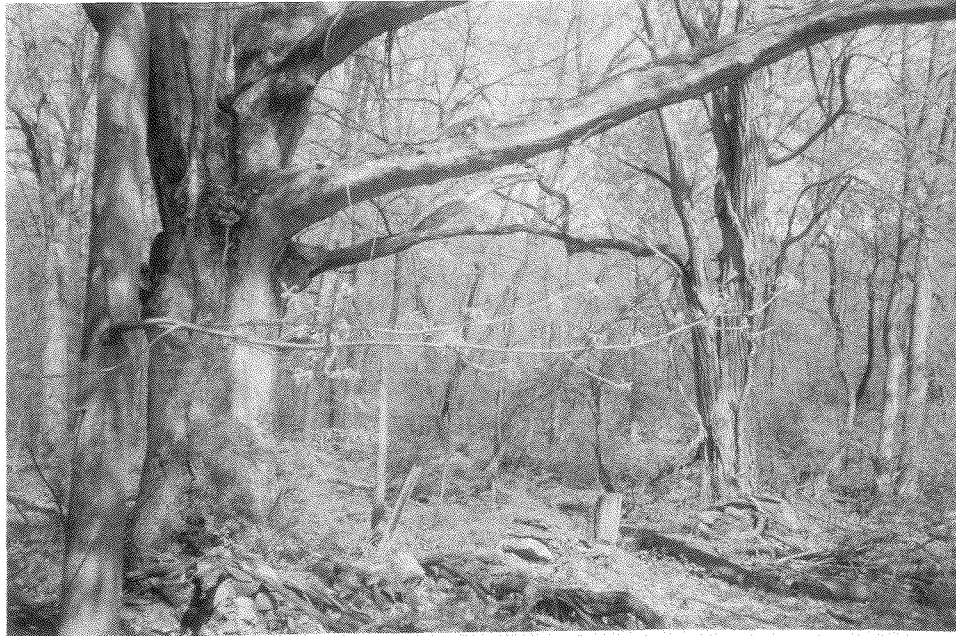
Figure 103 - Photograph of hedgerow (between east and west fields) from the southeast, 1996.

This is an old hedgerow delineated by a remnant stone wall. Mature oak, black locust and apple trees attest to its antiquity. In Church's lifetime, it separated the east and west fields that lay south of the Barn (see: 1886 Plan, fig. 22b). Today, the area is embowered in second-growth vegetation that is killing-off the lower limbs of the larger specimen trees. [RMT].

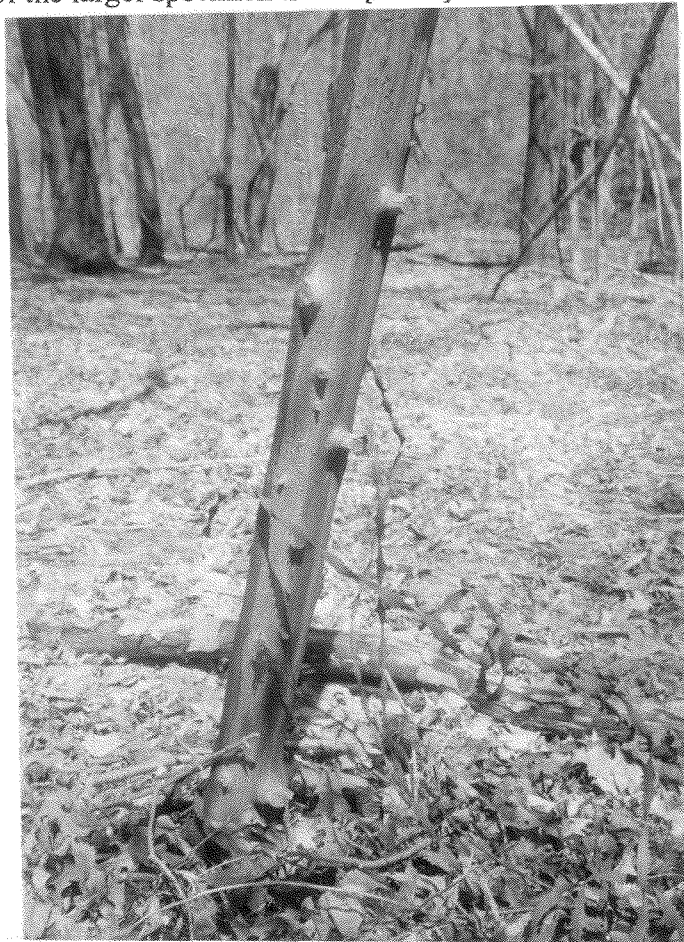
Figure 104 - Photograph of post with old barbed wire in southeast corner lot, 1996.

This old cedar post is all that can be found of a fence line installed by Frederic Church after his construction of the Crown Hill Road in 1885. The barbed wire is of a type that was manufactured briefly during this period. After Church's death, the fence was dismantled. Here a roll of wire was left beside the post, abandoned early in the 20th-century and left undisturbed it is now lost in the second-growth woods that have grown up in the past 50 years. [RMT].
