Historic Landscape Report

OLANA STATE HISTORIC SITE HUDSON, NEW YORK

December, 1996

Robert M. Toole
Landscape Architect

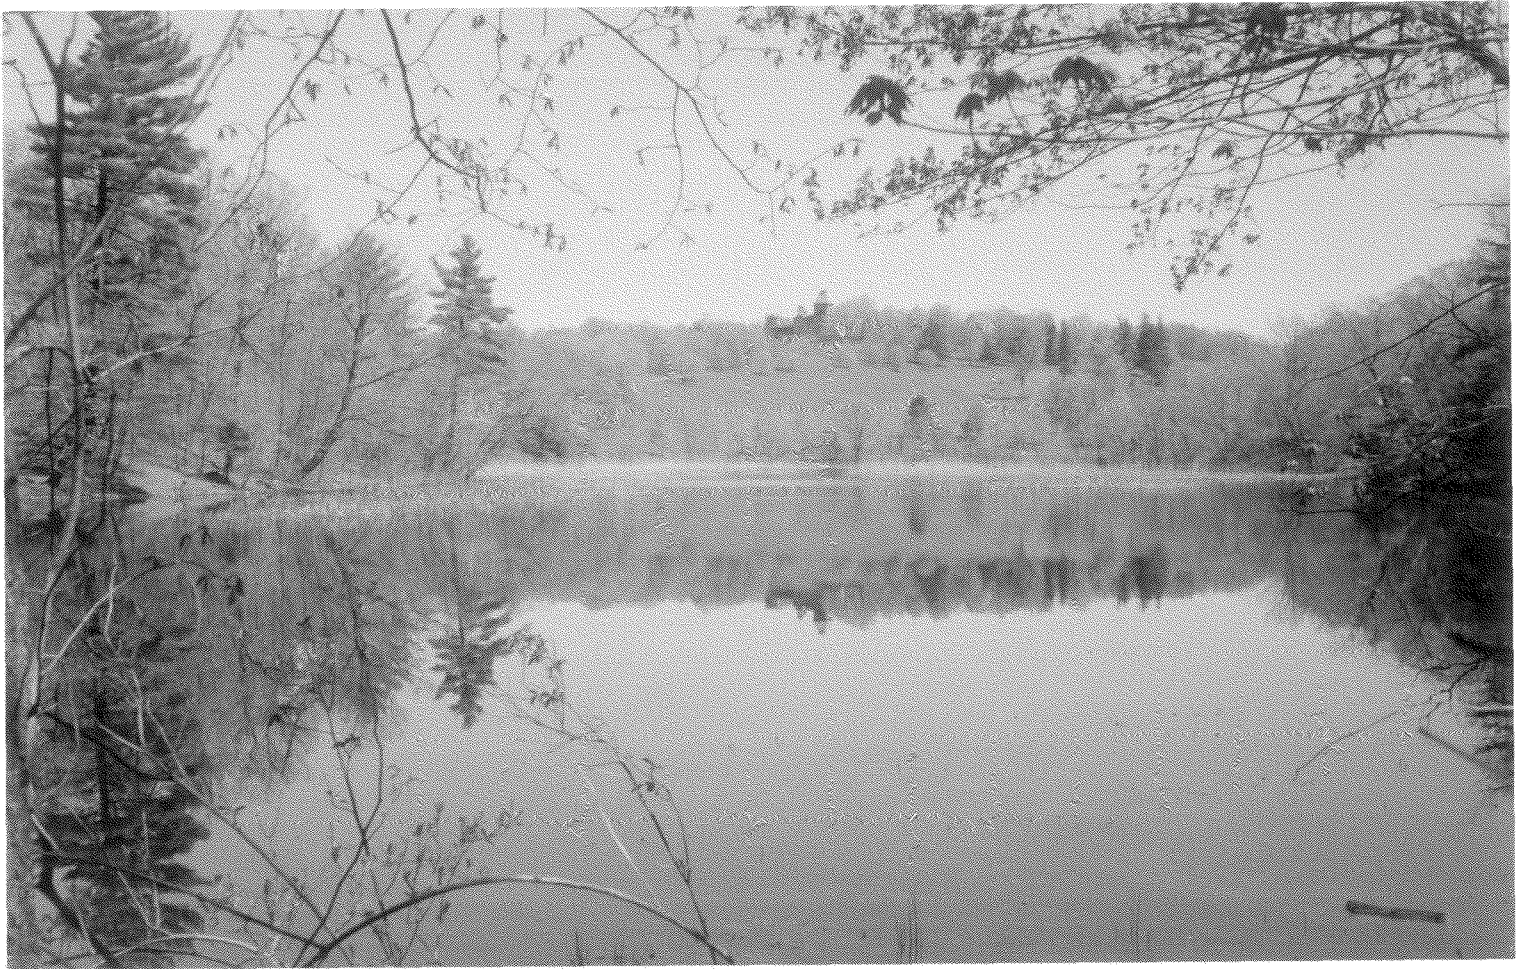
Figure 105 - Photograph of Lake, park and House from the south, 1996.

The spring photograph was taken before the emergence of rampant vegetation that by summer would have obliterated the open water. While a variety of factors are at work, the Lake has been slowly filling up with muck and its water depth has been reduced to inches in some areas. After this photograph was taken New York State began an extensive dredging operations that will -- in two seasons -- excavate a quantity of muck that Frederic Church needed two decades to accomplish. Note, the park to the north (compare with fig. 34). [RMT].

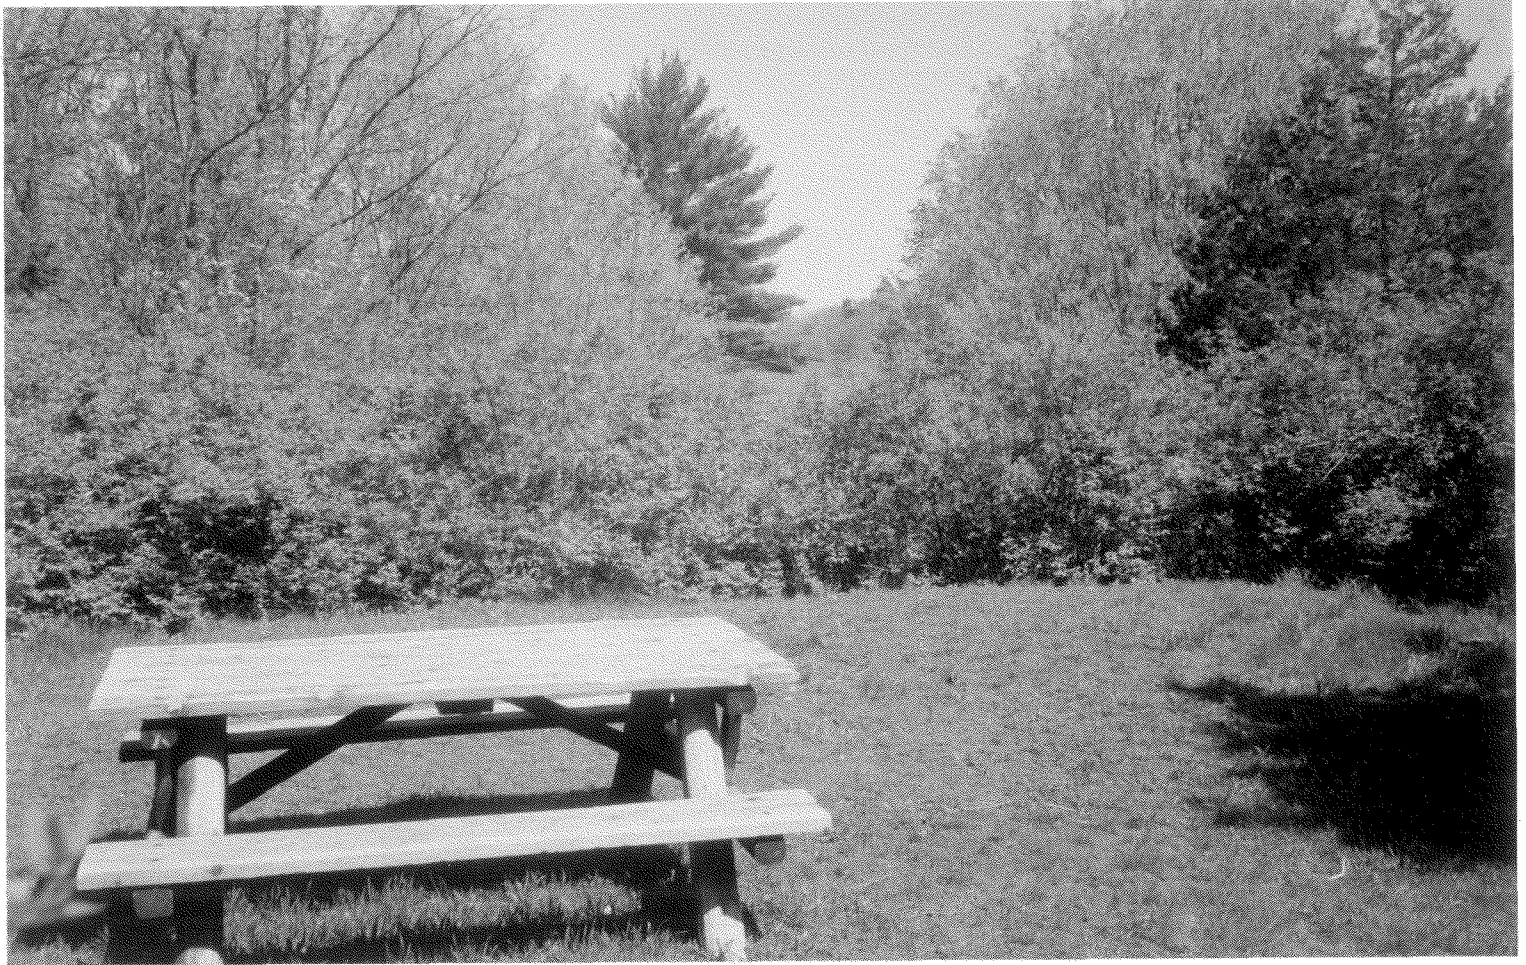
Figure 106 - Photograph of the view from Crown Hill looking north, 1996.

Taken from the turn-around at the top of Crown Hill, this view shows The House, barely visible through a narrow viewway cleared in the 1970s. But the historic panorama from this setting (compare with figure 45) has been lost to unchecked second-growth in the foreground, a situation that extends to the east (out of view to the right). The picnic table suggests contemporary use, but in fact the spot is seldom visited today due to its loss of amenity and distance from the House. [RMT].

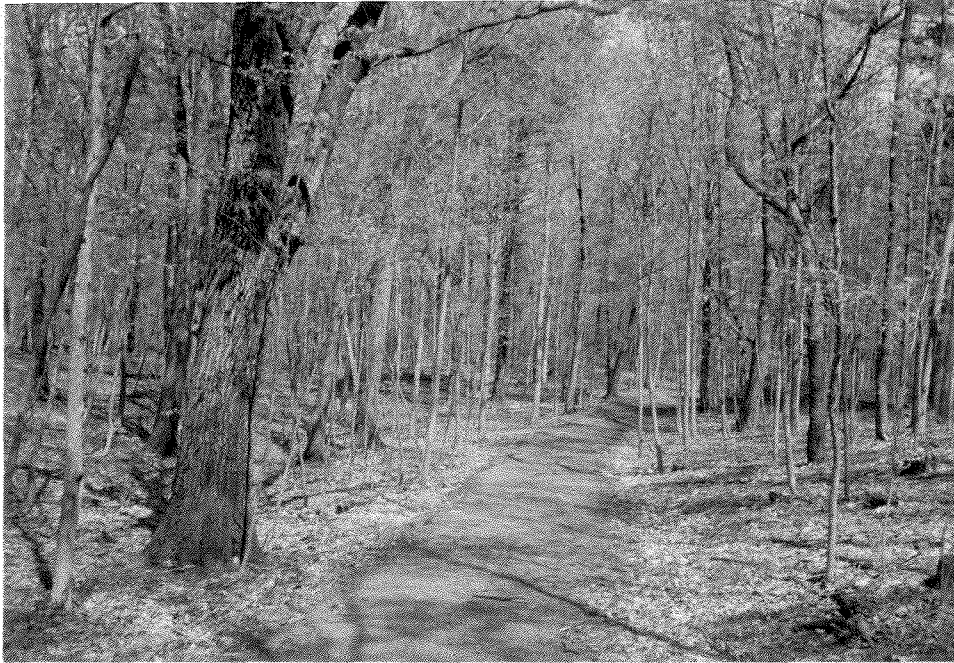
Figure 107 - Photograph of Crown Hill Road from the south, 1996.

This view shows Crown Hill Road as it descends from the summit. In Church's lifetime, there was a view ahead (compare with fig. 46). Note the few older trees and extensive second-growth of weed trees ahead. The road is now a walking trail. [RMT].

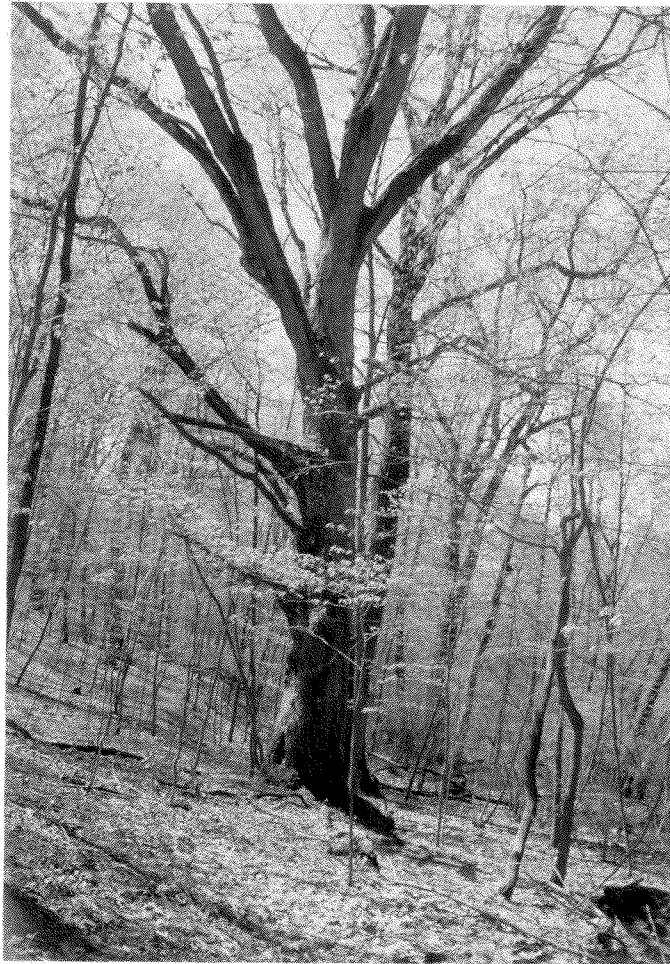
Figure 108 - Photograph of specimen tree along the Crown Hill Road, 1996.

As is the case elsewhere on the property, mature trees that were once featured in open areas -- as with this old oak tree along the Crown Hill Road -- are today struggling in second-growth woods. In foliage season, this photograph would be a blur of vegetation and the resulting deep shade is killing off the lower limbs of these trees which were intended as specimens. [RMT].

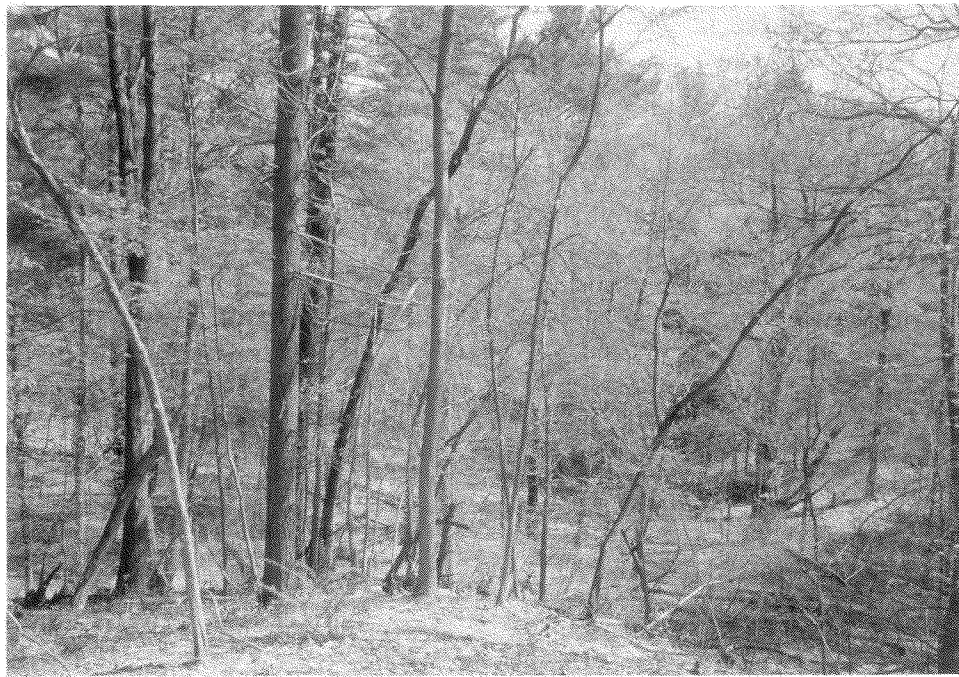
Figure 109 - Photograph of the view from Ridge Road looking north, 1996.

The view looks out over the formerly open north meadow (compare with figure 48) Today this is dense woodland. Note the larger tree in the right, middle ground. This is the same specimen seen in earlier images. [RMT].

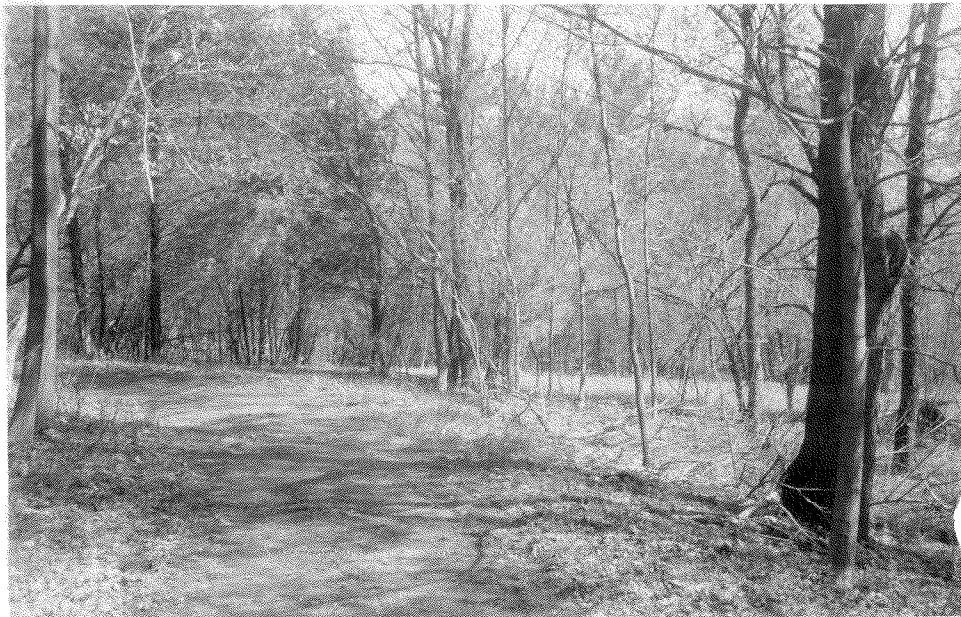
Figure 110 - Photograph of the view from Ridge Road looking northwest, 1996.

This is the northern limit of the Ridge Road (compare with figure 49). The road turns from here abruptly west and then south (to the left in the photograph). Today, only a diminutive clearing remains and all views are screened even outside foliage season. Note the single older tree near the road edge on the right. [RMT].

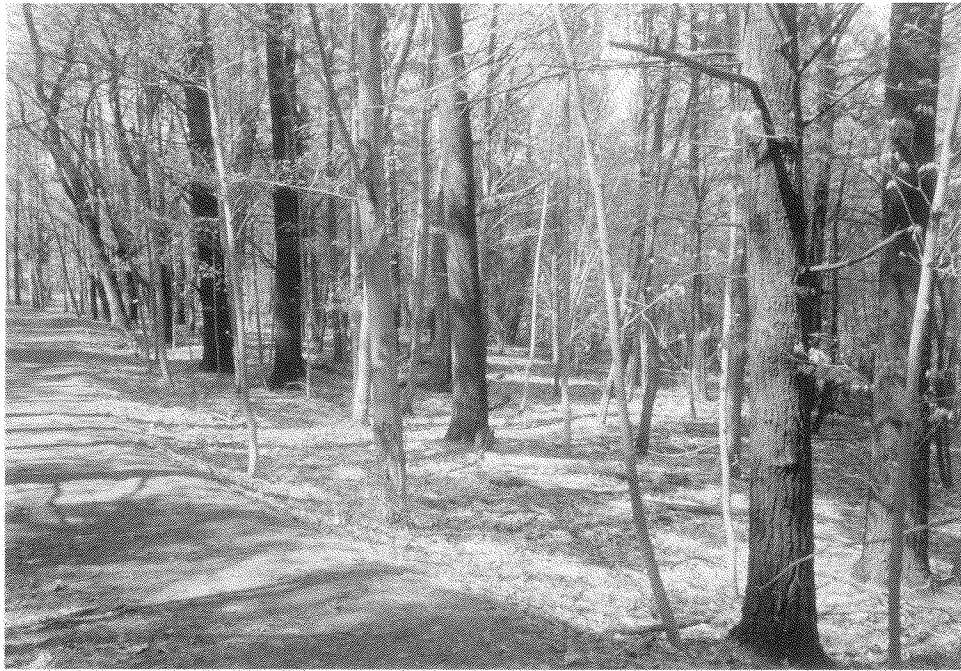
Figure 111 - Photograph of the view from Ridge Road looking south, 1996.

This view shows the west side of the Ridge Road bordered by an irregular arrangement of old pine trees, whose black trunks are clearly visible. These pines may have been present as small trees in the last decade of Church's lifetime. As such, they may have been used to compose and orient the views outward. Today, the tall pole-like trunks are set in second-growth that obscures all outward views even outside foliage season. [RMT].

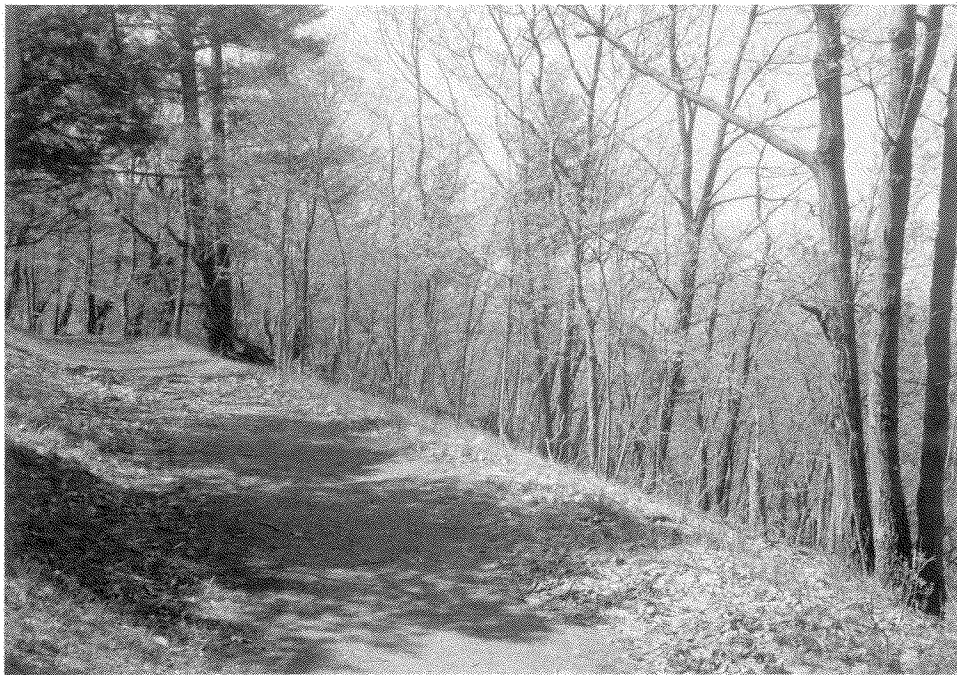
Figure 112 - Photograph of the view from Ridge Road entering woods looking southwest, 1996.

Here, the open Ridge Road approaches an old woodland edge that existed prior to Church's development (compare with figures 51 and 52). Even here, where views were preserved by the sharp descent of the topography, second-growth has encroached to the point where foliage screens all outward prospects. [RMT].

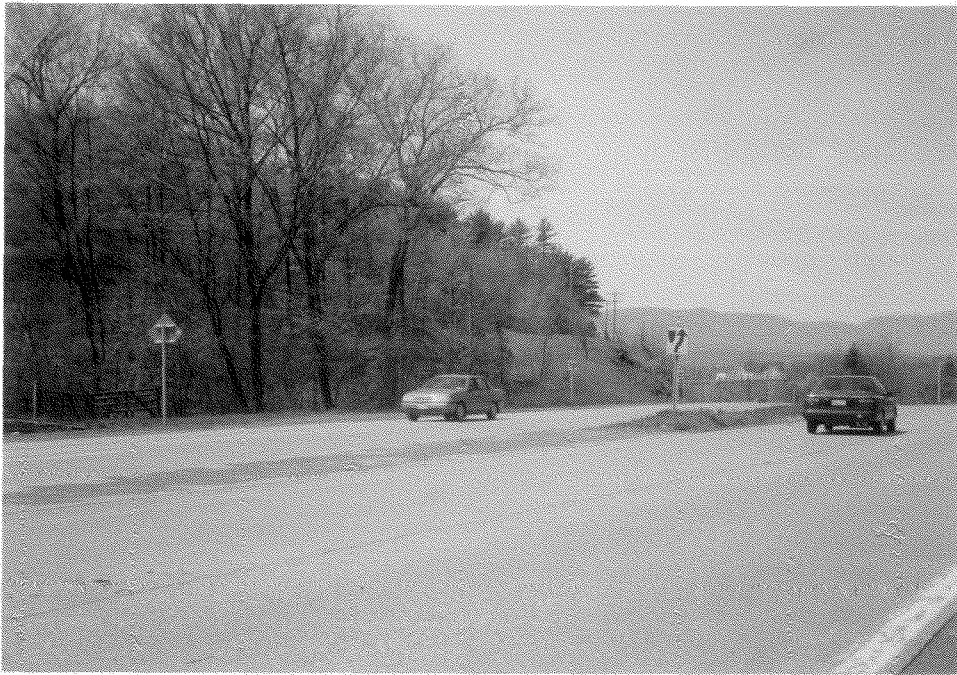
Figure 113 - Photograph of modern Route 23 as it crosses Olana, looking west, 1996.

This section of modern, divided highway was constructed in 1960 as part of highway improvements leading to the Rip Van Winkle Bridge, ahead. The severed North Road can be seen gated, beside the sign on the extreme left, with the older trees behind once part of the wooded North Road corridor. The North Entrance is out of view to the right. Today, it is an isolated remnant parcel (see fig. 75). [RMT].

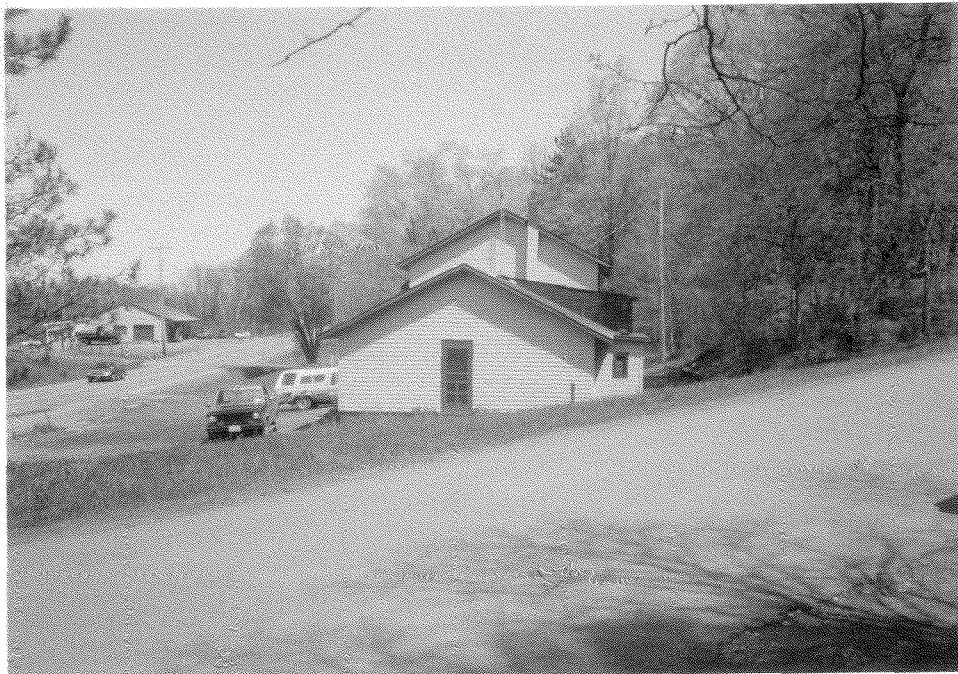
Figure 114 - Photograph of South Entrance from the south, 1996.

Olana's present entrance, the historic South Entrance, is in the foreground, with Route 9G ahead. The building just ahead was a restaurant before its purchase by New York State in 1968. It is now the Taconic State Park Region's restoration shop. Across Rt. 9G in the distance is a Taconic Region maintenance depot, a former fruit stand, located on a neighboring property also purchased in 1968. These developments do not enhance amenity at Olana's modern entrance. [RMT].
